## MEMORANDUM

SUBJECT: SUBMITTAL OF OUTFALL INSPECTION USING DEEPTREKKER  
REMOTELY OPERATED VEHICLE (ROV)

OUTFALL: MOKAPU OUTFALL

SAMPLING DATE: 09<sup>TH</sup> SEPTEMBER 2024

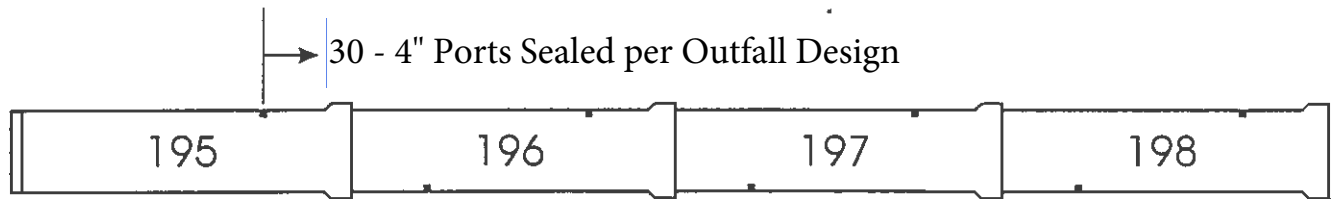
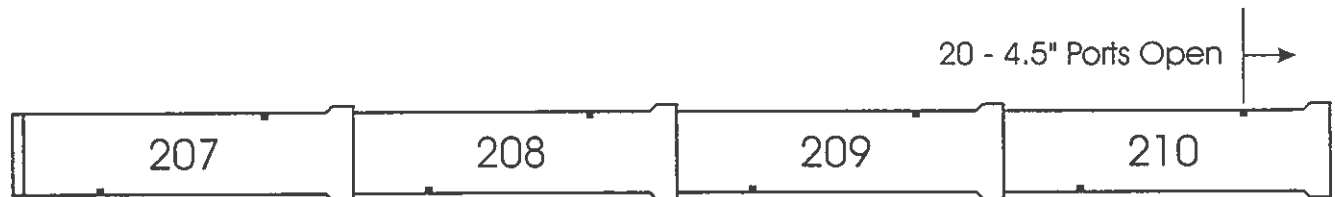
# Mokapu Outfall Diffuser (1 of 2)

1. Ocean Team's DeepTrekker ROV was used to record the inspection.
2. The Tremie concrete covering the pipe on the inside section and armor stone appears to be in good condition.
3. The pipe is flowing in diffuser port segments 210-235 on both shoreward and seaward ports, with the following exceptions: Per the outfall design, the shoreward (A) port of segment 210 is sealed, while the seaward (B) port is flowing. The seaward (B) port of segment 230 is partially restricted, while the shoreward (A) port is flowing. The seaward (B) port of segment 233 is flowing, but the shoreward (A) port is partially restricted.
4. No evidence of effluent flow is observable from segments 195 to 209, as these segments are sealed per the outfall design. Coral growth was observed on these segments.
