# Natural History, Hydrology & Water Quality of Kaelepulu Pond

The Urbanized Estuary of Enchanted Lake

Robert E. Bourke  
*Kailua, Hawaii*

MAY 16, 2017

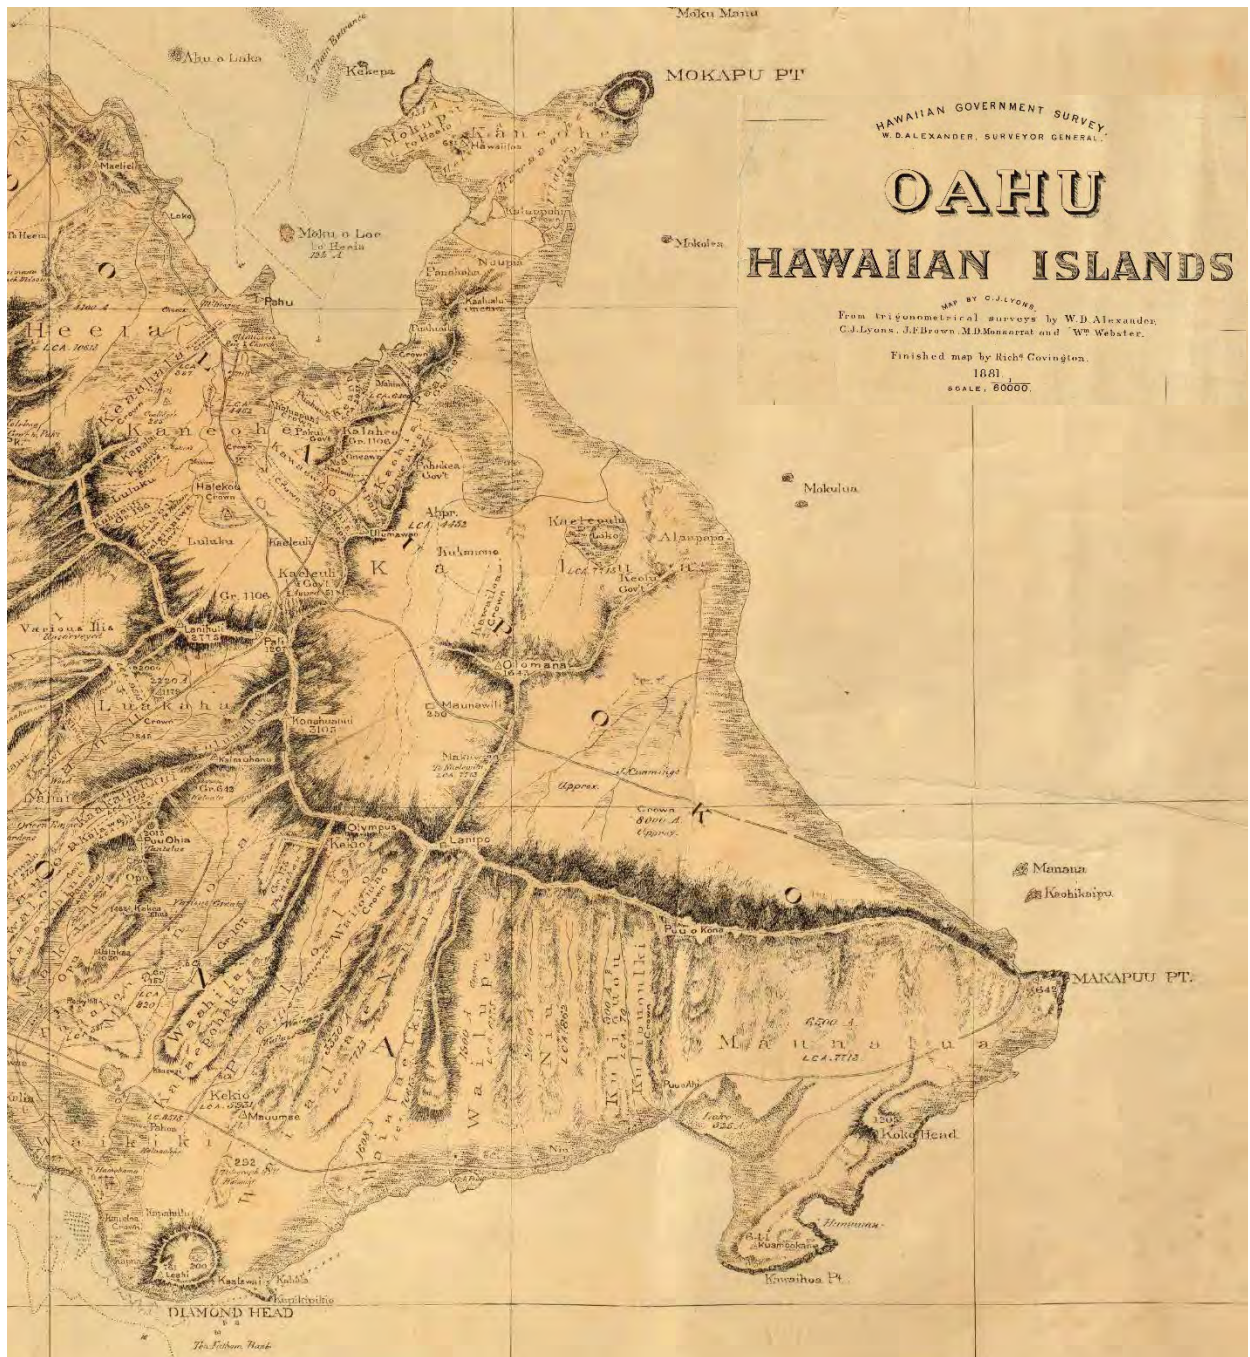
Figure 1. Section of Oahu map of 1881 by Rich Covington showing mouth of Kaelepu Stream about 1,000 feet west of its present location

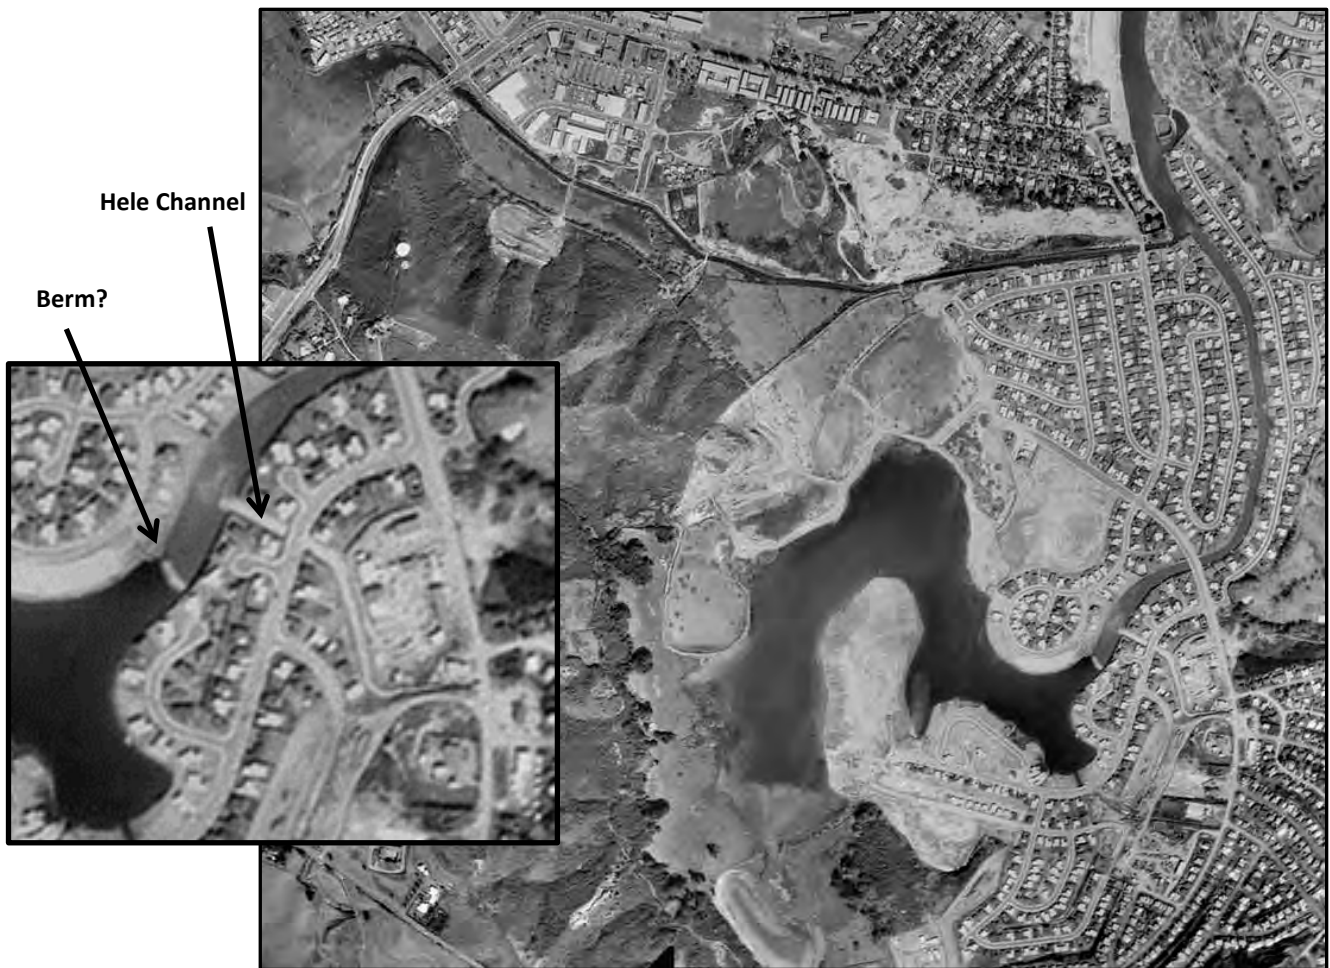
Figure 6. 1963 aerial photo of Enchanted Lake under construction. Note lack of Kawainui levee and presence of berm across stream exit from pond with heavy silt load entering from Hele Channel inlet (enlarged inset) where the stream channel is still very shallow. USGS: EKM-2CC-246, 1-14-63.

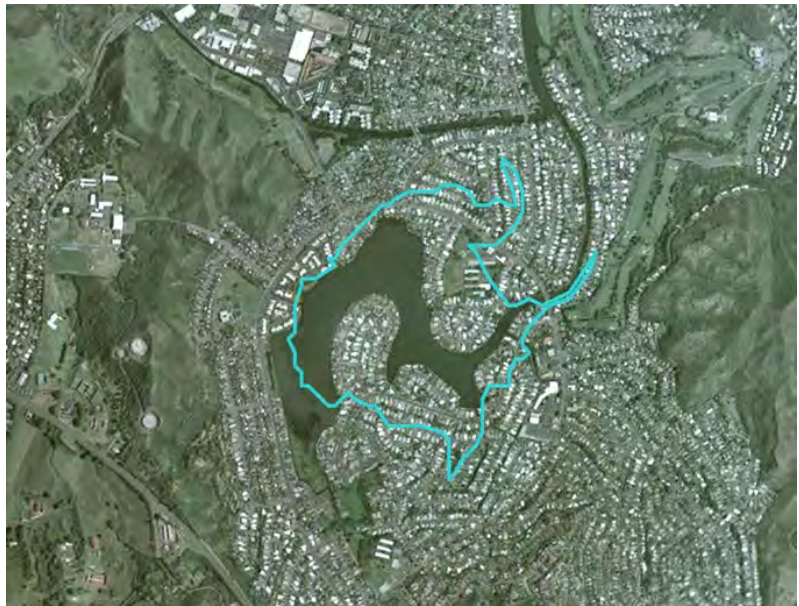
**Figure 7 Outline of the 1926 Kaelepulu Pond superimposed over present day Enchanted Lake.**

water surface area of about 135 acres to the estuary. As the community was constructed, each successive group of shoreline home lots was brought into the “Enchanted Lake Association” (ELA) for a total of 136 private home owners. An additional 37 home lots about the Kaelepulu wetland which, as it was outside the initial Bishop Estate properties leased to Lone Star, are not obligatory members of the community association (ELRA) who now own the lake. The present configuration of the pond has little resemblance to its historical footprint (Figure 7, Figure 8).

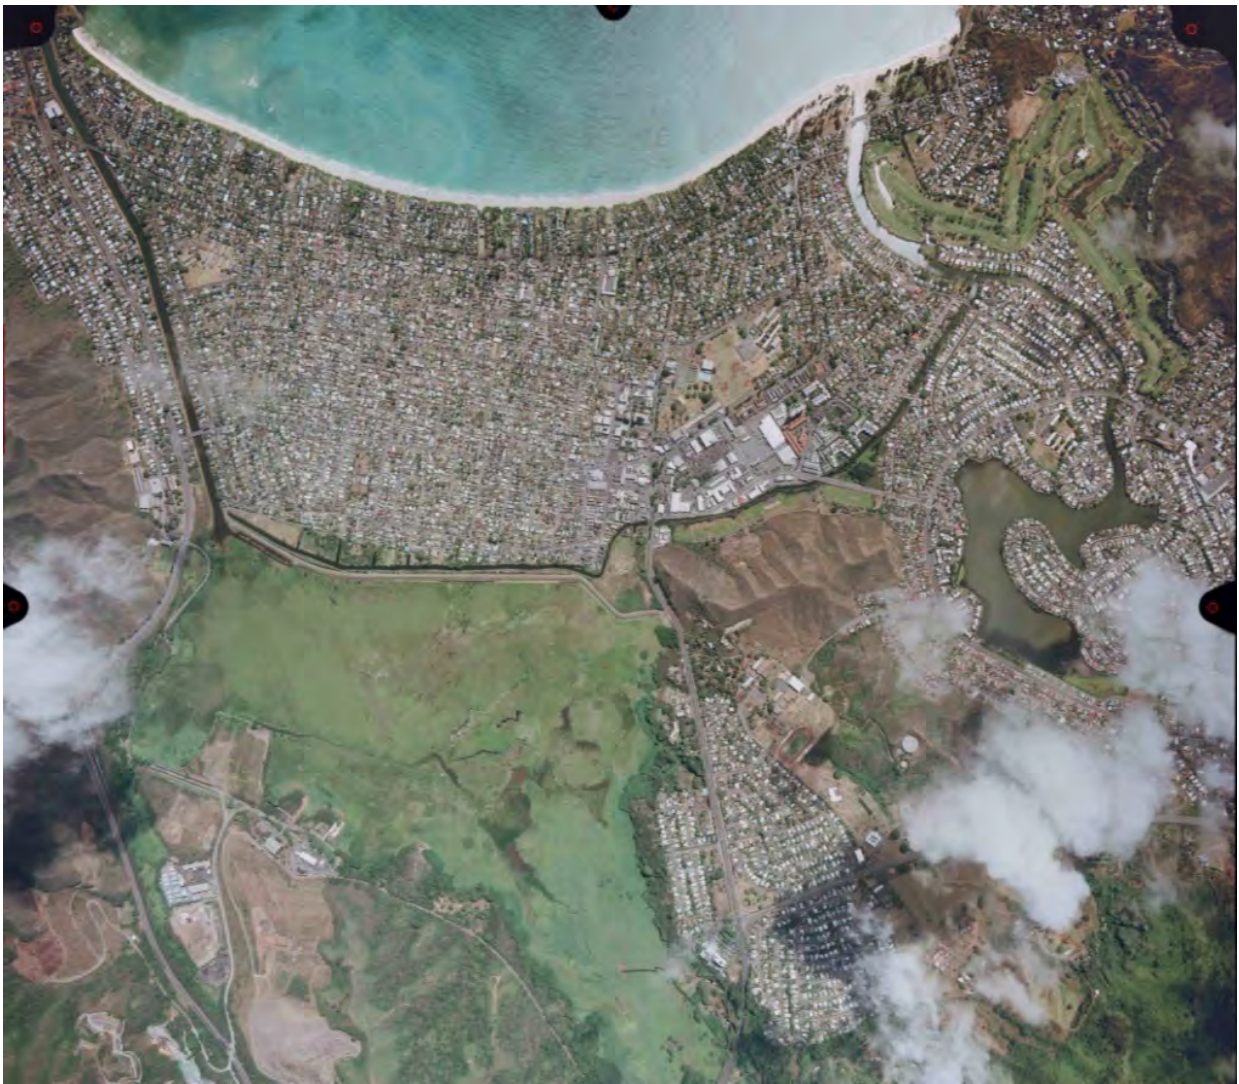
**Figure 8 1998 Aerial of Kaelepulu and Kawainui watersheds.**

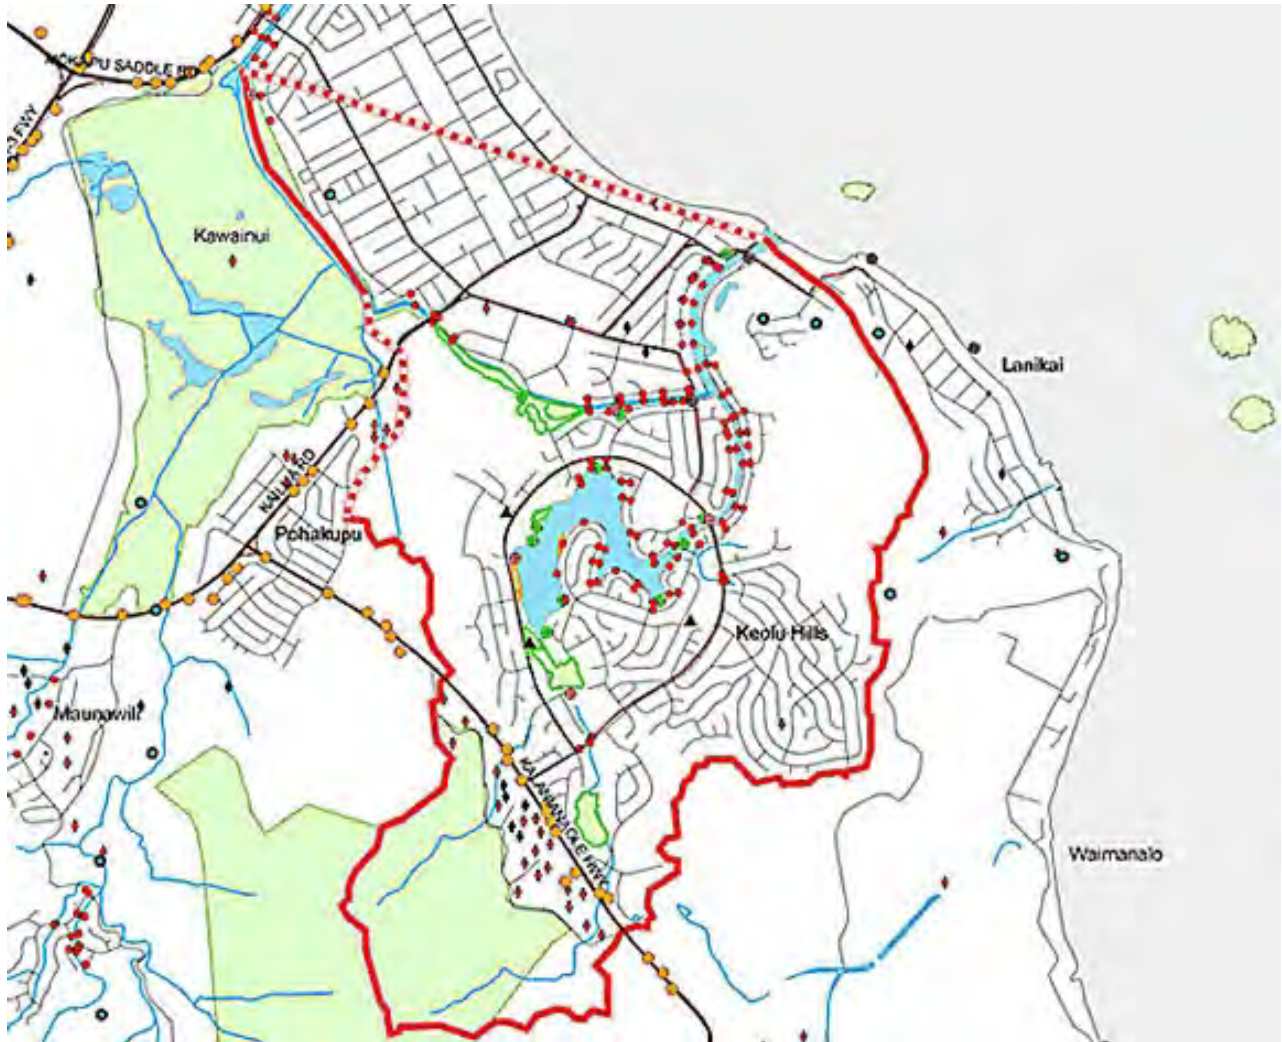
**Figure 9 Present day map with Kaelepu watershed boundary and effluent points from City storm drains.**

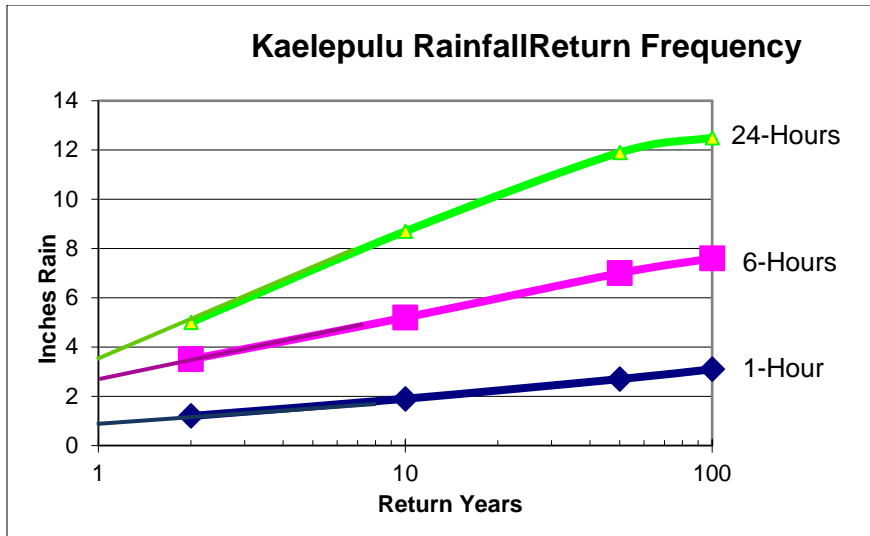
Figure 11 Rainfall long term expected incidence of large storm events at Kaelepulu. Derived from Gaibelluca et al. 2013

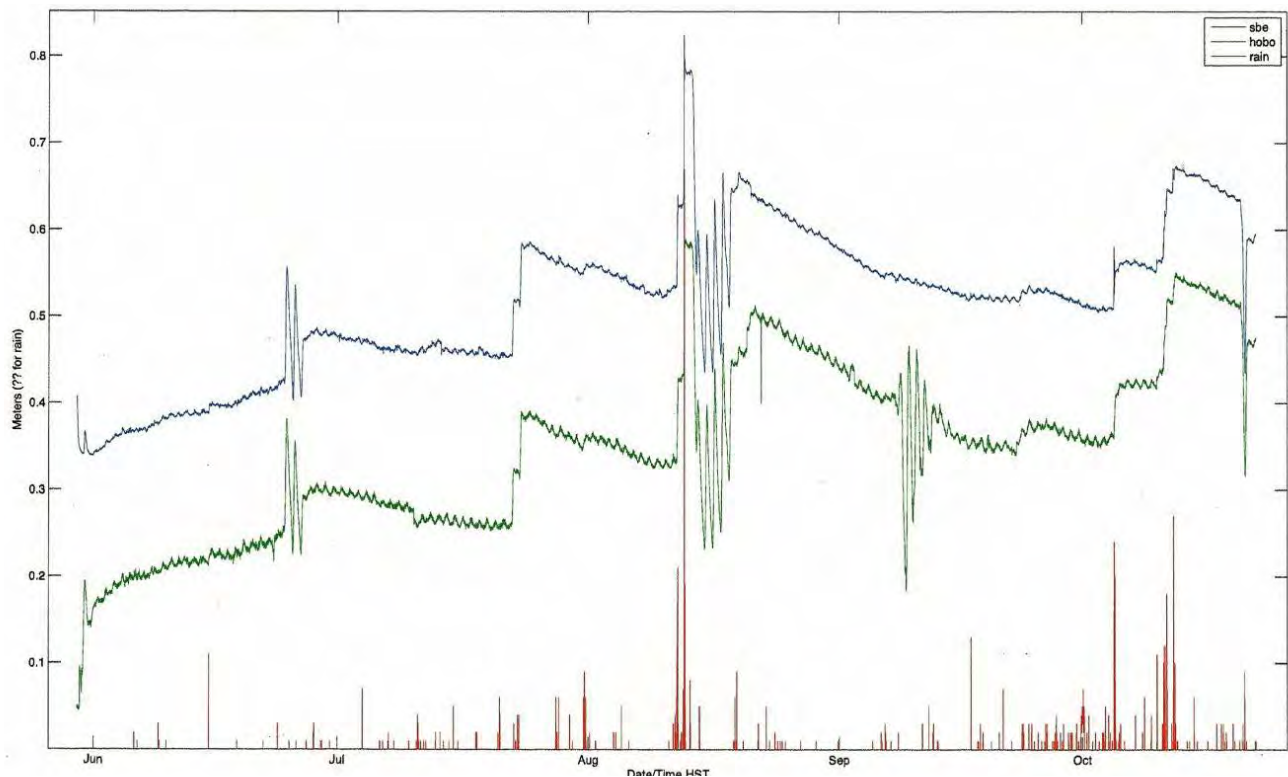
**Figure 16 Typical pond water surface elevation patterns associated with rainfall, evaporation, and stream mouth berm opening events as recorded 5/30/09 through 10/22/09. Evaporation rate in the absence of rainfall is about ¼-inch per day (From: Babcock & Tamura, 2010).**

Evaporation in the absence of rainfall results in an average .25-inch elevation drop in the system per day (7.5 inch/month)( Figure 16). Over the 135-acre area of the waterbody, this is equal to an evaporation rate of about 1.4 cubic feet per second (40L/s or 10 gal/sec) During the months of May through September when the average monthly rainfall is not sufficient (less than 2.5 inches per month) to offset the monthly evaporation (7.5-in/mo), the water surface elevation of the pond often falls to near mean sea level (1.2 ft LMLLW). below this elevation the rate of surface drop is much slower than 0.25-inch/day, likely due to the inflow of surrounding groundwater. Evaporation loss rates from the pond have been measured as high as 0.33-inch per day during dry periods with strong trade winds, and as low as 0.2 inches per day in the presence of humid weather and low wind speeds.

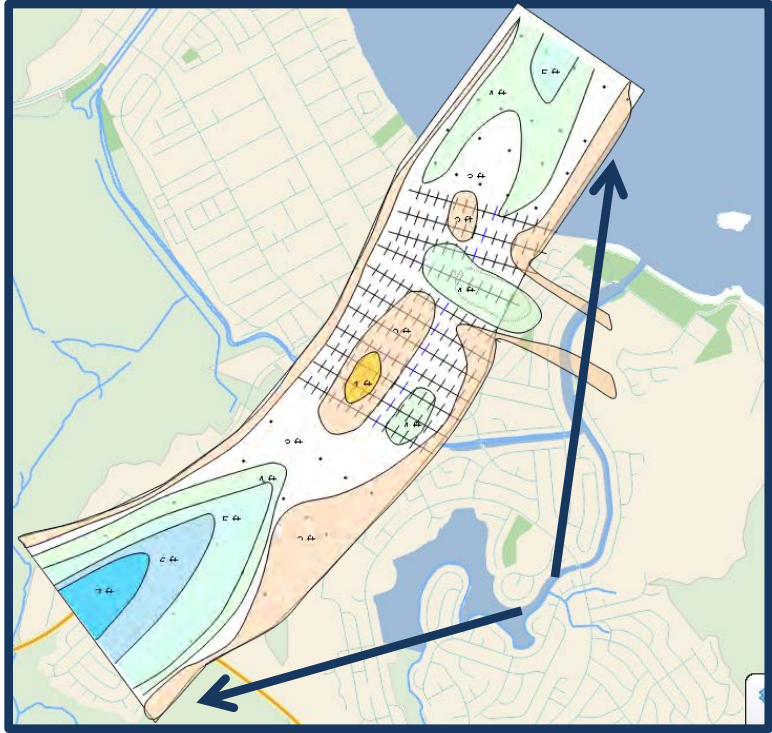
Figure 17. Top: The mouth of Kaelepulu Stream as it exits the pond is shoaled to within a foot of the surface and dramatically impacts circulation between the stream and the pond. Bottom map graphically depicts the estimated relative volume of water in each section of the estuary as represented by cubes with a base as shown

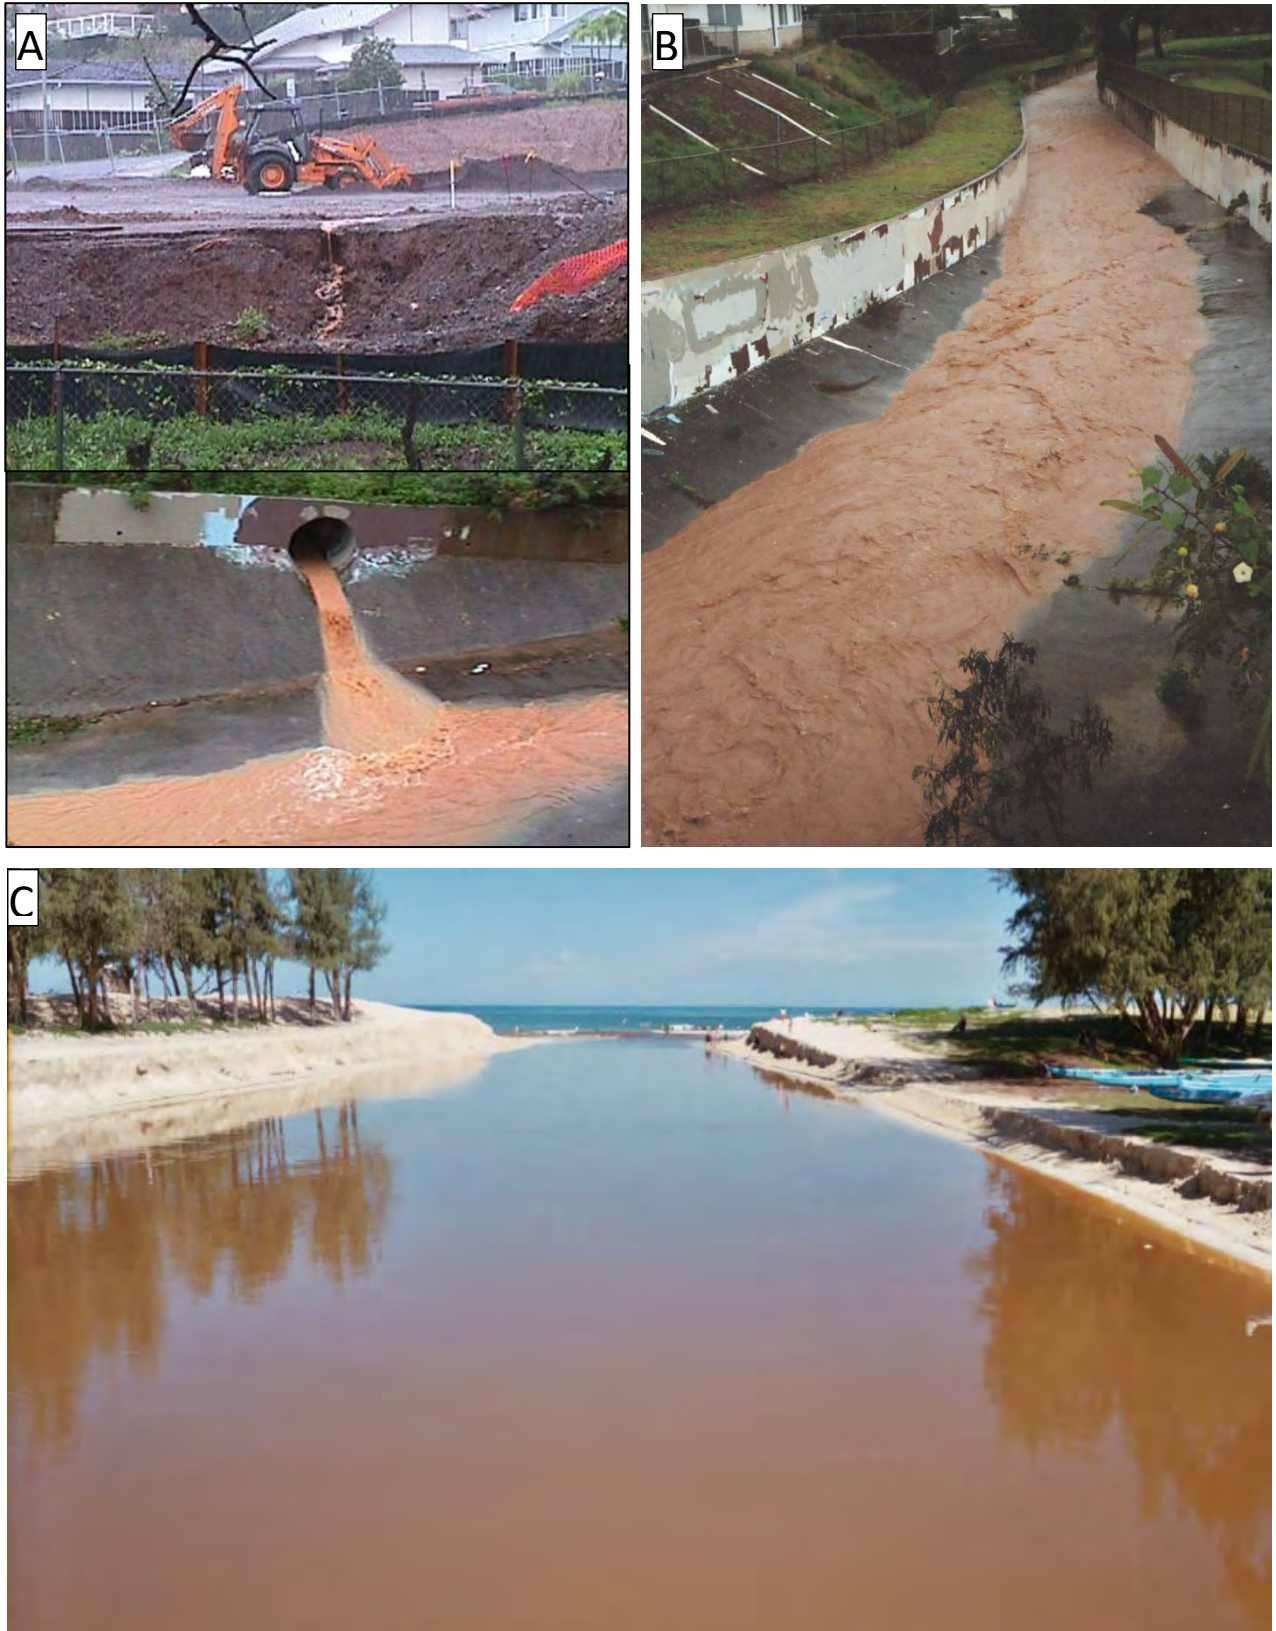
**Figure 20 Construction activities (A) have the greatest impact upon delivery of sediment and nutrient turbidity to the pond (B) and into the ocean (C) when the stream mouth is open.**

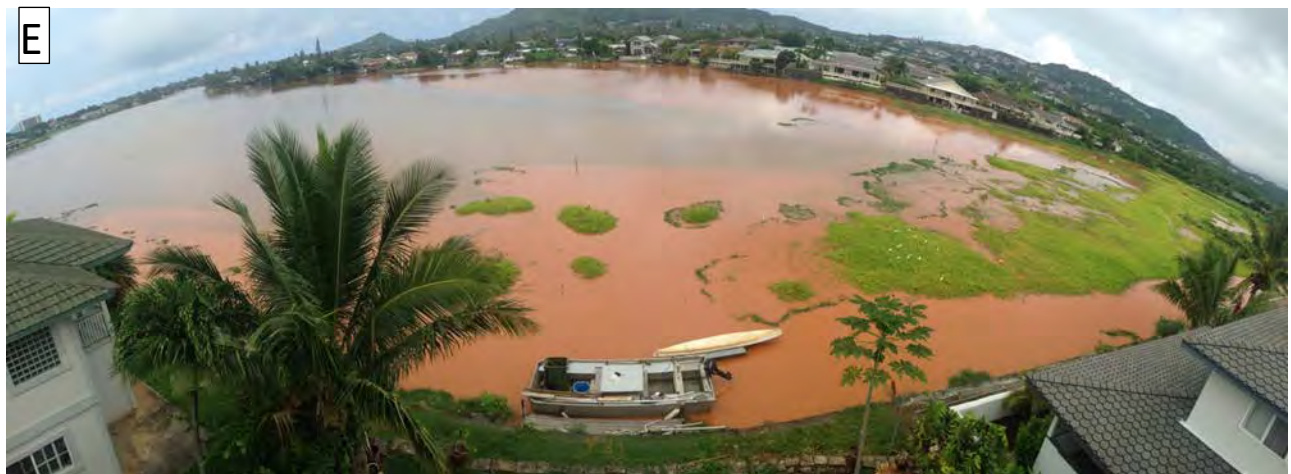
**Figure 21** Poorly implemented BMPs at construction sites (A) or intentional by-passing of required BMPs (B) result in significant plumes of turbid water entering the pond (C) and deposition of fine mud throughout the estuary (D). The high iron content of the soil colors the pond bright orange for several days following major rainfall events when land is being graded in the watershed.

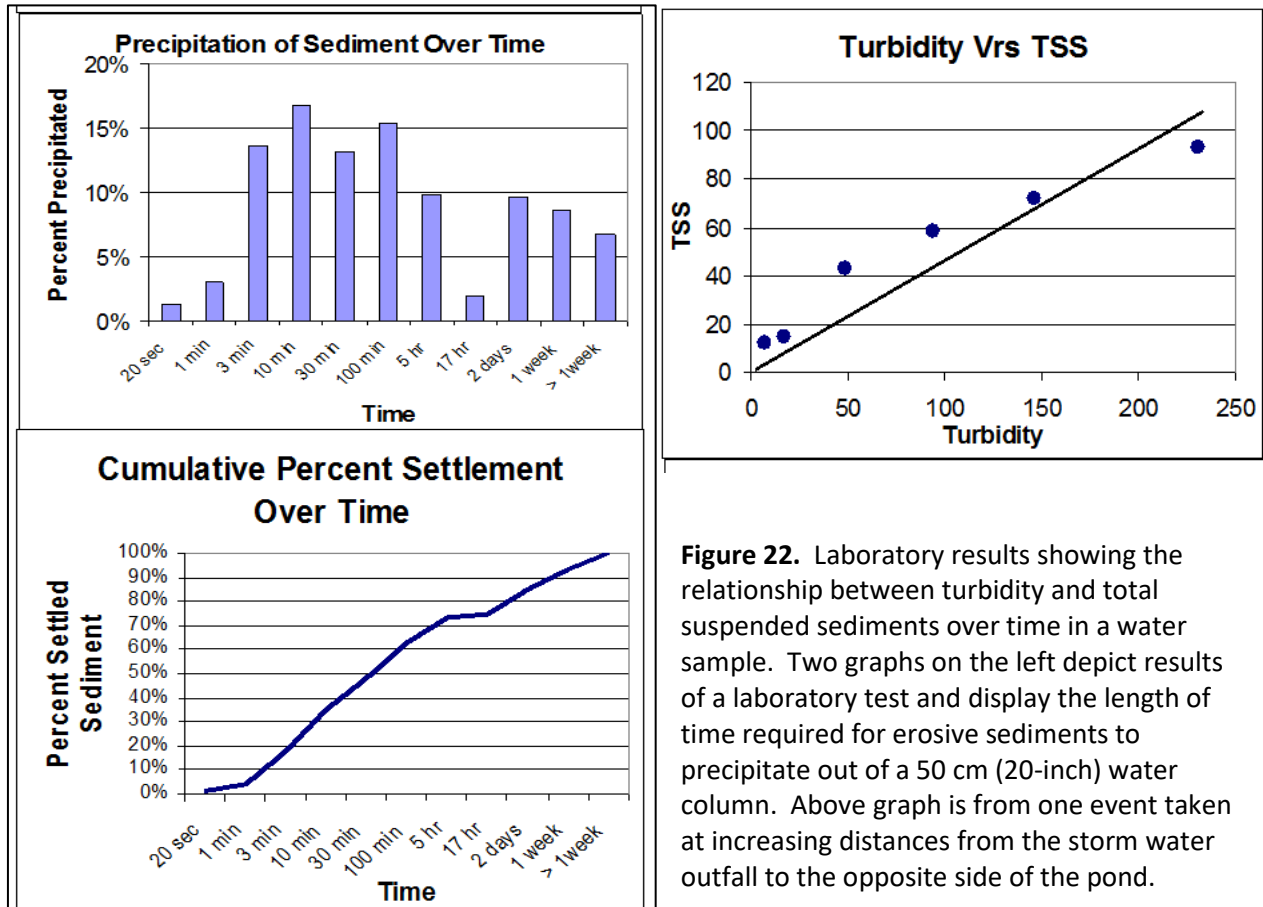
**Figure 22.** Laboratory results showing the relationship between turbidity and total suspended sediments over time in a water sample. Two graphs on the left depict results of a laboratory test and display the length of time required for erosive sediments to precipitate out of a 50 cm (20-inch) water column. Above graph is from one event taken at increasing distances from the storm water outfall to the opposite side of the pond.

The most visible sign of pollutant loads to the pond is the turbidity caused by suspended sediment load. The relationship between turbidity and sediment load from a construction site is shown in the top right graphic of Figure 22. The most common source of these sediments has been from grading activities on construction sites. As a first estimate the quantity of sediment as measured in milligrams per liter (mg/L) is half the turbidity NTU reading. The graphic (Figure 22) shows the relationship between turbidity and TSS as measured in a set of samples from a single storm event, adjacent to the plume inlet drain (230 NTU) to the opposite side of the pond (15 NTU).

In the runoff event displayed in Figure 24 we estimate that 22 tons of sediment were washed into Kailua Bay, but we know from sediment settlement calculations (Figure 22) that it is likely that upwards of 90% of the sediment (200 tons) remained in the pond and stream channels. When construction sites have large quantities of land open and inadequately protected from erosion, the quantity of material that is transported to the pond and from there to Kailua Beach over the period of several storms can be highly significant.

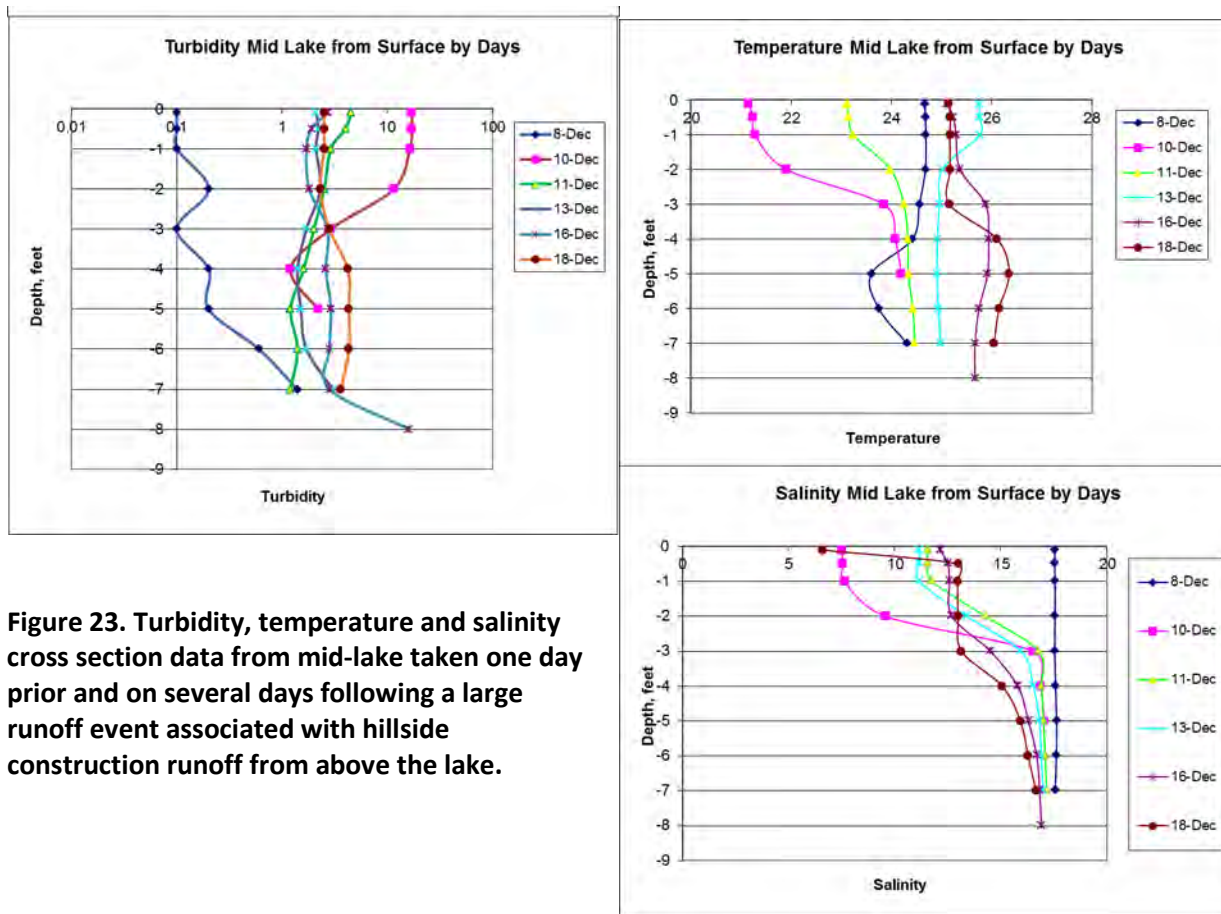
**Figure 23. Turbidity, temperature and salinity cross section data from mid-lake taken one day prior and on several days following a large runoff event associated with hillside construction runoff from above the lake.**

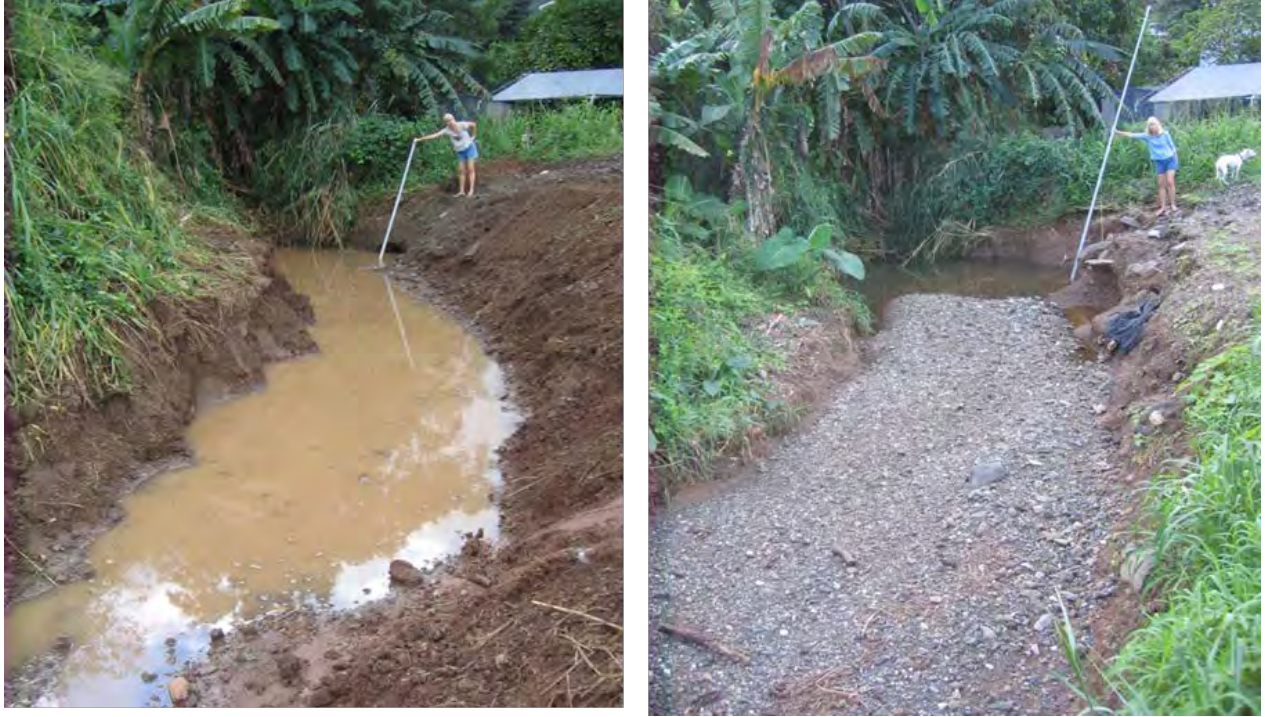
**Figure 25. Before (left) and after(right) sediment from a City storm drain filled this swale during a single storm. The staff is a 16-foot survey rod.**

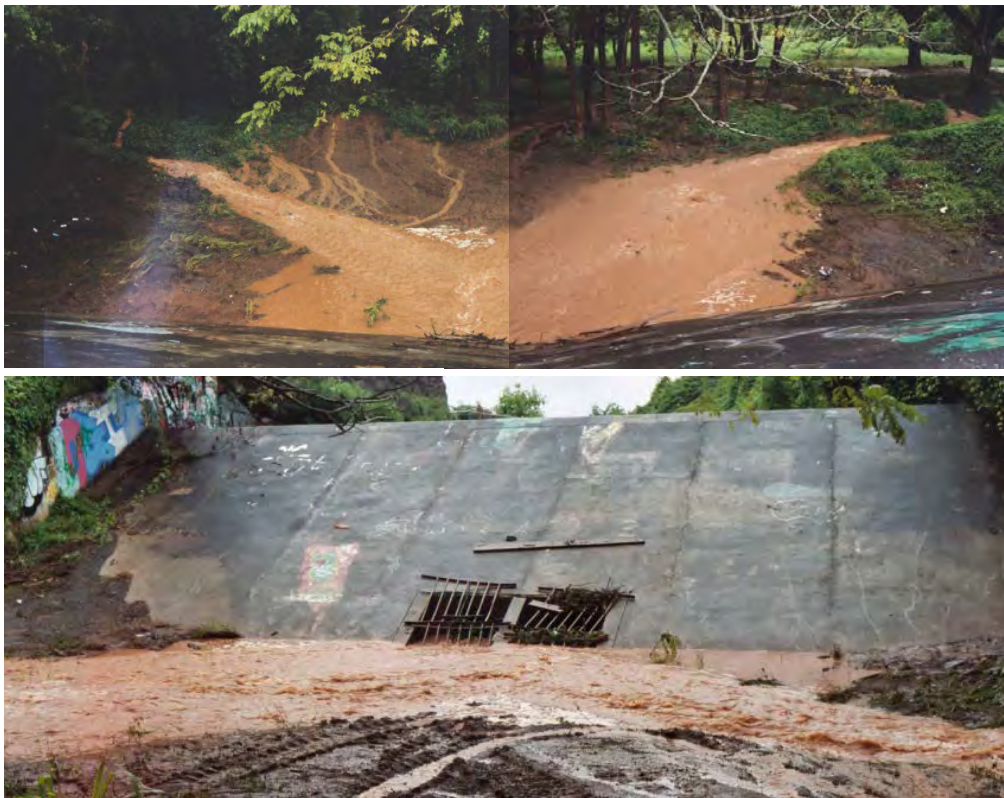
**Figure 26. Top: Looking down the inside Keopu dam face as muddy water pours through the two erosional channels cut through the internal raised berm. Bottom: Inside the basin looking at the back of the dam face with the muddy water flowing into the two flow control structures beneath the dam.**

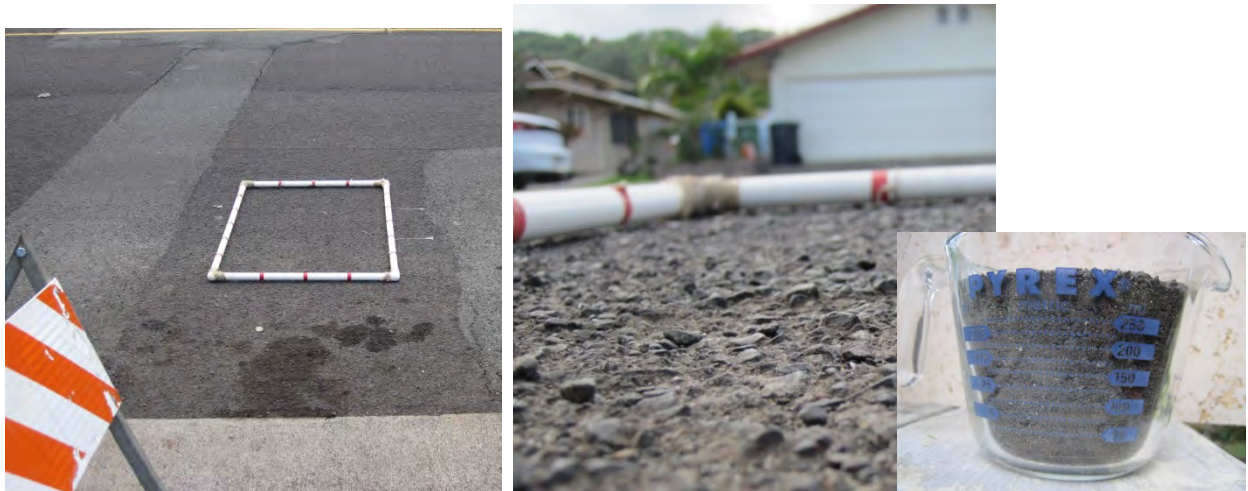
Figure 27 Testing for quantity and quality of material eroded from City road surfaces.

Many of the inlets into the pond are fronted by a shallow area of built up sediment. When digging in these areas one often comes across deposits of fine gravel similar to the type used in asphalt. When Keolu Drive was re-surfaced in 2010, measurements of the eroded street surface were made prior to re-surfacing. One square meter of road surface was found to have eroded at least 3 liters of material of which 325 cc's of sand and gravel still remained indicating 2.675 L of erosion. Given that there are 57.5 miles of City roadways in the watershed, the total area of all roads (assumed average width of 34 ft) is about 1-million square meters and the total eroded material is about 2,675 cubic meters of material. This is equal to about 3,000 cubic yards, or 200 ten-yard dump trucks. Assuming this erosion took place over a period of 15 years yields an annual erosion rate from City Roads of about 200 yd<sup>3</sup>/year.

Road surfaces are often considered to be sources of heavy metals like Chromium, Lead, and Cadmium due primarily from automobile engine and brake wear. Samples of gravel from the lake below a storm drain after a big storm, another of fresh (hot!) asphalt, and the third sample of 325 cc vacuumed from the road surface all tested at below detection limits for arsenic, cadmium, chromium, lead, mercury, selenium and silver.

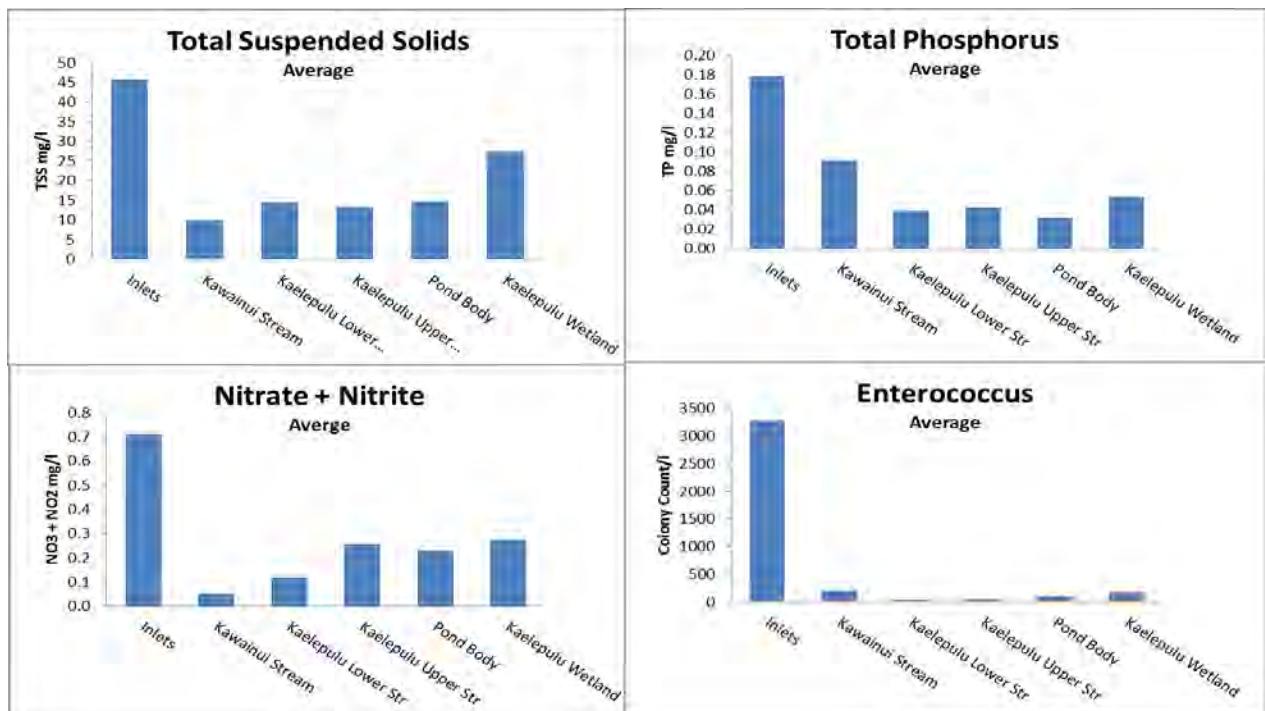
Figure 28 TMDL data summarized by general location within the estuary clearly shows that inlets to the system (City storm drains) are the primary source of nutrients, bacteria, and turbidity to the system.

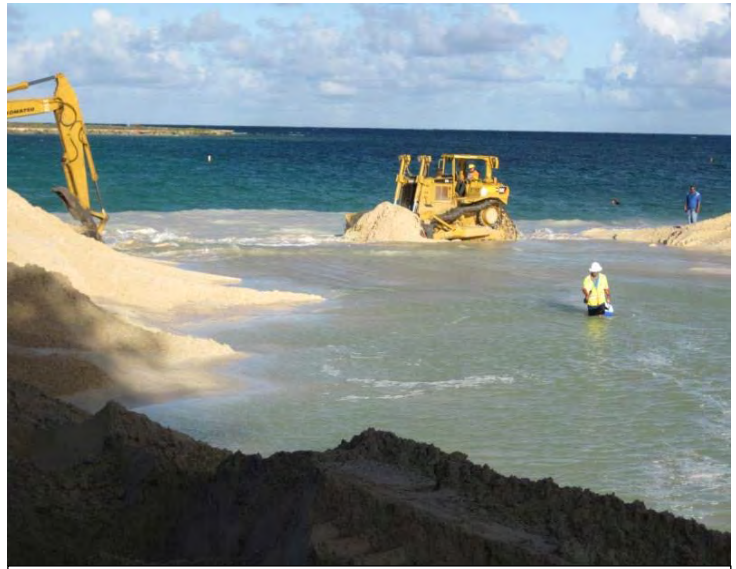
**Figure 29** The City uses heavy equipment to open the stream mouth about nine times per year.

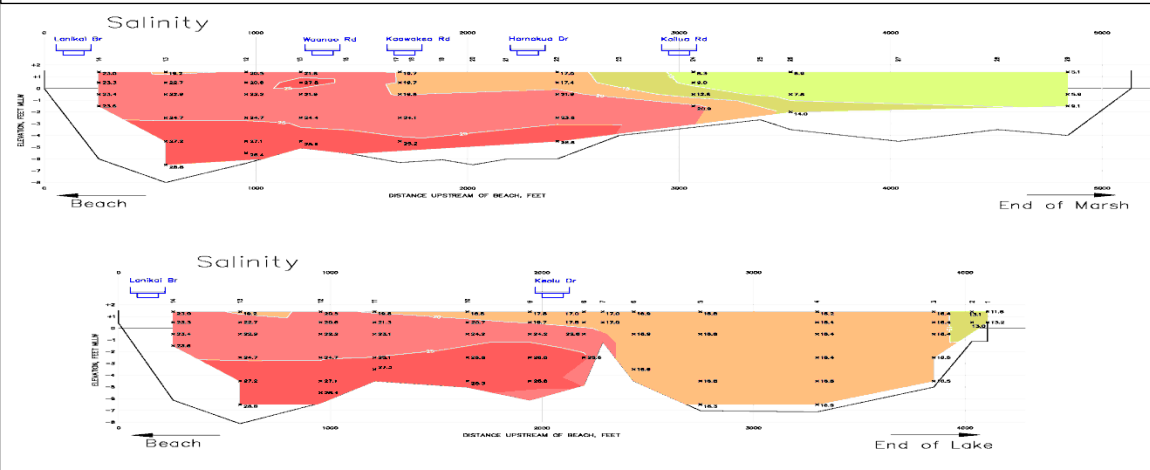
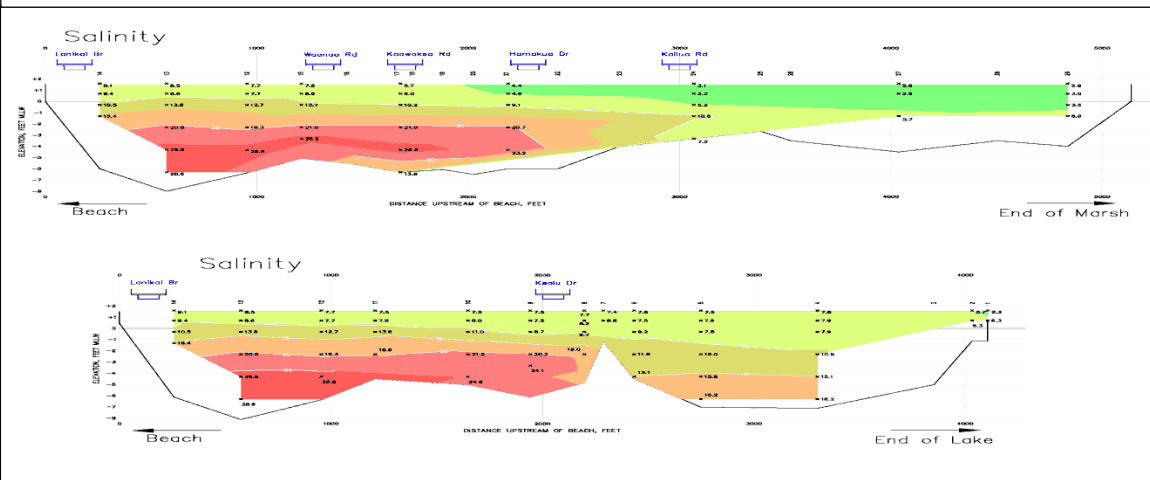
After minor opening event the flow of the salt wedge to the pond is blocked by shoal

Rainfall runoff forms a new stratification within the estuary.

Figure 31 Water quality cross sections of Kawainui (top, each pair) and Kaelepulu (bottom of each pair) before (top) and after stream mouth opening (middle), followed by inflow from rainfall (bottom).

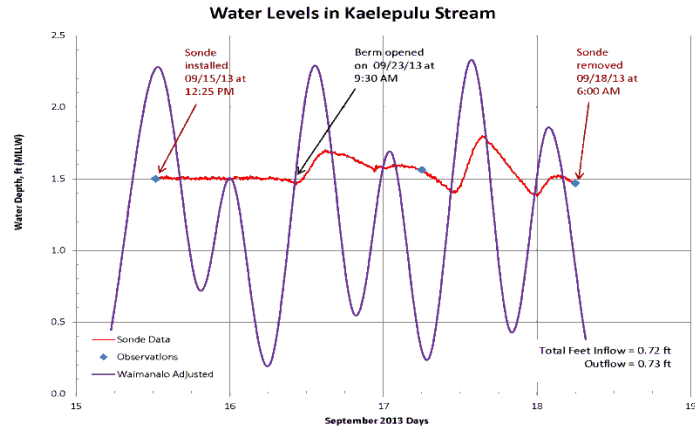
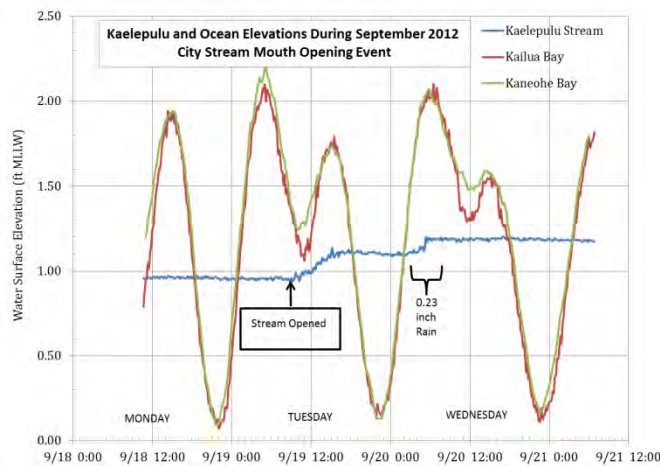
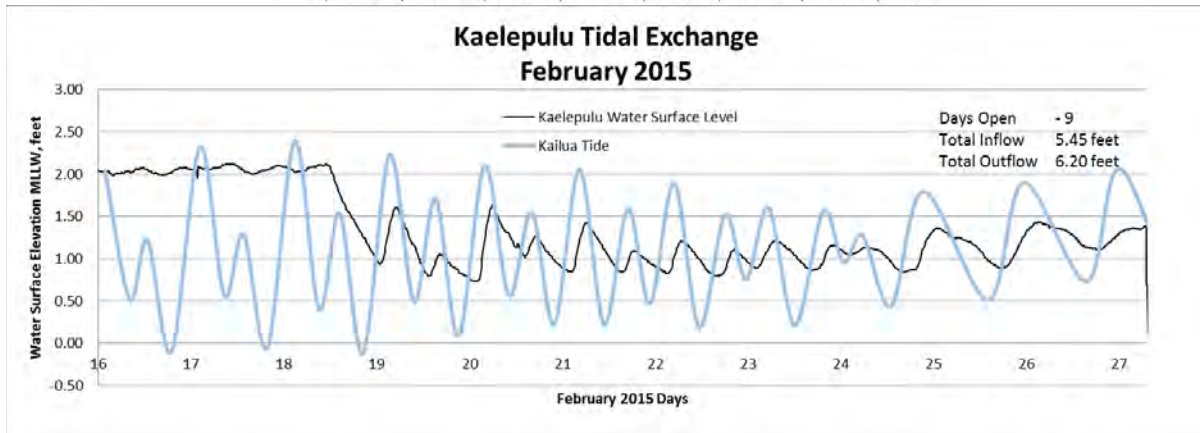
Figure 32. Stream mouth openings initiated by City heavy equipment operators vary greatly in the quantity of resulting exchange. Openings made with only a short outflow period until the incoming tide (top) or those openings made when the sea level were higher than the stream (middle) were not effective. Openings that produce greater exchange are the result of a high initial water surface elevation, high amplitude tides, and the timing of the openings to produce a long period of initial draw down. It is presumed that the long period of initial drawdown served to erode a larger channel through the beach which then requires more time to close over several tidal cycles.

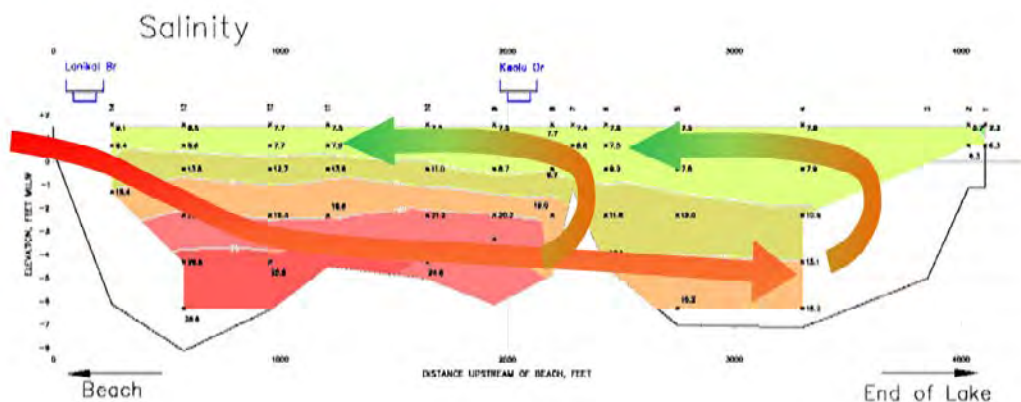
Figure 33 Top: Results of percent exchange calculations, based upon salinity changes following one stream mouth opening event. As expected the greatest exchange occurs nearest the stream mouth, however it is also evident that the shallow area in Kaelepulu Stream (lower graphic) is a significant block to effective water exchange. Bottom: Removal of this obstruction by dredging will allow the inflowing salt water to penetrate all the way into the body of the pond, greatly improving total circulation.

During periods when the stream mouth is open to flow, channel erosion and widening occurs if the water flow speed exceeds about 3 feet per second. At speeds above about 5 feet per second there is significant fluidization of the sand bed and very rapid erosion and channel widening occur. The rate at which the channel closes itself is dependent upon the size of the initial opening at the end of the initial draw down, the size of waves generating suspended sand particles in the stream mouth surf zone, and the height of the incoming tides governing flow speed through the channel. Flow speeds less than about 3 ft/sec allow suspended sand to precipitate and fill the channel. Experience has demonstrated that the best time for the City to open the stream channel is on a low low falling tide several days prior to the highest tides of the month. If done properly, this maximizes the initial water head and duration of outflow and allows the outflowing water to erode a channel of significant width and depth. This wide and deep channel then stays open on subsequent inflow events if the inflow velocity remains near or above 3 feet per second across the sand bar. The eroded sand stays in the Kailua Bay system and is eventually re-deposited on the beach. The series of photos in Figure 30 show an initial 15-foot wide, 1 foot deep channel created by the City's bulldozer widening to a 30 foot wide 3 foot deep channel in about an hour and fifteen minutes. A half hour after the final photo the channel was 50 feet wide. The City had attempted to open the stream four hours prior (10 am) and were not successful because of a high tide. Timing openings with the tide is very important.
