# Natural History, Hydrology & Water Quality of Kaelepulu Pond

The Urbanized Estuary of Enchanted Lake

Robert E. Bourke  
*Kailua, Hawaii*

MAY 16, 2017

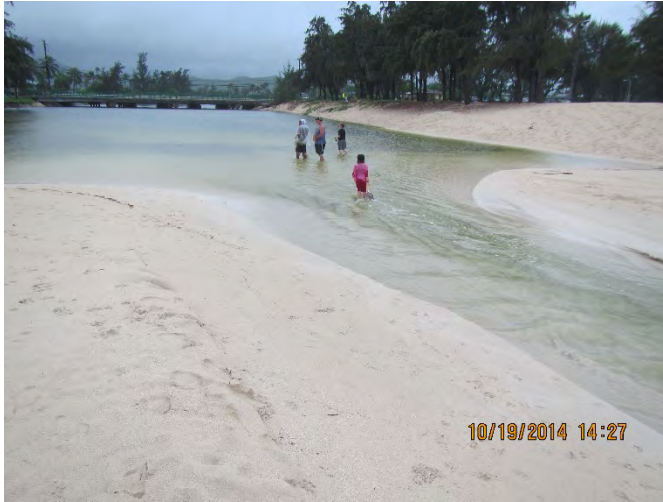
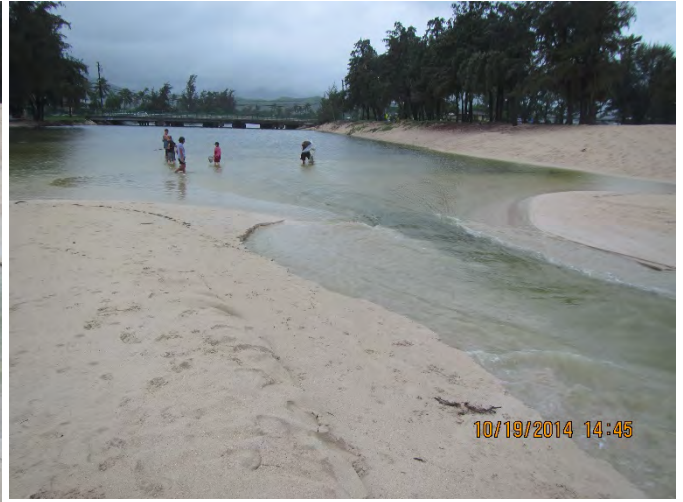
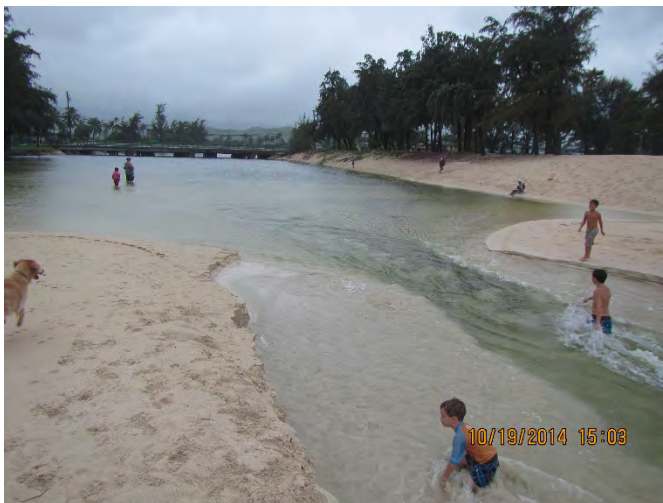
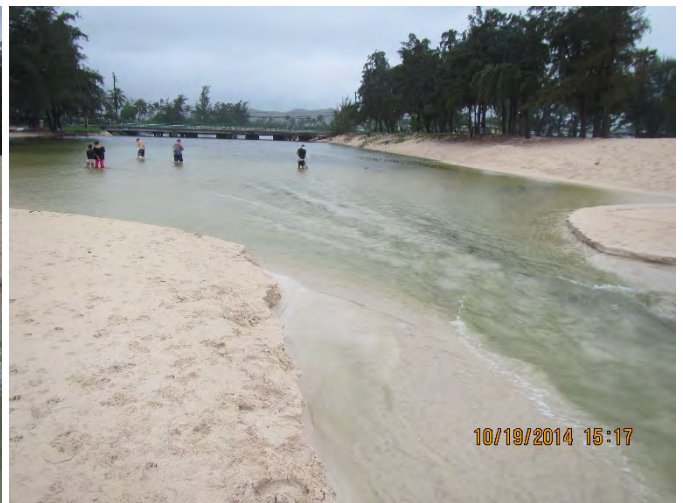
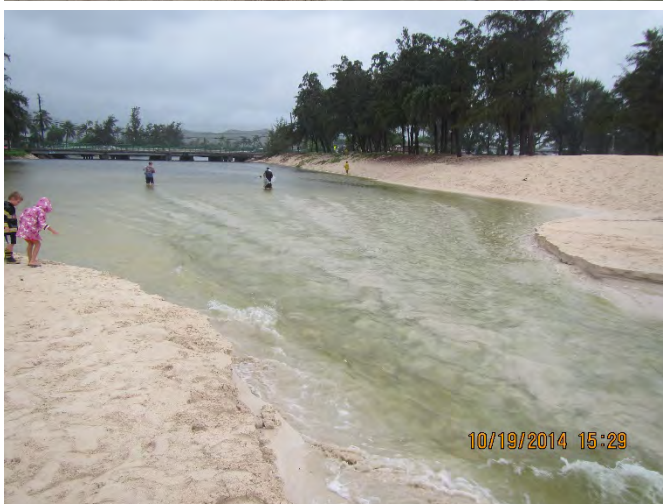
**Figure 34. October 2014 the City responded to a high water surface in the pond and an impending rainstorm to conduct an “emergency” opening of the stream mouth. Flow established in a 1-foot deep 15 foot wide channel completed at 16:15 developed into a 30-foot wide 3 foot deep channel in about an hour and fifteen minutes. Within minutes of the last photo the cameraman had to abandon his location as the bank was eroding from beneath his feet.**

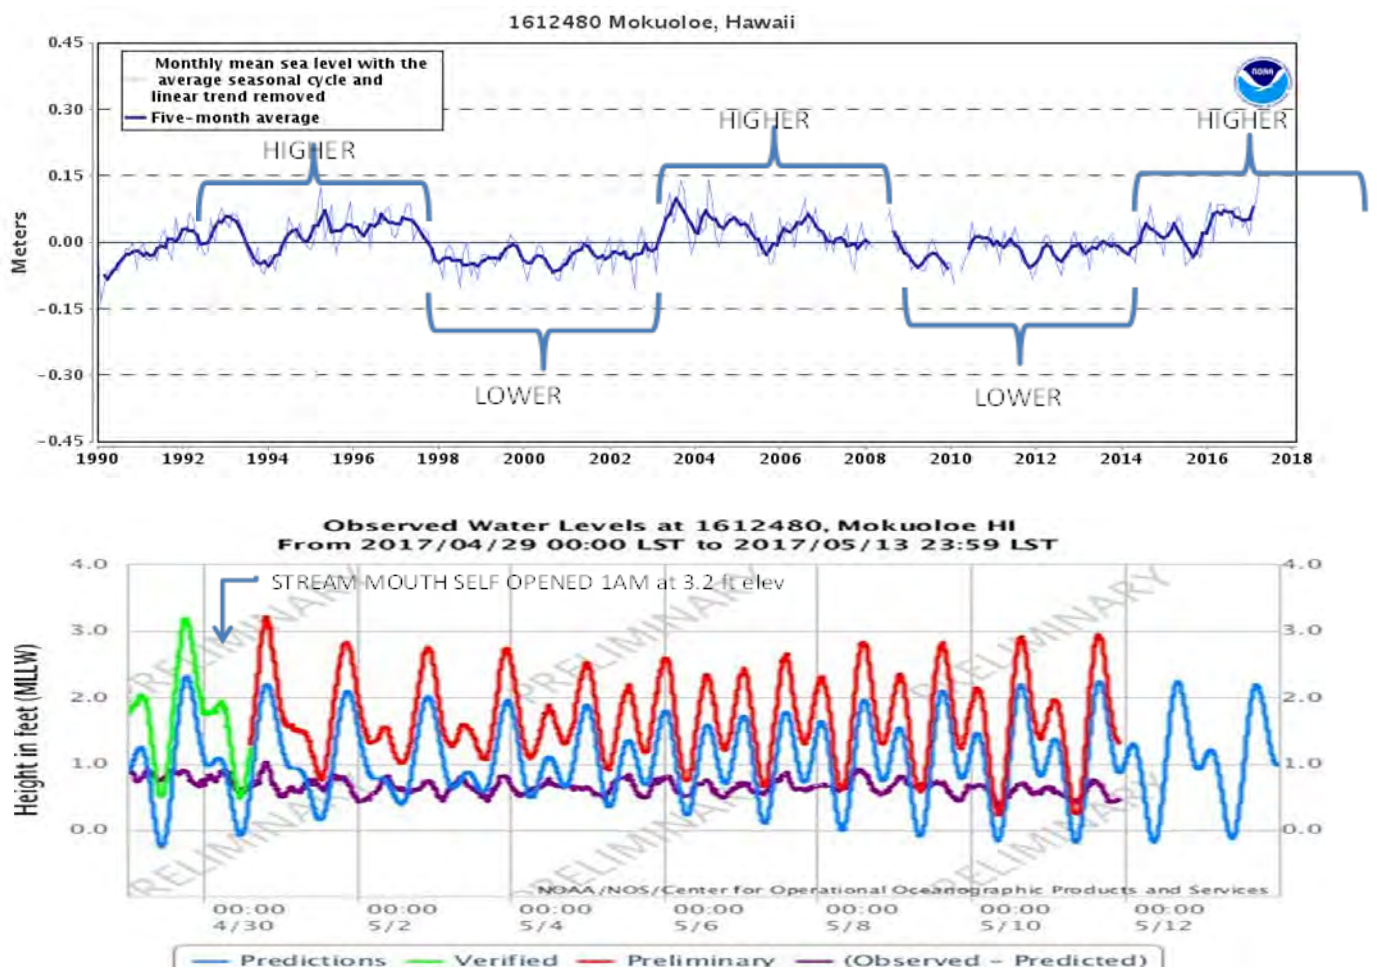
Figure 35. Long term variations in average sea level (top) can result in sea levels very much different from what is anticipated. Lower graphic predicted tide is in blue, with measured in red and green.

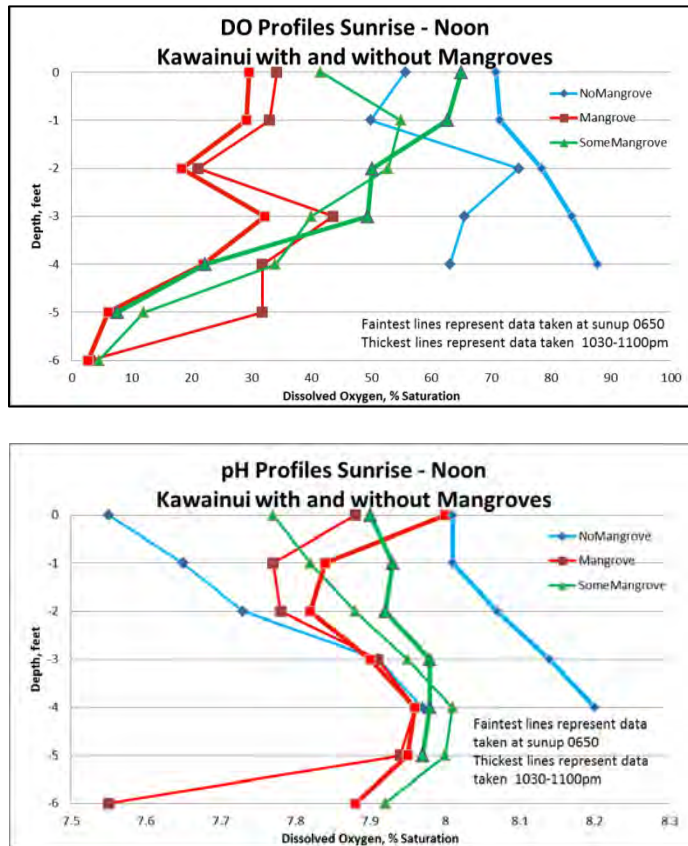
**Figure 38 Dissolved oxygen and pH profiles obtained in Kawainui channel at dawn and again at noon at three locations 1) in the midst of mature mangrove growth, 2) in an area where mangrove had been removed two-years prior, and 3) in an area with no mangroves. These graphics depict the adverse impact of mangroves upon dissolved oxygen and pH. Consistent with similar results obtained in Pearl Harbor, the ability of mangroves to adversely impact oxygen and pH water quality exists long after their removal, likely due to the presence of the massive root systems which are not typically removed when the trees are cut.**

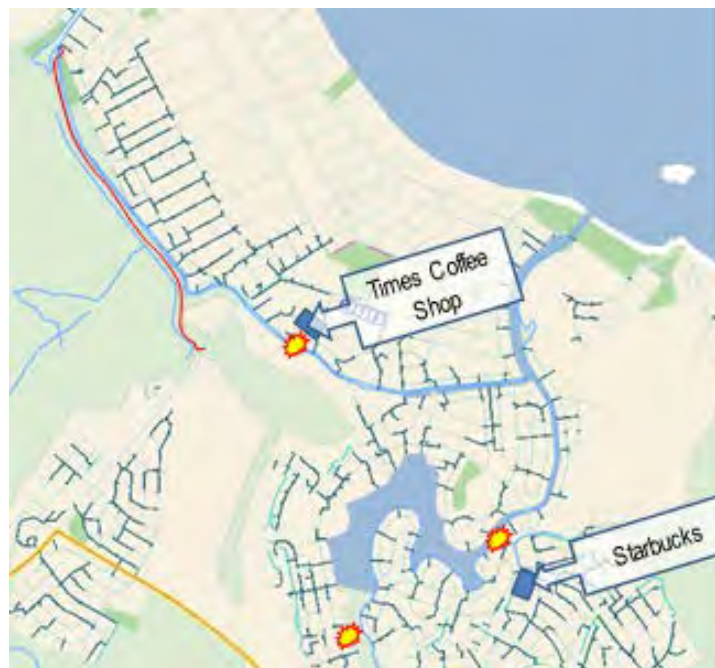
**Figure 42 Sample sites where caffeine was detected in surface waters, with overlay of local coffee houses.**
