Name of Project: **Establishing TMDLs to address wet weather flow impacts, pathogens, and NPDES program strategies in a priority urban watershed – Kaelepulu, Hawaii – Biological Survey**

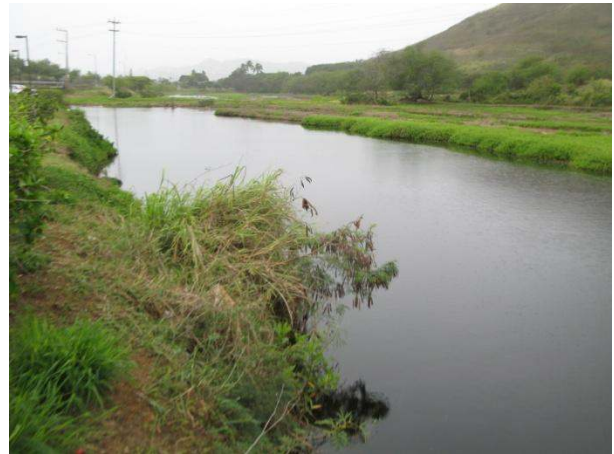
Channel alteration is a measure of large-scale changes in the shape of a stream channel and many streams in urban and agricultural areas have been straightened, deepened, or diverted into concrete channels, often for flood control or irrigation purposes. Such streams have far fewer natural habitats for fish, macroinvertebrates, and plants than do naturally meandering streams. Channel alteration is present when artificial embankments, and other forms of artificial bank stabilization or structures are present and when the stream is very straight for significant distances. A summary of this parameter for the various sample sites is provided in Table 11. A poor rating consists of banks shored with gabion or cement; over 80% of the stream reach channelized and disrupted. Although certain sample sites (e.g., #5, #6 and #7) clearly are not streams or even stream like they are being included in the assessment as the shorelines for each of the sampling sites clearly fit the criteria for the poor rating.

Figure 3. Sample Site #2 of the biological survey.

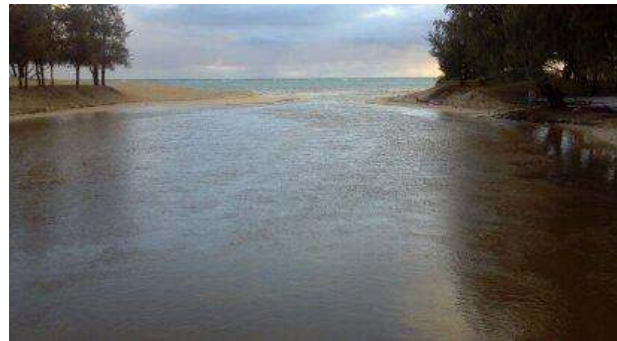
Sample of debris from Site #3 was quite devoid of anything living. There were a few very small diatom tests but they did not appear to be alive. There were a few flagellated and ciliated protozoans present but very few. This type of sample is usually characteristic of acidic waters containing decomposing vegetation. When left standing the water takes on a brown color (Figure 4) due to the build-up of tannins from the decomposition of leaf litter.

Figure 4. Water downstream of Site #3 emptying into Kailua Bay .

Since the area of the sampling was recently flushed with rain runoff it is suspected that the brown color would be flushed out leaving only sand and vegetative debris.

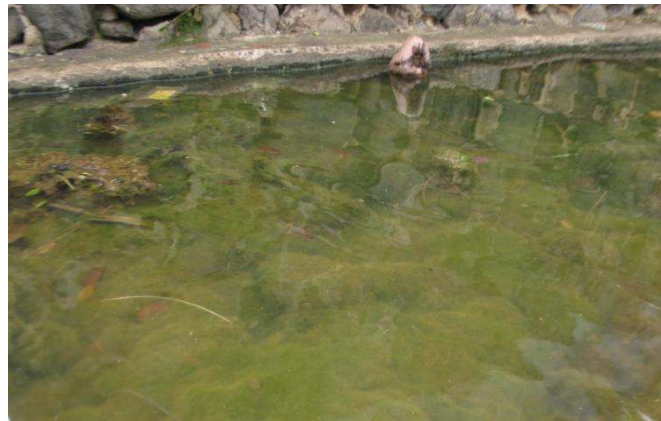
At Sample Site #6 a green filamentous algae was found covering 100% of the *G. tikvahiae* that was present. The green algae was keyed out to *Cladophora sericea*. This species is a branching green filamentous alga found on most reefs in Hawai‘i⁴. While this species is considered to be a native species it is also classified as invasive as it can spread and overgrow areas under the right conditions. *C. sericea* has demonstrated invasive characteristics in Hawai‘i, unlike the intertidal *C. vagabunda*. Approximately 10 years ago the alga became exceedingly abundant on leeward reefs in Maui and large blooms now occur seasonally. During the blooms, large masses of the alga drift in the water column, snagging on coral and rock outcroppings and smothering out the organisms beneath.

Figure 5. Photograph of *C. sericea* completely covering *G. tikvahiae* at Sample Site #6.

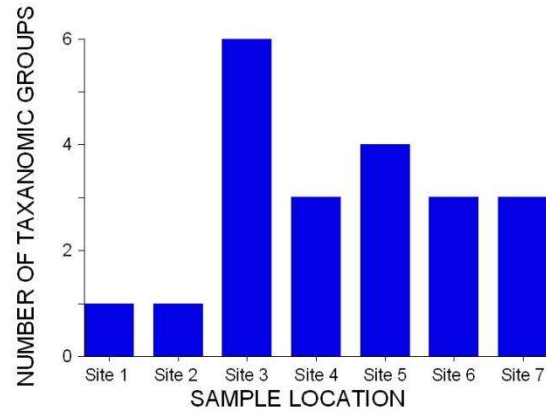
The number of distinct taxonomic groups represents the diversity of the macroinvertebrates within the survey and is a metric known as Taxa richness. This metric usually consists of species level identifications but can also be evaluated as designated groupings of taxa, often as higher taxonomic groups (i.e., genera, families, orders, class etc.) just as has been done for the assessment of macroinvertebrate assemblages in the current survey. The expected response to increasing perturbation varies depending on the metric but increasing diversity correlates with increasing health of the assemblage and suggests that niche space, habitat, and food source are

adequate to support survival and propagation of many species. The predicted response of the number of taxa to a perturbation is for the Taxa richness metric to decrease. This can be illustrated graphically by displaying the number of taxa per sample location (Figure 6). Sample Site #3 was found to possess the highest taxa richness metric of all the sample sites. Sites #1 and #2 were observed to have the lowest values for the same metric. Both of these sites also possess the lowest dissolved oxygen levels as well as salinity clearly marking them as being impacted habitat. The lowered value in taxa richness at these two sites is consistent with a suitable metric that responds as predicted.

Figure 6. Variation in the number of taxonomic groups of macroinvertebrates at various sampling sites obtained during the current biological survey.

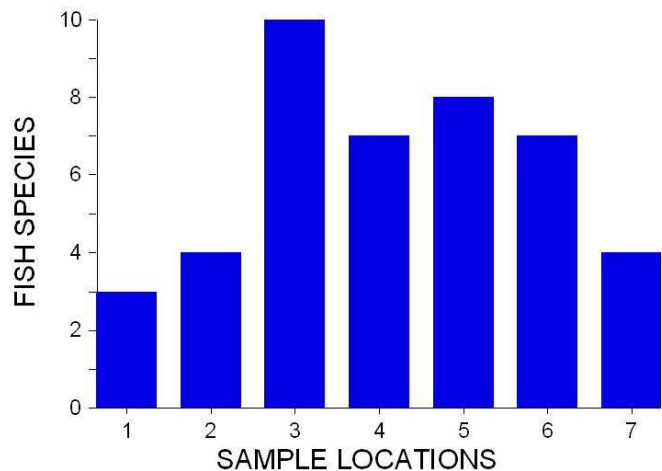
A total of 13 fish species were collected or visually identified during the survey period. Based on discussions and observations made throughout the year there are clearly other species that are present that are not represented in this particular survey. However, to make the comparisons of the various sites requires that the data be standardized and only species collected or visually identified during the current survey are being used. Photographs of each of the species obtained make up the species list and is presented in the Appendix. A summary of the number of fish species among the various sample sites is presented in Figure 7. It is interesting to note that this particular metric of diversity mimics that observed for the macroinvertebrates where Sites #1 and #2 have the least

Figure 7. Total number of species found at each of the sample sites during the survey.

number of species and Site #3 has the most. The three fish species that were found at all of the sampling sites is presented in Figure 8. From top to bottom they are the mosquito fish (*Gambusia affinis*), mollies (*Poecilia* sp.) and the black chin tilapia (*Sarotherodon melanotheron*). All three species share several characteristics and they are:

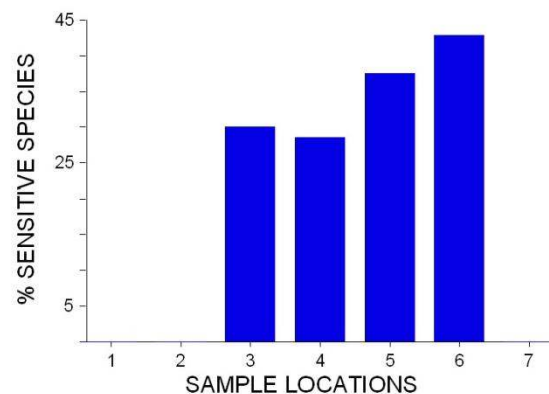
A graphic summary of the percent composition of sensitive species among the various sample sites is provided in Figure 9. Sites #1, #2 and #7 were found to be devoid of sensitive species and indicates that these areas have been impacted.

Figure 9. Percent composition of sensitive species among the various sampling sites.

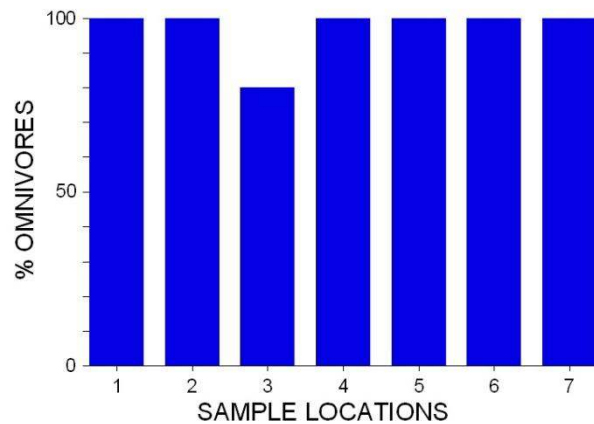
Omnivores are defined as species that consistently feed on substantial proportions of plant and animal material. The species that are omnivorous in the current survey were identified and are summarized in Table 18. The rationale for the use of this metric is that the percent of omnivores in the community increases as the physical and chemical habitat deteriorates. The percentage of omnivorous species that were found at each of the sampling sites is summarized in Figure 10. Only site #3 was found to have less than 100% of the species composition being omnivorous due to the presence of at least two carnivorous species (*S. gracilis* and *S. barracuda*). The high percentage of omnivores present in the majority of sampling sites indicates a substantial deterioration of the physical and chemical habitat in the study area.

Figure 10. Distribution of omnivorous fish species among the various sampling sites in the current survey.

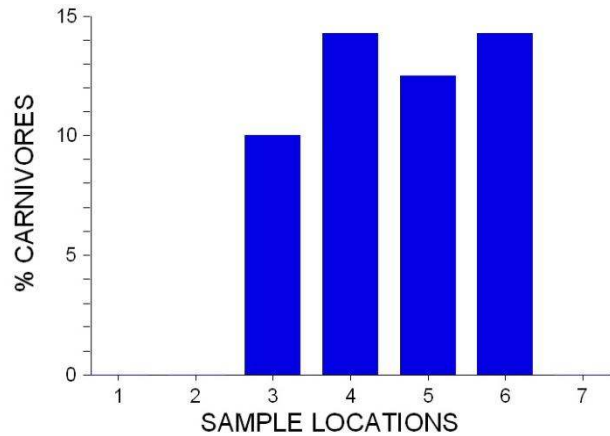
Interestingly this metric mimics that of the sensitive species as sites #1, #2 and #7 are devoid of carnivores. As mentioned

previously the existence of a carnivore at site 7 is highly probably and may have not been sampled appropriately due the large amount of macroalgae present. None the less their presence in four of the seven sampling sites would indicate that there are areas of the study area that still remain of moderate integrity.

Figure 11. Summary of the percent composition of carnivorous fish species among the various sampling sites of the current survey.
