**Name of Project:**     **Establishing TMDLs to address wet weather flow impacts, pathogens, and NPDES program strategies in a priority urban watershed – Kaelepulu, Hawaii**

Reporting Period: January 1, 2009 – December 31, 2011.

### **Purpose**

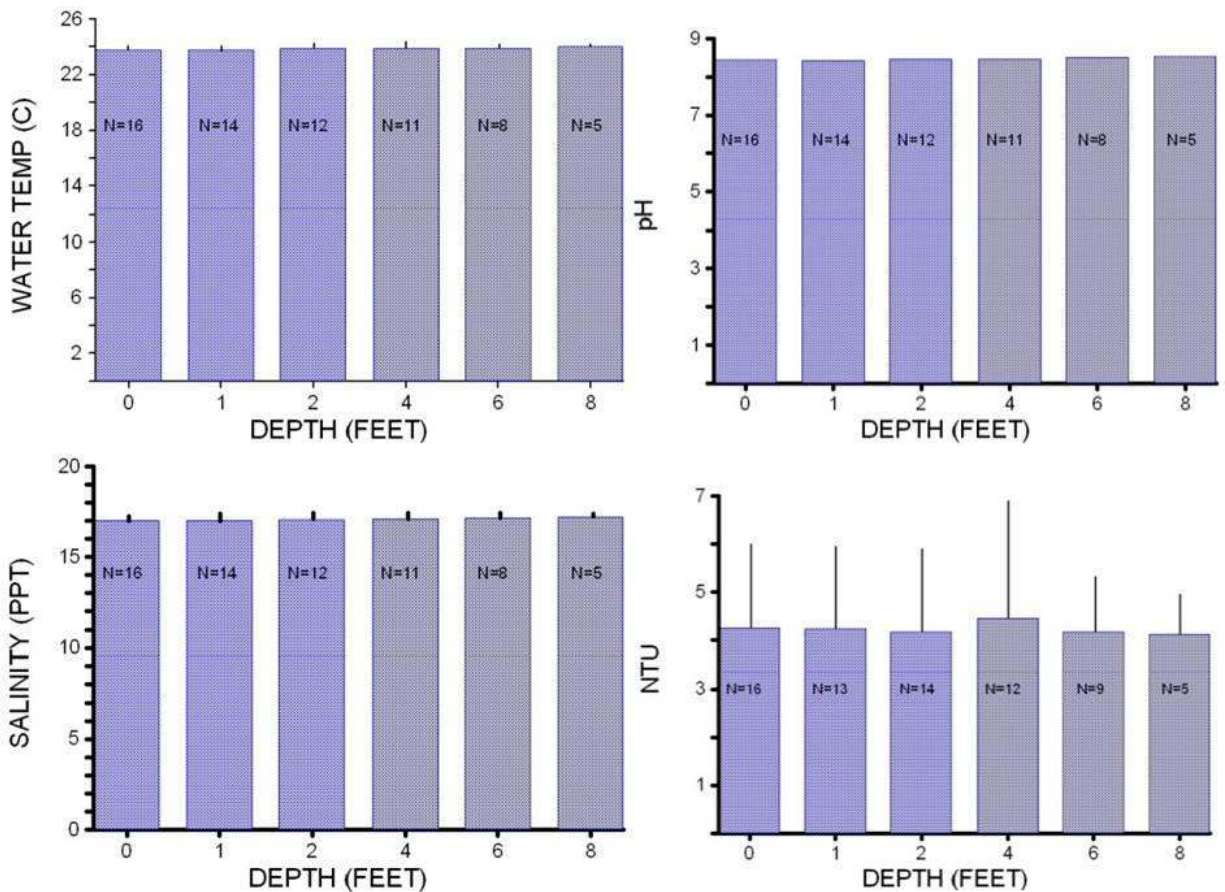
**Figure 1.** Summary of initial survey of Kaelepulu lake conducted in collaboration with Bob Bourke ERLA environmental coordinator.

YSI Sonde on loan from Oceanit Laboratories and a summary of the various water quality data is provided in Figure 1. The initial survey was done per request of Bob Bourke to familiarize the PI with the lake and adjoining tributaries and an indication of the interaction and collaboration of this particular stakeholder group. One striking feature of the data obtained was the uniformity of all parameters at various depths indicating that on this particular day the mixing of the lake was uniform. The data obtained supported the use of the sampling protocol that was presented in the sampling plan (see objective 2) and used throughout the reporting periods.

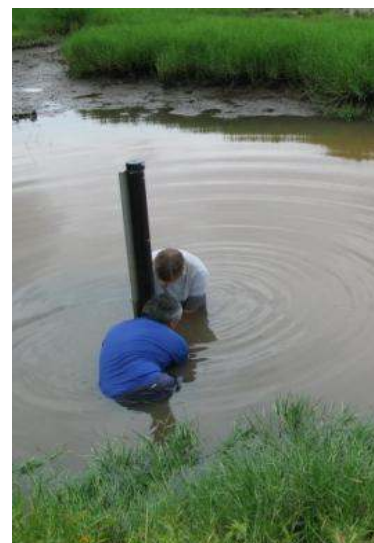
**Figure 2.** PI and Hugo Defries deploying automated tide sensor, May 30, 2009).

**Progress Towards Objectives:** To accomplish this task the project work group enlisted the assistance of Dr. Mark Merrifield and Christopher P. Kontoes of the Oceanography Department at the School of Ocean Earth Science and Technology. They would loan a Sea Bird (SBE26) wave and tide recorder<sup>1</sup> to monitor depth changes in the lake. The gauge was installed on 5/30/2009 (Figure 2) at the following coordinates (21° 22'27.58"N 157° 44'19.22"W) which is adjacent to the residence of Hugo Defries. The rationale for location of the sensor was its proximity to a secure location as well as being close to an automated weather station that is located on the property of Hugo Defries. The changes in barometric pressure is needed to correct for the actual height of the water level being monitored and that data is being monitored by the weather station and available on line<sup>2</sup>. In addition, another automated tide gauge (HOBO U20<sup>3</sup>) was also loaned to the project work group and both gauges were set to record at 15 minute intervals. In this case the HOBO tide gauge was placed adjacent to the residence of Bob Bourke at the following coordinates (21° 22'32.84"N 157° 44'22.96"W). Both gauges

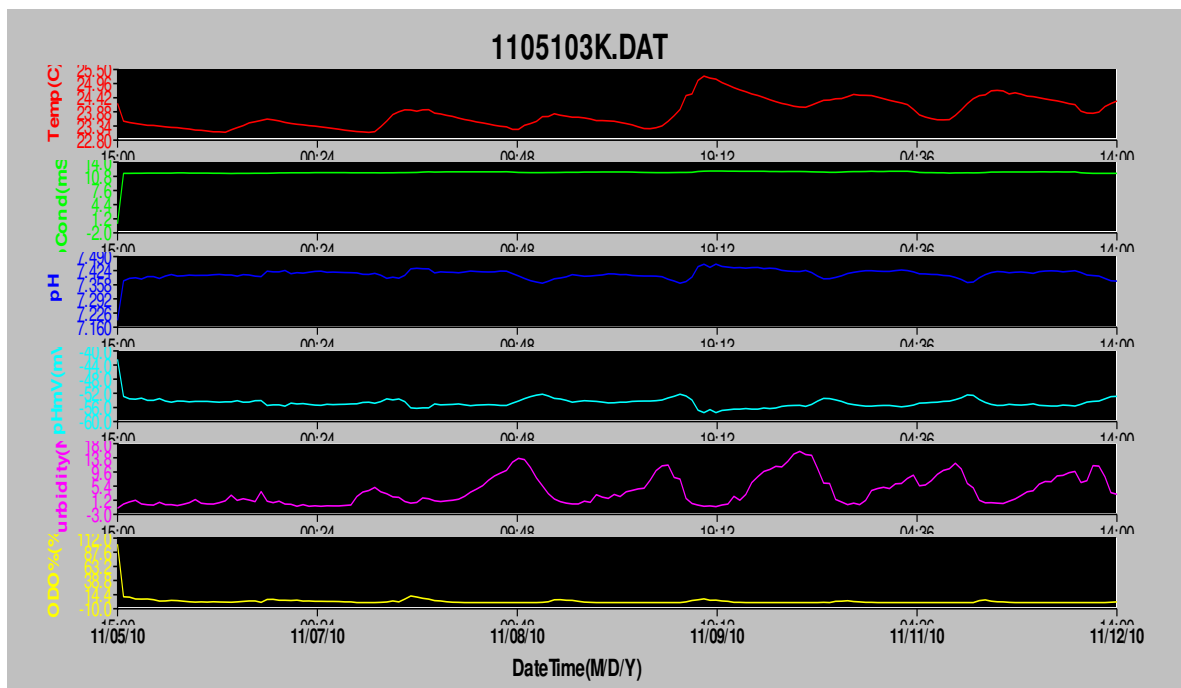
**Figure 5.** Temporal changes in six water quality parameters recorded by a YSI Sonde deployed at Site # 51 adjacent to Kaha park.

**Progress Towards Objectives:** The sonde’s to be used for this task required repair and servicing and were not available during 2009. After servicing the sondes were deployed on 9/17/2010, 9/28/2010, 10/9/2010, 11/5/2010 and 11/20/2010 at various locations and also at various depths. In all cases the units were set to record over the course of seven days and at 15 minute intervals. The raw data for all recordings are provided in the Appendix. An example of the temporal changes in water temperature, conductivity, pH, dissolved oxygen and turbidity is presented in Figure 5. This particular sonde unit was deployed in the upper reaches of the tributary that must be entered from Kaha Park. While there are some clear diurnal patterns in some of the water quality parameters (e.g., temperature, turbidity) many parameters remain relatively stable over the course of the sampling period. A remarkable finding at this location was the very low dissolved oxygen level that does not fluctuate indicating a severely impacted segment of the study area. The only kinds of fish species that are able to tolerate these levels is tilapia and not surprising they are the only species present in this segment of the estuary.

Interestingly, turbidity was observed to rise and fall in a recurring pattern to the point of being diurnal in nature. Further investigation is required to determine the reason that turbidity should be varying in such a fashion. One possible explanation is changes in phytoplankton density and clearly requires further examination.

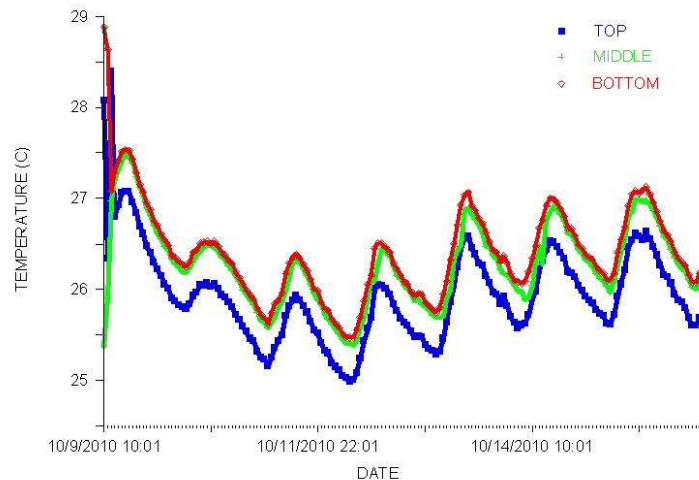
**Figure 6.** Recorded temporal changes in water temperature at three depths located at sampling Site #24 .

One of the reasons for deploying the sonde's was to obtain profiles to indicate stratification taking place or spatial differences in basic water parameters being recorded by the sonde units. At site #24 located in the the deepest portion of the lake three sonde's were deployed at different depths and allowed to record for a week interval. The resulting temperature profile from the three units are summarized in Figure 6. Some thermal stratification was observed with the coolest water temperatures being recorded closest to the surface and the warmest values were obtained close to the bottom of the lake. There is also a clear diurnal pattern in the change of water temperature at all depths with the coolest temperatures being recorded during dawn hours at all depths. While there are clear patterns emerging the differences between the diurnal variation at each depth is just over one degree C. The differences in water temperatures between the different depths is less than a degree C and indicates that at this sample location the water temperatures are relatively uniform in distribution.

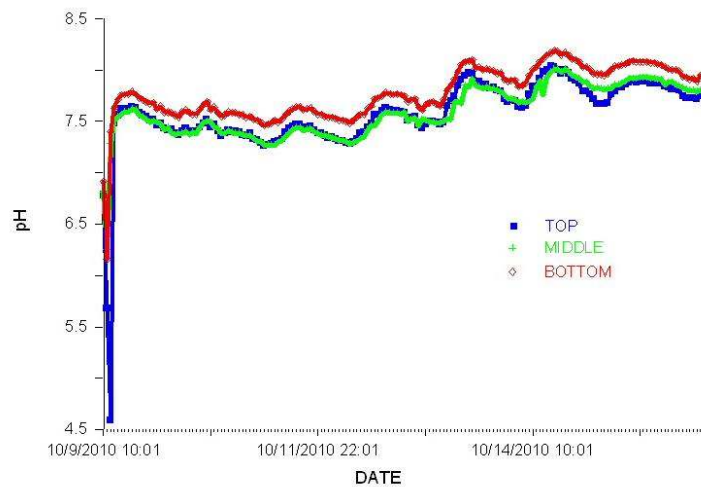
**Figure 7.** Recorded temporal changes in pH recorded at various depths at Site #24.

Recorded values of pH, a second physical parameter is summarized in Figure 7. This particular water quality parameter like water temperature was found to be very consistent at the three depths. A similar situation was also recorded with conductivity and together these physical parameters indicate a uniformly distributed water column at this location. This is also consistent with the data presented in Figure 1 which was obtained over the main expanse of the lake.

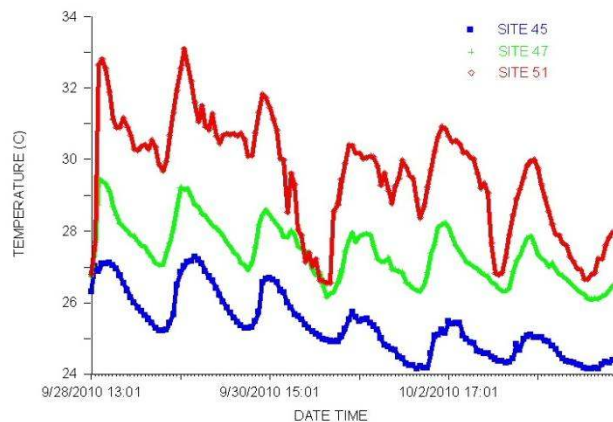
**Figure 9.** Temporal and spatial differences in water temperature at three sampling sites.

Sondes were also deployed at different locations throughout the sampling sites and set to record during the same seven day period. This would provide an estimate of the spatial variation of water quality parameters that occurs among the various locations. Water temperature data is summarized (Figure 9) for three sample sites (i.e., #45, #47, and #51) which span the Hamakua canal that begins at Kaha park (Site #51). Clearly there are significant differences in water temperatures recorded for each of the different sites. Water temperatures as high as 33 C were recorded from Site #51 which is the highest recorded for any sampling site throughout the study area and study period. Although temperatures have the beginnings of a diurnal cycle at this location it does not have the regularity seen for the other two sample sites. The decrease in water temperatures and increase in the regularity of the diurnal fluctuations in water temperature are coincident with an increase in water depth and also decrease in distance from the main tributary feeding the lake.

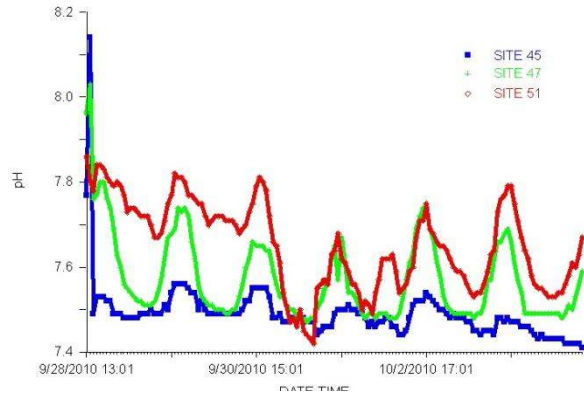
**Figure 10.** Temporal and spatial differences in pH at three sampling sites.

A summary of the recorded pH during the same time period is presented in Figure 10. Diurnal variations as well as spatial differences in recorded pH are clearly evident. It should not be surprising that the data indicate that different locations of the sampling areas are spatially differentiated with regard to physical water quality parameters.

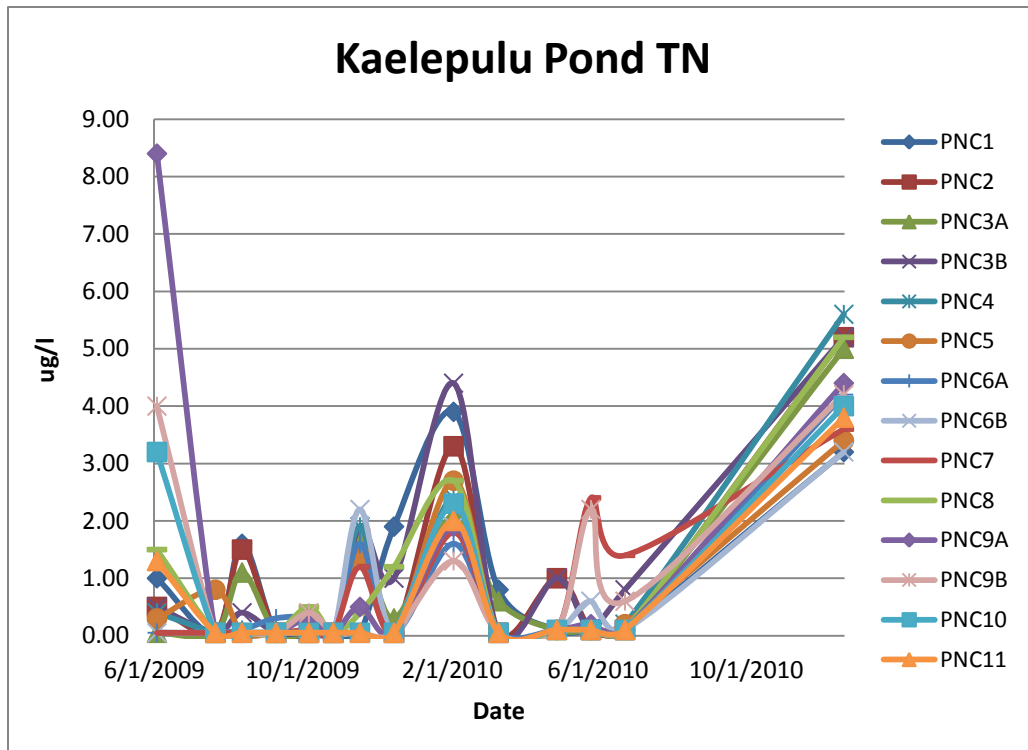
Figure 12. Summary of Total N obtained over the course of the study period.

The water quality data were compared to the current standards using “specific criteria for recreational area” (HAR 11-54-5.2 and 11-54-8) and several parameters did not meet current standards in various categories and those have been marked in red. Using the geometric mean criteria, ammonia, chlorophyll a and turbidity exceeded the prescribed standard. When using the “not to exceed the given value more than 10% of the time” criteria total N, ammonia, chlorophyll a and turbidity were found to be non-compliant. The temporal changes in total N obtained from the pond over the course of the sampling period is summarized in Figure 12 to illustrate the variability that occurred during the study period. Interestingly when the geometric mean criteria is used for Enterococcus the value was found to be compliant with current water quality standards. However, when using the “no single sample shall exceed the maximum of 89 CFU/100ml” criteria there were 16 instances in which the pond was found to be non-compliant. Inputs were found to contain the most Enterococcus with an average of 2,712 CFU/100ml (range: 1 – 52,000 CFU/100ml) per sample site whereas an average of 162 CFU/100ml (range: 1 – 3,040 CFU/100ml) and 292 CFU/100ml (range: 1 – 2,140 CFU/100ml) were found for the Kaelepulu pond and Hamakua + Kaelepulu canals, respectively.

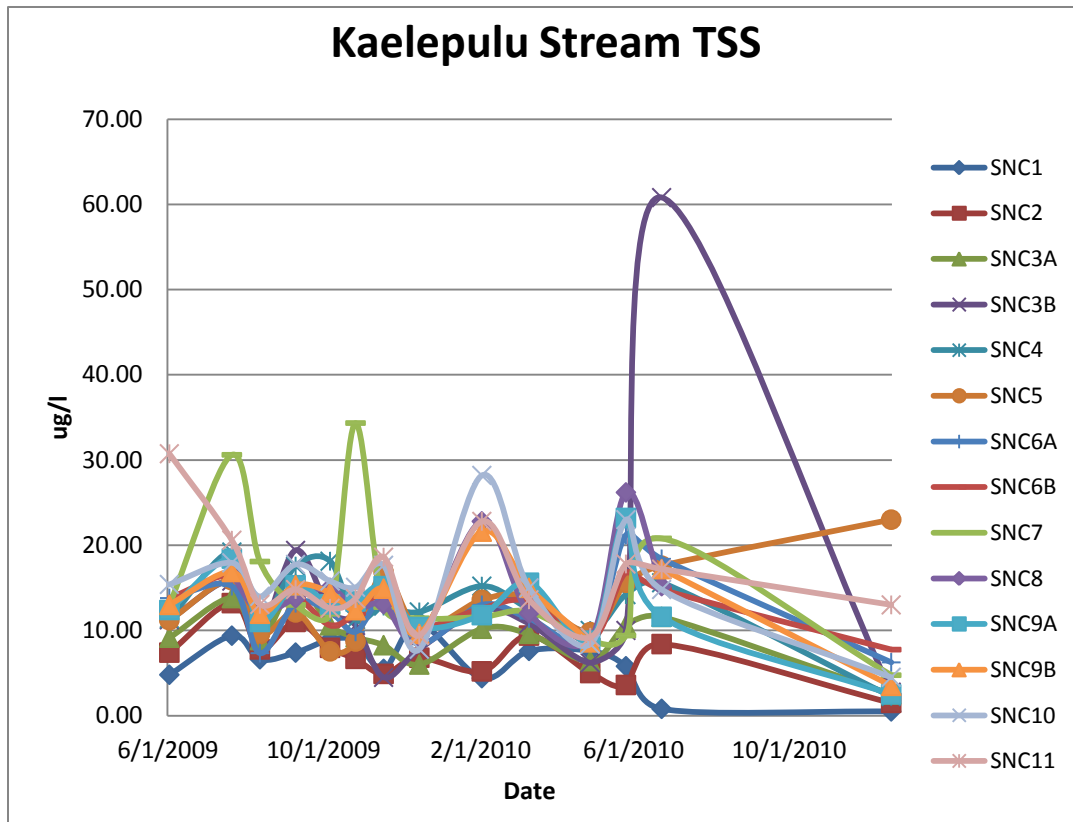
**Figure 13.** Summary of TSS in the stream section obtained over the course of the study period

Water quality standards were also compared with values obtained from the stream sections of the study area and they are summarized in Table 2. In this case the dry standard is being compared and total N, TSS and Turbidity were found to exceed the geometric mean criteria. The temporal changes in TSS over the course of the study period is summarized in Figure 13. As with the pond situation when using the geometric mean criteria for Enterococcus the water quality standard was met. However, on 23 instances the steam sections failed to meet the single sample criteria.

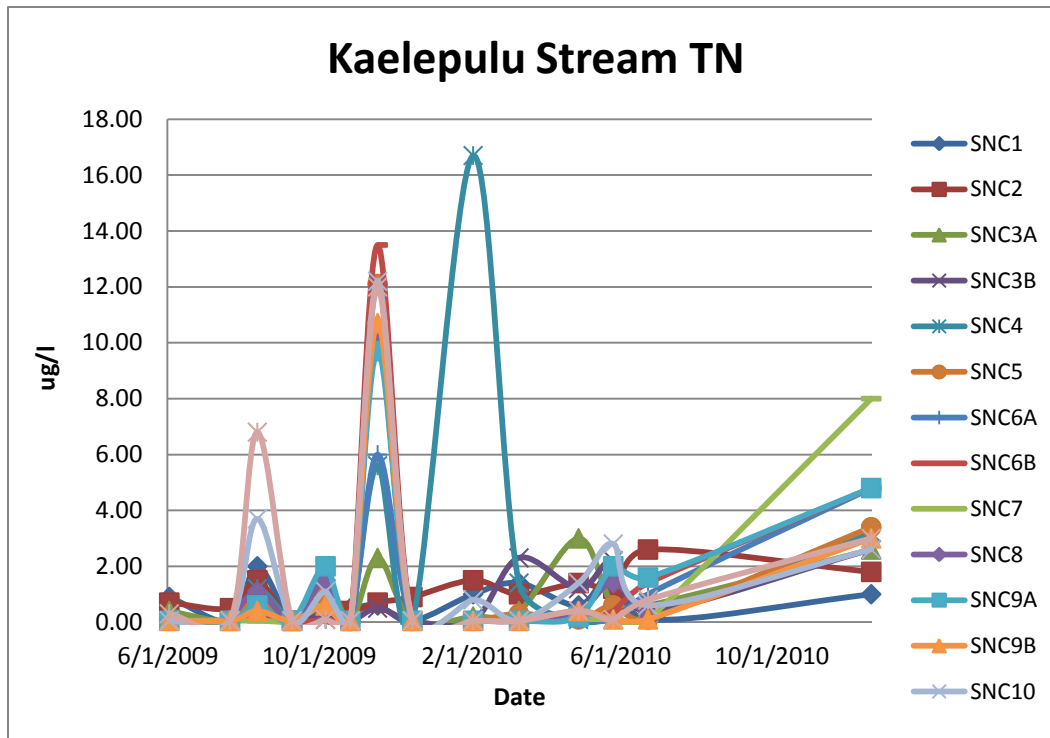
**Figure 14.** Temporal changes in Total N observed over the course of the study period.

Stream data was compared to “Wet” water quality standards and the results are summarized in Table 3. Total N was the only parameter found to exceed the geometric mean criteria whereas Total N, Total P and TSS were found to exceed the not less than 10% criteria using the wet standard. As with the other situations presented Enterococcus met the geometric mean standard but was found to exceed the single maximum sample on 12 occasions. A summary of the temporal variation in Total N values obtained over the course of the study period is presented in Figure 14. The spreadsheet of the compiled data for all samples is provided in Appendix 2 under the spreadsheet titled (Compiled\_Kaelepulu\_TMDL\_data\_w\_summary\_(YL)(1).xls).

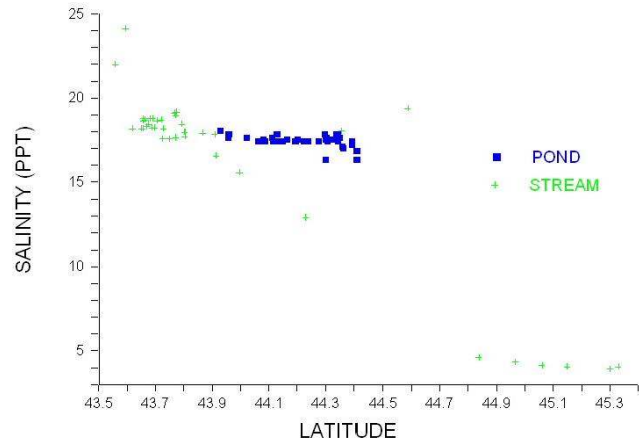
**Figure 16.** Summary of the distribution of salinity across the study area obtained on April 30, 2010.

A scatter plot of the observed salinity across the study area is presented in Figure 16 and reveals the variation observed among the various locations. The average salinity was calculated at 16.8 ppt but was also accompanied by a considerable range (3.9 – 24.1 ppt). The low salinity values were recorded at the most westerly sites located in the Hamakua canal that have also been reported on previously (Figure 11). Interestingly while there is no physical connection between Kawainui Marsh and this section of the study area the low salinity indicates some seepage across the man made berm that currently separates the two water bodies.

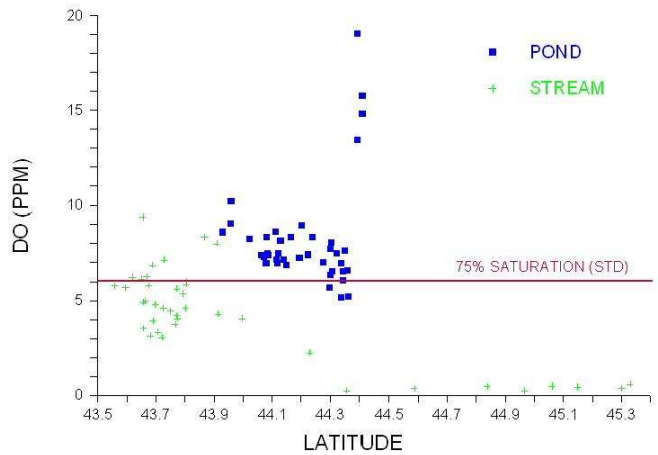
**Figure 17.** Summary of the distribution of dissolved oxygen across the study area obtained on April 30, 2010.

A similar scatter plot is presented for dissolved oxygen in Figure 17. The average dissolved oxygen for the entire study area was calculated at 6.2 ppm (range: 0.2 – 19.0 ppm). There are clearly areas of the study area that do not meet the must be above 75% saturation criteria and the majority of these sites are located in the Hamakua and Kaelepulu canals. The very high dissolved oxygen values are obtained in the shallowest section of the pond that is also accompanied with a substantial amount of macroalgal growth. As mentioned previously when obtaining the dissolved oxygen values these were done at mid day.

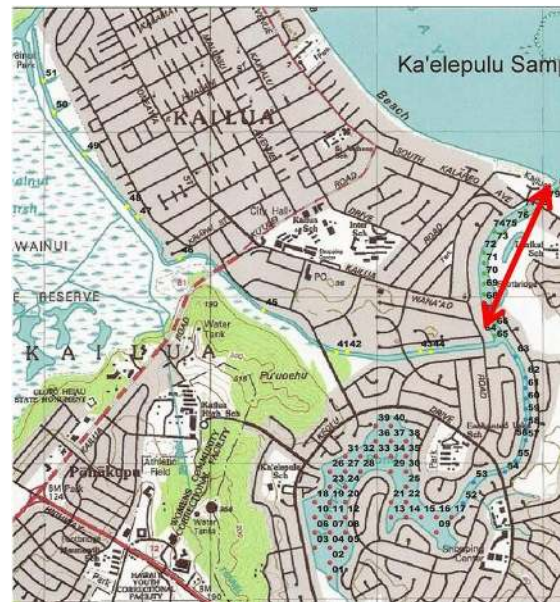
**Figure 19.** Red arrow indicates location where the majority of activities take place.

**Progress Towards Objectives:** A photographic survey of activities ongoing on the inland waters were taken utilizing the sample sites (n=80) as a makeshift transect line on two separate occasions (06/20/2009 and 07/20/2009). As seen in the photos the major activities that occur are kayaking, canoeing, paddle-boarding and fishing. Fishing consist of both netting (e.g., hand net, throw net, lay net) as well as pole fishing. No attempt was made at addressing frequency at this point in time. One clear result is that the amount of use of the inland waters is restricted to the waterways that extend between site 80 and 65 (Figure 19). On both occasions no activity was observed along the entire

length of the Hamakua canal or on the lake itself. That is not to say that there is no activity ongoing as there are numerous launching areas and floating docks along the banks of the lake.

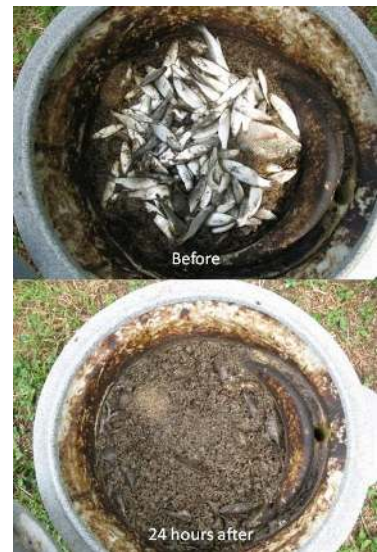
**Figure 20.** Before and after photos trash fish being consumed by black soldier fly larvae.

Conversion of organic material by saprophages has gained in popularity over the last decade and larvae of the black soldier fly (BSL) *Hermetia illucens* have been shown to be capable of converting large amounts of organic waste into protein rich biomass (Figure 20). The grubs reportedly can serve as a substitute for fishmeal or use directly as a fish or chicken food. During the reporting period three Biopods™ were stocked with feral tilapia collected exclusively from Kaelepulu over the course of three months to assess the food conversion ratio from fish to grubs. Average input for the three bipods was  $16.5 \pm 0.5$  kg wet weight and average output of live grubs was  $0.64 \pm 0.1$  kg resulting in a  $3.9 \pm 0.7\%$  FCR. The low recovery value is attributed to the large amount of indigestible matter (e.g., bones, scales) that remain. While the output of grubs was low they do represent a readily available source of feed that have the potential to be used as a feed directly for either fish or chickens.

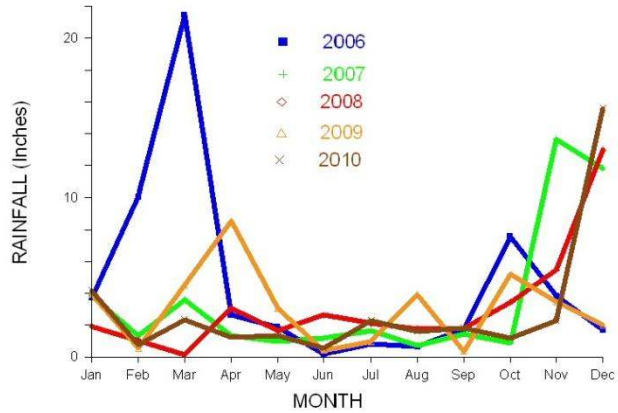
**Figure 22.** Monthly total rainfall recorded over five years at the rain gauge located at the Olomana Fire Station.

National Weather Service (NOAA). The raw data of all rain gauges on Oahu between 2006 and part of 2011 were obtained and is provided in Appendix 6. The rainfall data is recorded on a daily basis for each gauge site and have been placed in a spreadsheet from which data can easily be extracted and summarized for individual gauges such as for the Olomana Fire Station which is presented in Figure 22. This illustration shows the total rainfall for each month between 2006 -2010. Plotted in this form it is easy to determine the onset of the wet periods for each year and the variation of rainfall for each year.

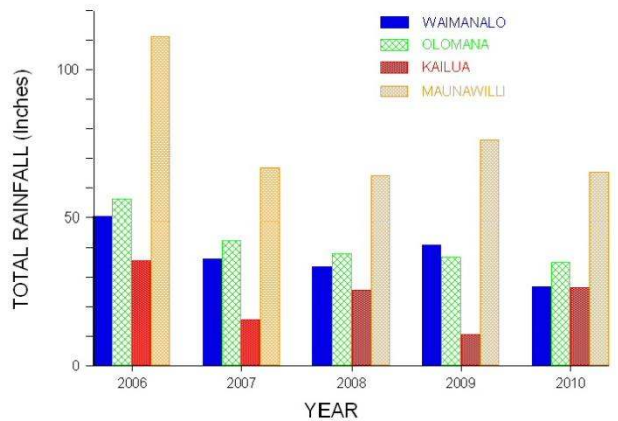
**Figure 23.** Total annual rainfall recorded over a five year period for gauges at four locations surrounding the study area.

The total annual rainfall recorded for gauges in Waimanalo, Maunawilli, Kailua Fire Station and Olomana Fire Station were summarized between 2006 -2010. A graphic example of the results recorded for all five years is presented in Figure 23. The gauge located in Maunawilli consistently records the highest amount of rainfall annually and indicates one area that can substantially impact the study area. However, the contributions by the Waimanalo and Olomana watersheds as represented by total rainfall recorded when combined represent the largest contribution of freshwater to the study area.

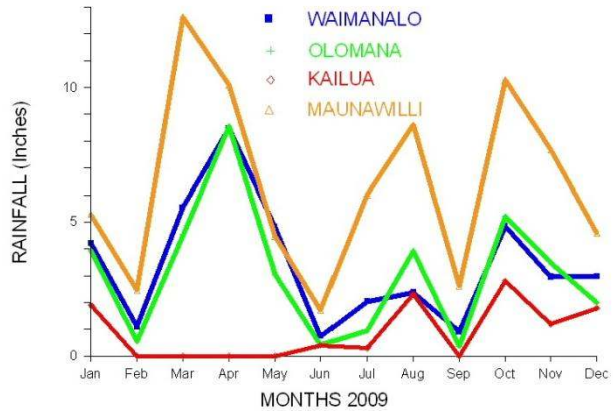
**Figure 24.** Total monthly rainfall at four gauges recorded during 2009.

Using the 2009 monthly rainfall data recorded for all four gauges (Figure 24) it appears that even though the amount of rainfall varies at each location they are all apparently recording the same rain event. This pattern was consistently observed for all five years of which data was obtained and indicates that all of these systems will contribute water into Kaelepulu system to some degree during a single rain event.

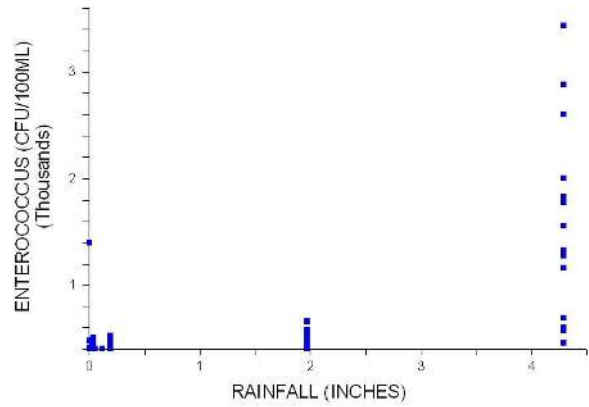
**Figure 26.** Correlation between rainfall from the Maunawilli rain gauge versus enterococcus found in the pond.

Normal rainfall data (storm events are removed) was correlated with several water quality parameters and a positive correlation between rainfall and enterococcus values was detected. Figure 26 depicts the correlation between the rainfall data from the Maunawilli rain gauge and enterococcus values that were obtained from the pond over the course of the study period.
