KAWAI NUI STREAM FLOW RESTORATION PROJECT

SIPHON FLOW RESTORATION EXPERIMENT REPORT

MAY 2016

Oceanit Laboratories Inc.

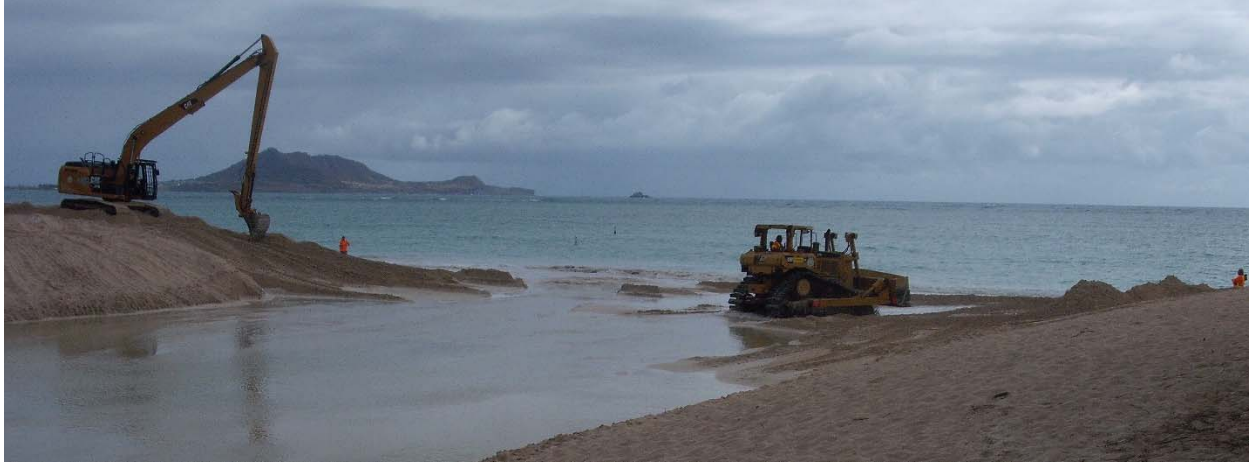
Figure 1.6 A long-reach excavator and bulldozer are typically used to conduct stream mouth openings.

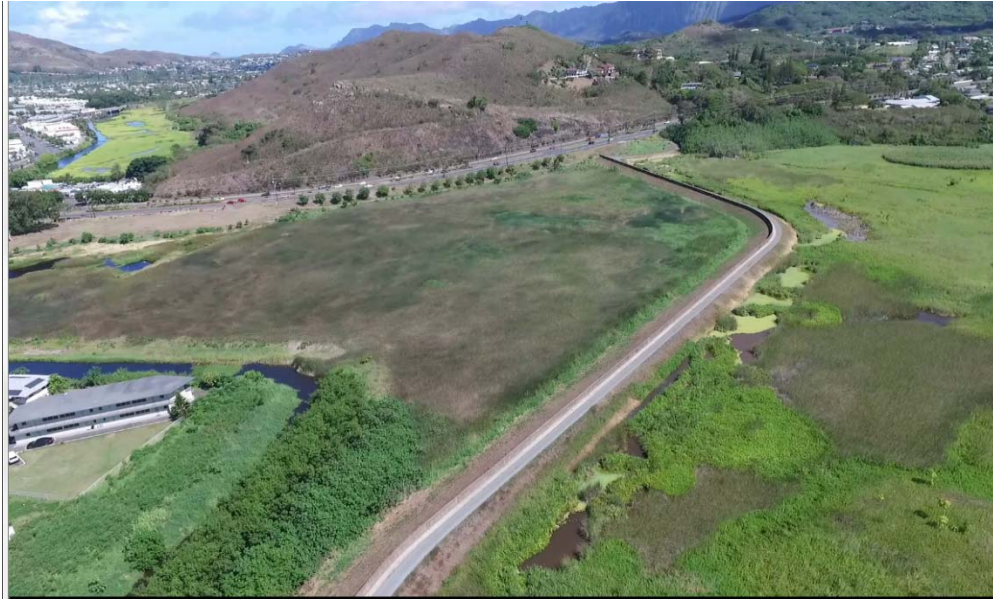
Figure 2.1 View from above siphon site to Kailua Road

A temporary syphon was constructed across the Kawai Nui Levee approximately 1,550 feet west of its junction with Kailua Road. The site is approximately 100 feet north of the existing USGS water level gauge (#16264100). Aerial views of the levee and the syphon site are shown in Figure 2.1 to 2.3.

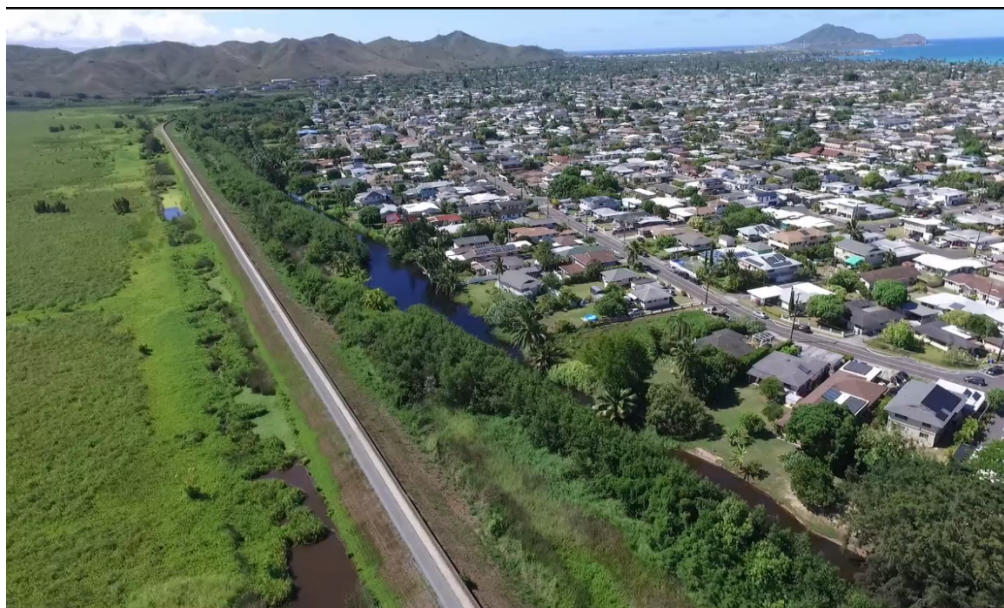
Figure 2.2 View from above siphon site towards Aikahi and Mokapu.

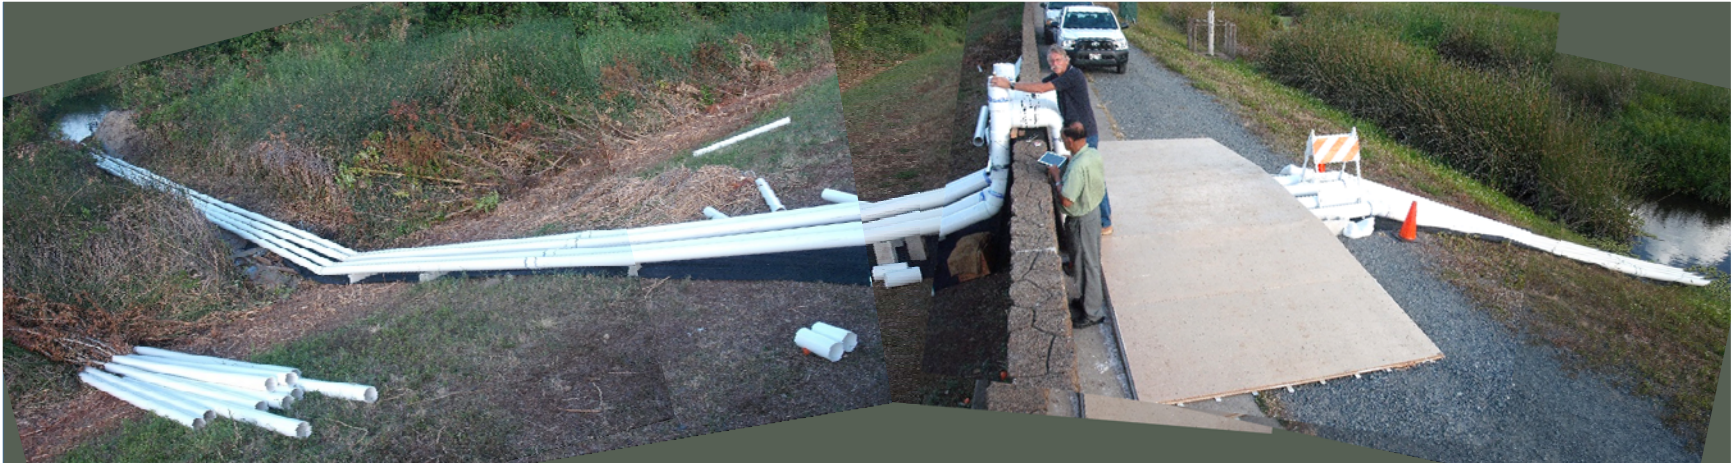
Figure 2.4. Syphon and pedestrian ramp across the levee.

The syphons were checked on a daily basis and re-primed as necessary when flow stopped due to air accumulation at the top of the pipe. Syphon flow was discontinued on September 3, 2015 when the elevation of Kawai Nui Stream rose above 2.0 ft. MLLW.

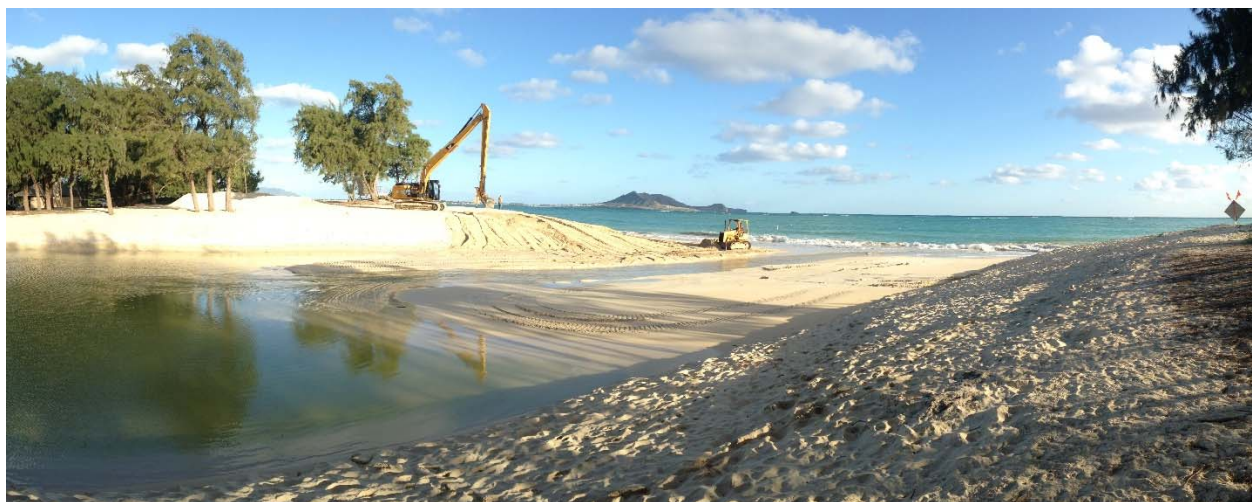
Figure 2.7 Opening the Kaelepulu Stream mouth at Kailua Beach using a small bull dozer and a long reach excavator. Beginning pile of excavated sand can be seen between trees behind the excavator.

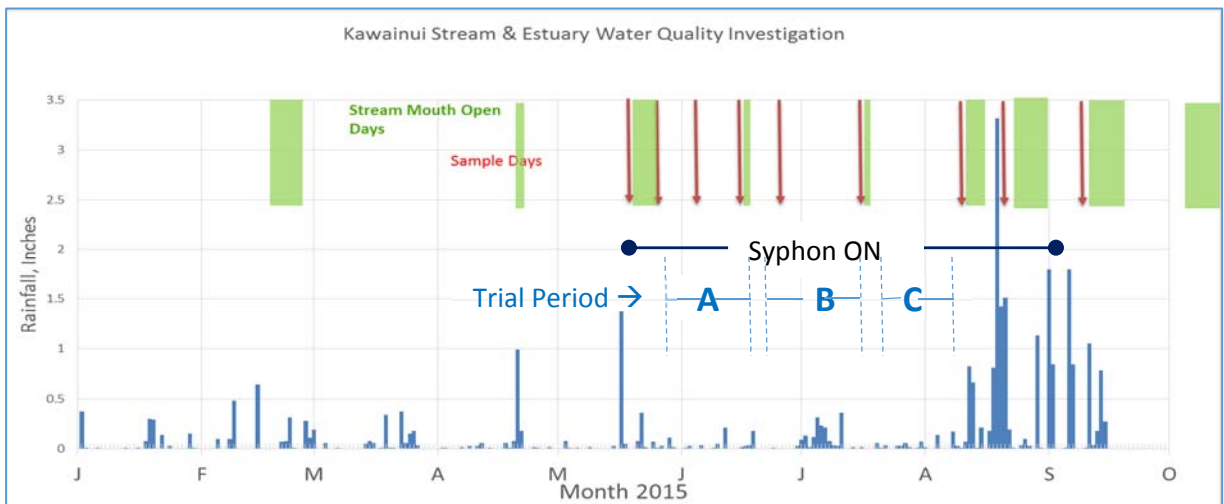
Figure 3.5 2015 Kaelepulu Rainfall with overlay showing berm openings and timing of sampling events

The syphon transferred water from the marsh to the stream for a total of 104 days. During this time three complete and one partial exchange cycles were monitored between May 22 and September 3, 2015 (Figure 3.4, Figure 3.5). Maintaining consistent flow in all four syphons proved to be a challenge (due to minute air leaks in the PVC joints) and resulted a range of flow rates less than the 2.2 cfs anticipated from the initial measurements. During this period of time the system was open to flow at the stream mouth on five occasions for a total of 28 days. The final partial filling cycle only lasted 5 days, and was interrupted by heavy rainfall from a series of near-miss hurricanes which coincided with the termination of the experiment. For the purpose of the analyses, this experiment will only examine the initial first three fill and drain cycles between A) May 25 – June 16, B) June 21 – July 15, and C) July 19 – August 11. The syphons were turned off on September 3, 2015, when the water surface elevation reached 2.0 ft MLLW and heavy rainfall from nearby hurricanes began to impact Oahu.

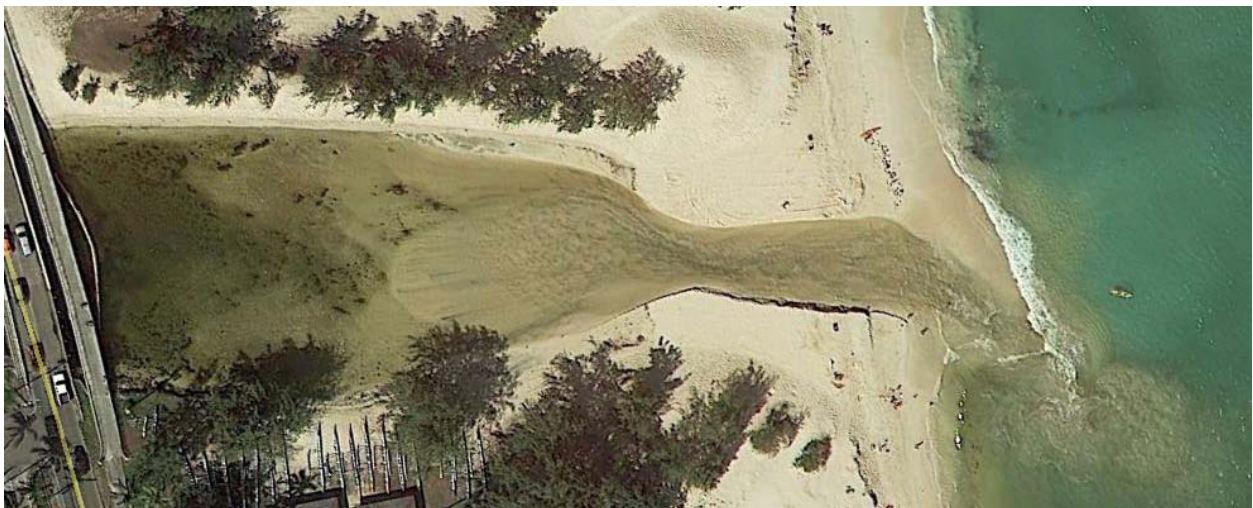
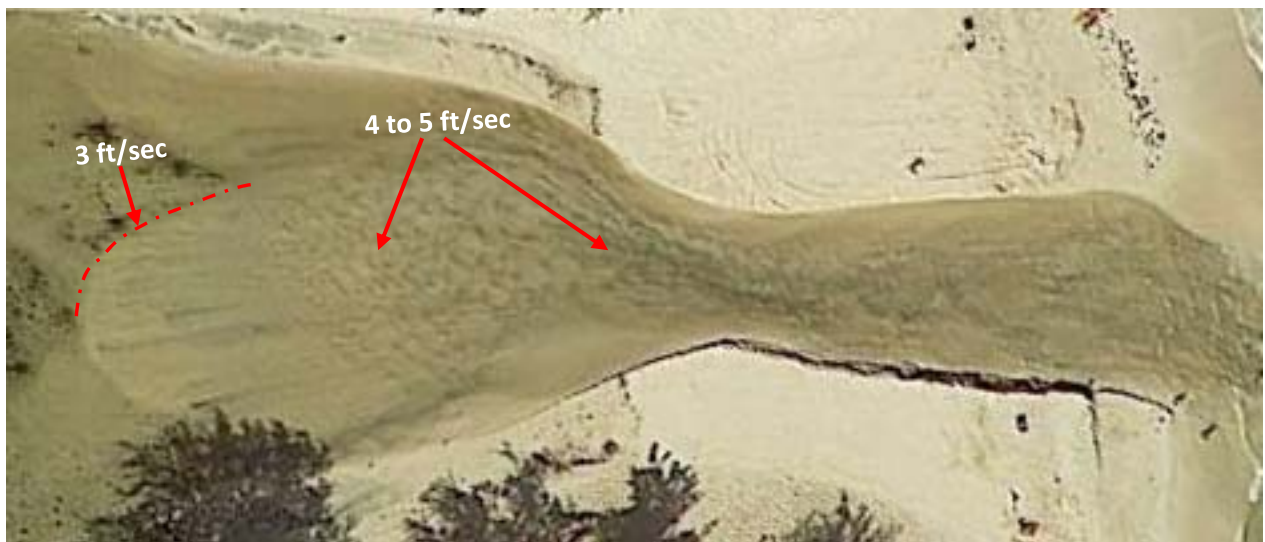
Figure 3.8 Stream mouth opening by storm overflow (1/29/13. Google). Upper photo: Area between Lanikai Bridge and Kailua Beach with ocean current flowing from west to east (top to bottom) and sand being deposited just offshore and to the west (boat ramp) end of Kailua Beach. Lower photo shows how outflowing current erodes sand from the channel as the current speed increases in the narrow channel.

The outflowing stream is capable of eroding a significant channel over a short time span if there is sufficient hydraulic head. As can be seen in the lower portion of Figure 3.8, during a self-initiated overflow event, the laminar stream flow begins eroding sand from the surface of the bed as the stream narrows and flow velocity increases. Separate measurements suggest that this critical flow to induce shear erosion is about 3 feet per second. As the stream continues to narrow, flow speed increases and becomes turbulent which greatly increases the rate of erosion and sand transfer to the ocean. Once the flow reaches the ocean, the average flow speed quickly decreases and the sand is deposited in the nearshore. Longshore currents in Kailua Bay can run in either direction along the beach. On January 29, 2013 the currents were moving from east to west (top to bottom in the photo) and sand transfer from the stream mouth was to the west, towards the Lanikai boat ramp.

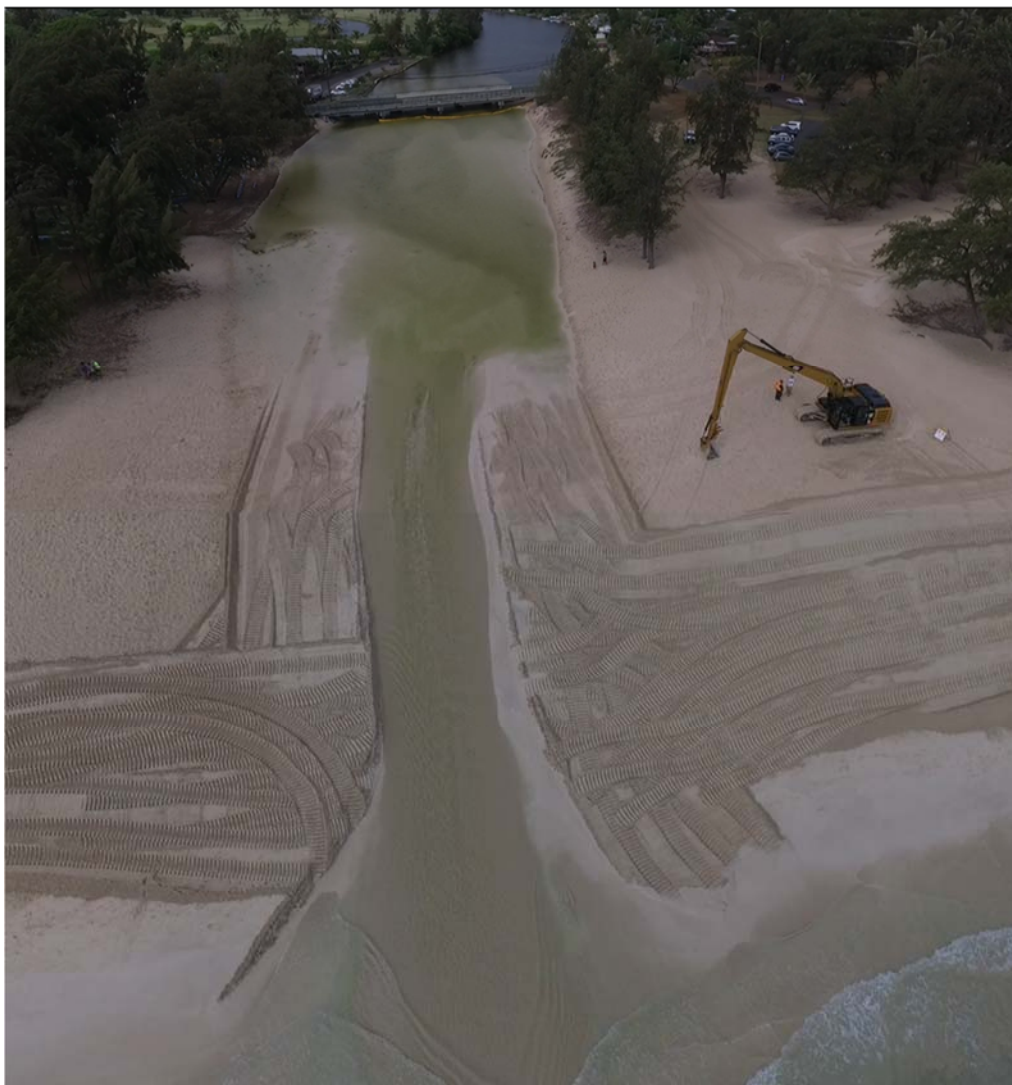
Figure 3.9. Stream mouth initial outflow, August 11, 2015

To better understand the dynamics of the stream erosion and accretion dynamics a drone was used to capture aerial videos of the outflowing and inflowing stream process on October 13, 2015 (Figure 3.9).

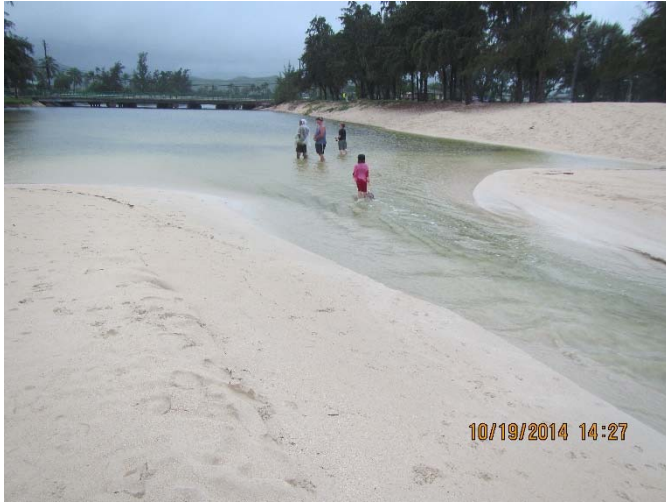
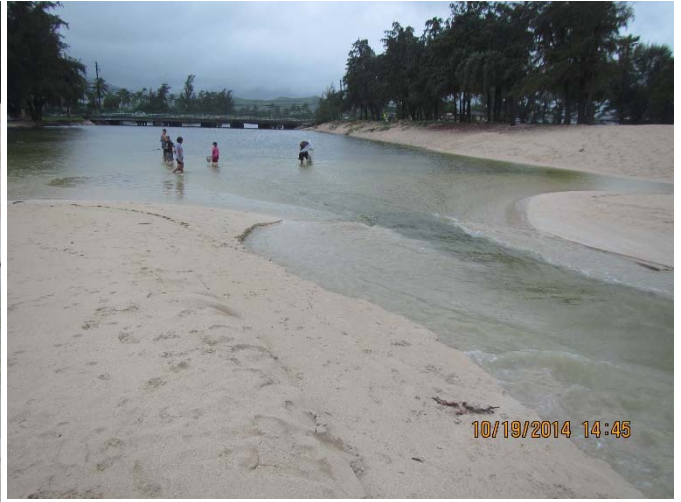
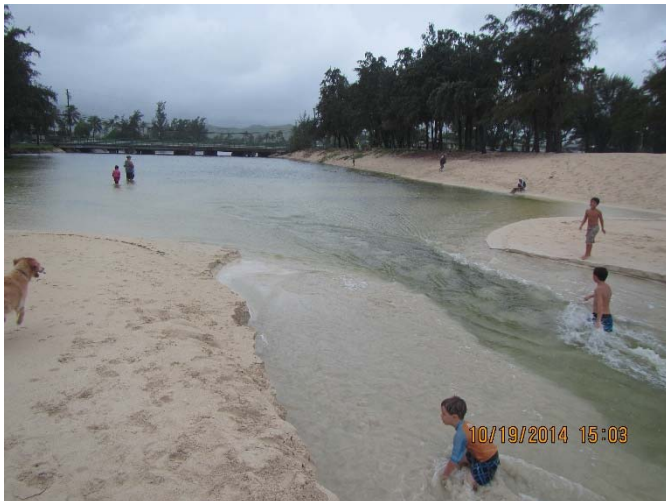
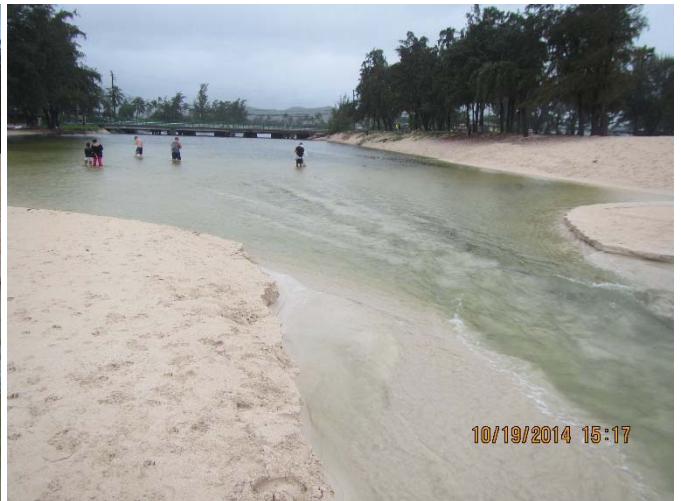
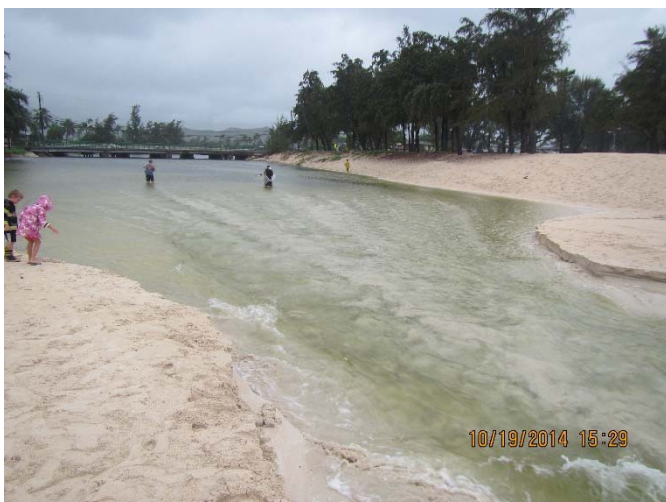
Figure 3.10 October 2014 the City responded to a high water surface in the pond and an impending rainstorm by conducting an “emergency” opening of the stream mouth. Flow established in a 1/2-foot deep 20 foot wide channel completed at 16:15. Flow and erosion first concentrate at the center of the channel and then widen into a 40-foot wide 3 foot deep channel in about an hour and fifteen minutes.

The ability of the stream channel to open itself when properly timed with the ocean tides was demonstrated on Sunday, October 19, 2014 (Figure 3.10), when the City responded to the flood threat of a high water surface elevation (2.81 ft MLLW) and an approaching rainstorm. The City crew arrived in the morning and successfully graded down the sand dune by 10:00, at which time they attempted to open the stream mouth to flow. Unfortunately the combination of a high tide (2.3 ft MLLW, about a half foot higher than predicted), stiff trade winds, and high (for Kailua) surf rapidly closed the opening they attempted to make. At 13:00 as the tide was rapidly falling, they again attempted to develop an opening, this time with much better results. A single bulldozer pass through the shallow sand bar quickly established an outflow that, over the course of about 2 hours, eroded the stream to a 40 foot wide and 2 to 3 ft deep channel. Between 13:00 when flow was established and 22:00 when the falling pond reached the level of the incoming tide (1.20 ft MLLW) a total of about 10 million cubic feet of water flowed out of the system for an average flow rate of about 300 CFS.

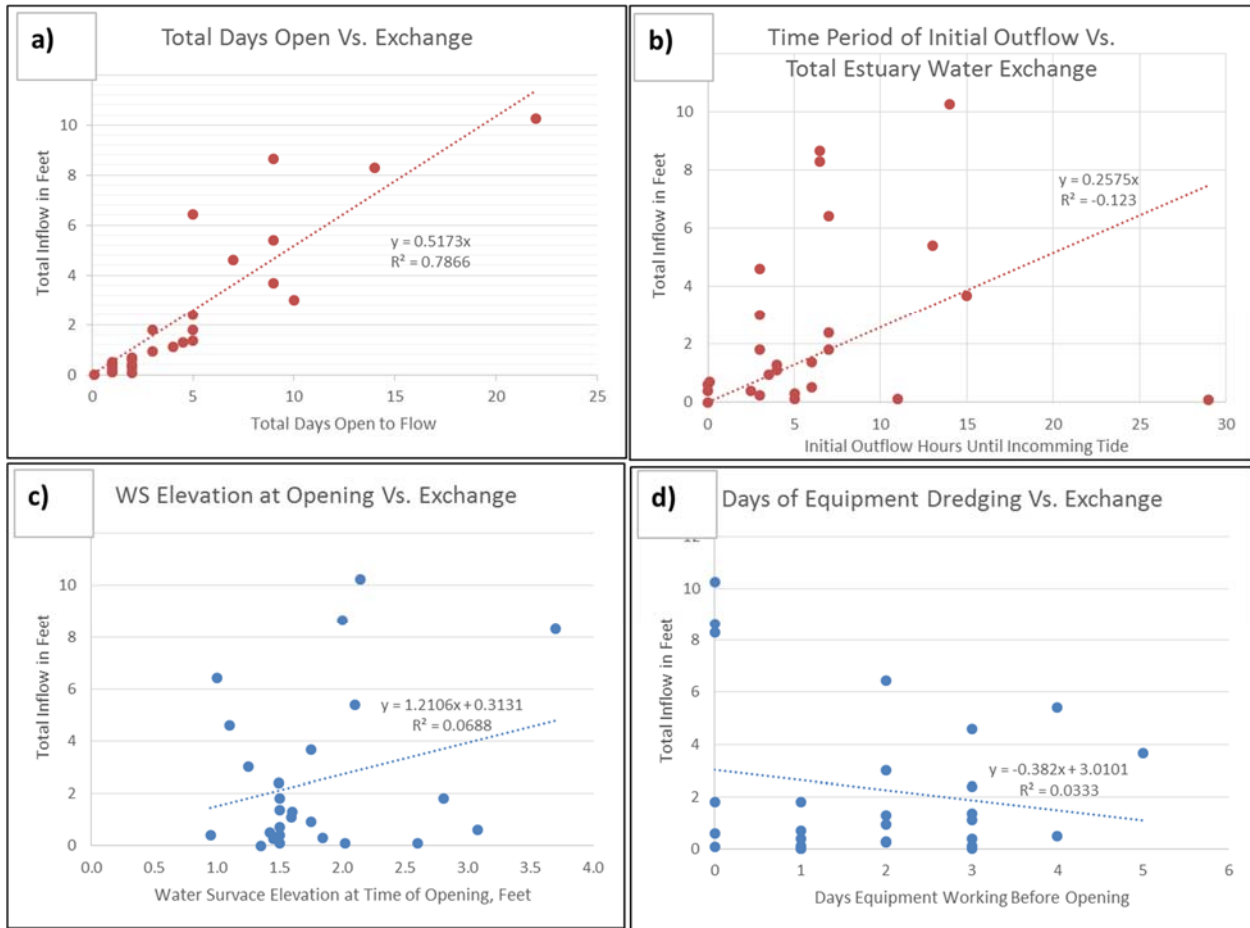
Figure 3.13 Most important factors influencing the total ocean inflow to the estuary during an opening event were a) the total days the stream mouth was open to flow, b) the length of time of the initial outflow, and c) the height of the stream water at the time of opening. The number of days used by City equipment operators to open the channel to flow had no correlation with the number of days the stream remained open to flow.

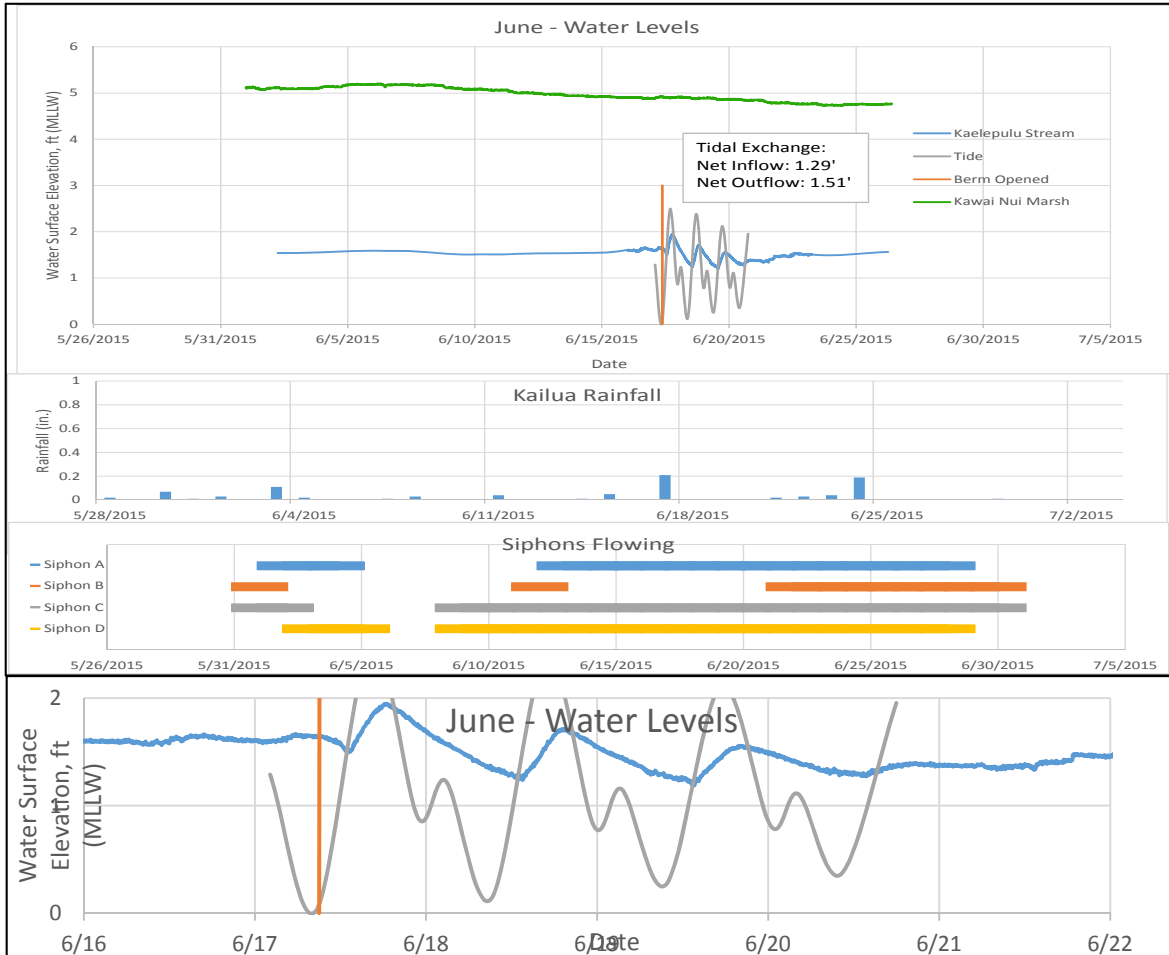
Figure 3.14 June 2015 Water surface elevations and syphon operation

The stream mouth opening on June 15 began at 0900 with a 60 foot wide, but only 6-inch deep, channel cut by the bulldozer with the excavator being used to move sand up off the beach above the high water line. By 1200, the channel had narrowed to about 12-feet and deepened to about 2-feet with a velocity of 4 ft/sec and was visibly eroding a larger channel. However, the incoming tide began at 1230, and a significant channel did not develop on the first outflow. The channel closed during high tide 4 ½ days after the opening at an elevation of 1.49 ft after allowing a total net inflow of about 1.3 feet of ocean water to the estuary during 4 high tide periods. The stream water elevation at the time of opening was only 1.6 ft, up from 1.28 ft at the previous stream mouth closing on May 25. The measured rain fall of 0.89-inches during the 22 ½ days the berm was closed (May 25-June15) would be expected to contribute about (3X) 2.6-inches to the stream water surface elevation, but the evaporation (-0.2 inch/da) would be expected to lower the water surface elevation by 4.5-inches. This would yield a predicted elevation at opening on June 15, of only 1.12 feet. The syphon therefore contributed about 0.48 feet to the water surface elevation during the 22 ½ days for an average flow rate of 1.53 cfs. During the month, problems were encountered keeping the syphons flowing consistently, but typically 3 of the 4 syphons were running most of the time.

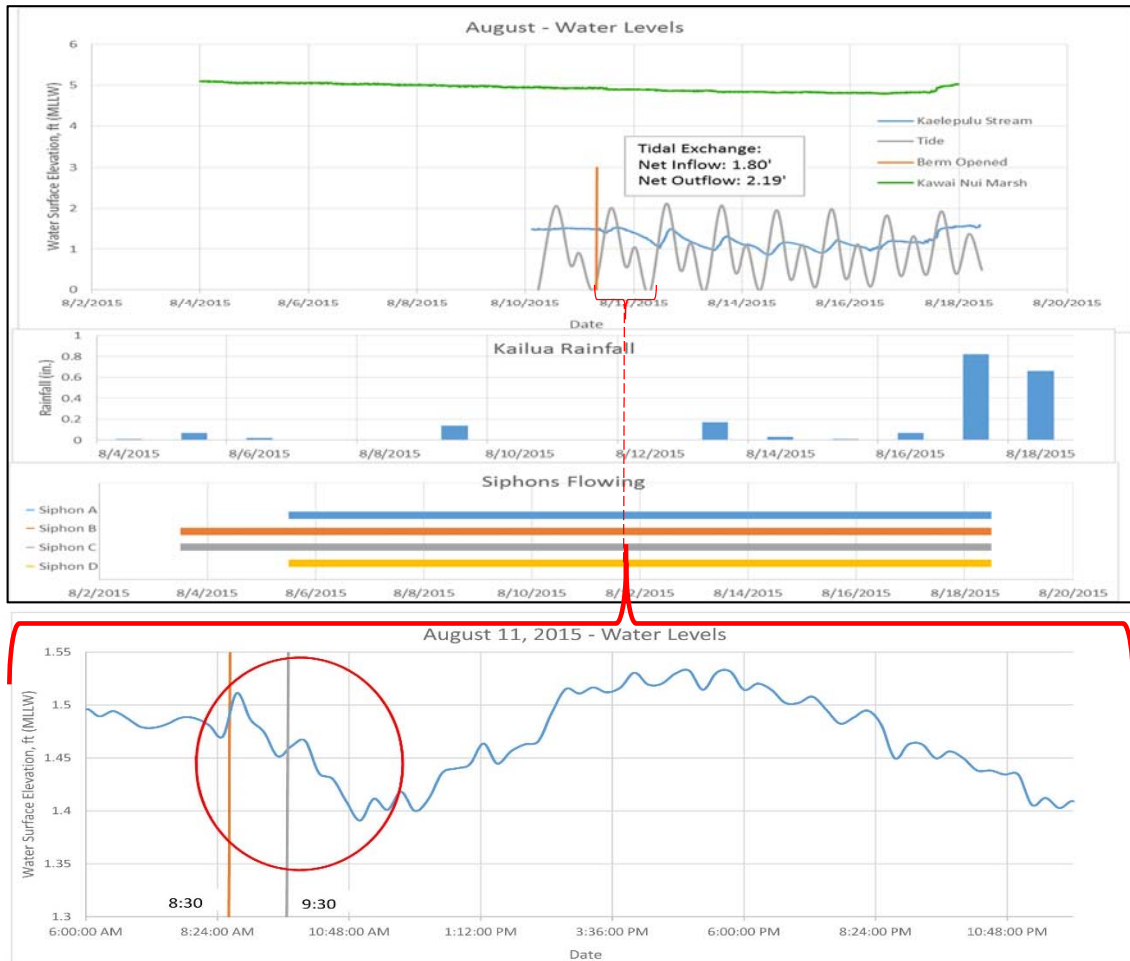
Figure 3.16 August 2015 Water surface elevations and syphon operation.

The stream mouth opening on August 11 was initiated at 0830 from a stream water surface elevation of 1.5 ft, up from an elevation of 1.05 ft at the closing of the stream mouth 25 days earlier (July 19). The stream mouth across the beach was opened with a relatively narrow (20 ft) channel cut through the center of the sand berm which had been graded down to less than a foot above the stream water elevation. An hour after the opening (0930) the excavator was used to dredge a narrow (~4 ft) but deep (~3 ft) channel through the center of the flow. The effect of the narrow deeper channel was visually dramatic, with obvious channel bank and bed erosion occurring at an increased rate in proportion to the flow rate. In the enlarged (lower) portion of Figure 3.16 below, the effect of the narrow channel can be seen as a steep decrease in the surface elevation. Even though the opening was initiated only about 5 hours prior to the inflowing tide, the channel developed was sufficient to maintain flow over a period of almost 7 days. The opening achieved an inflow of 1.8 feet with an outflow of 2.2 feet and closed at an elevation of 1.6 feet. Rainfall during the closed period was 0.66-inch which could contribute (3X) 2.0-inch to the water surface elevation of the stream. Evaporative loss (0.2 inch/da) would be expected to decrease the water surface elevation by 4.9 inches, yielding an expected elevation of 0.81 feet. This low water surface elevation in the estuary would generally be associated with fish die-offs, the threat of bird botulism, and complaints of foul odors from adjacent residential neighborhoods. The difference in water surface elevations is attributed to inflow from the syphon of 2.06 cfs. During the flow period all four syphons were flowing most of the time with only occasional needs for re-priming.

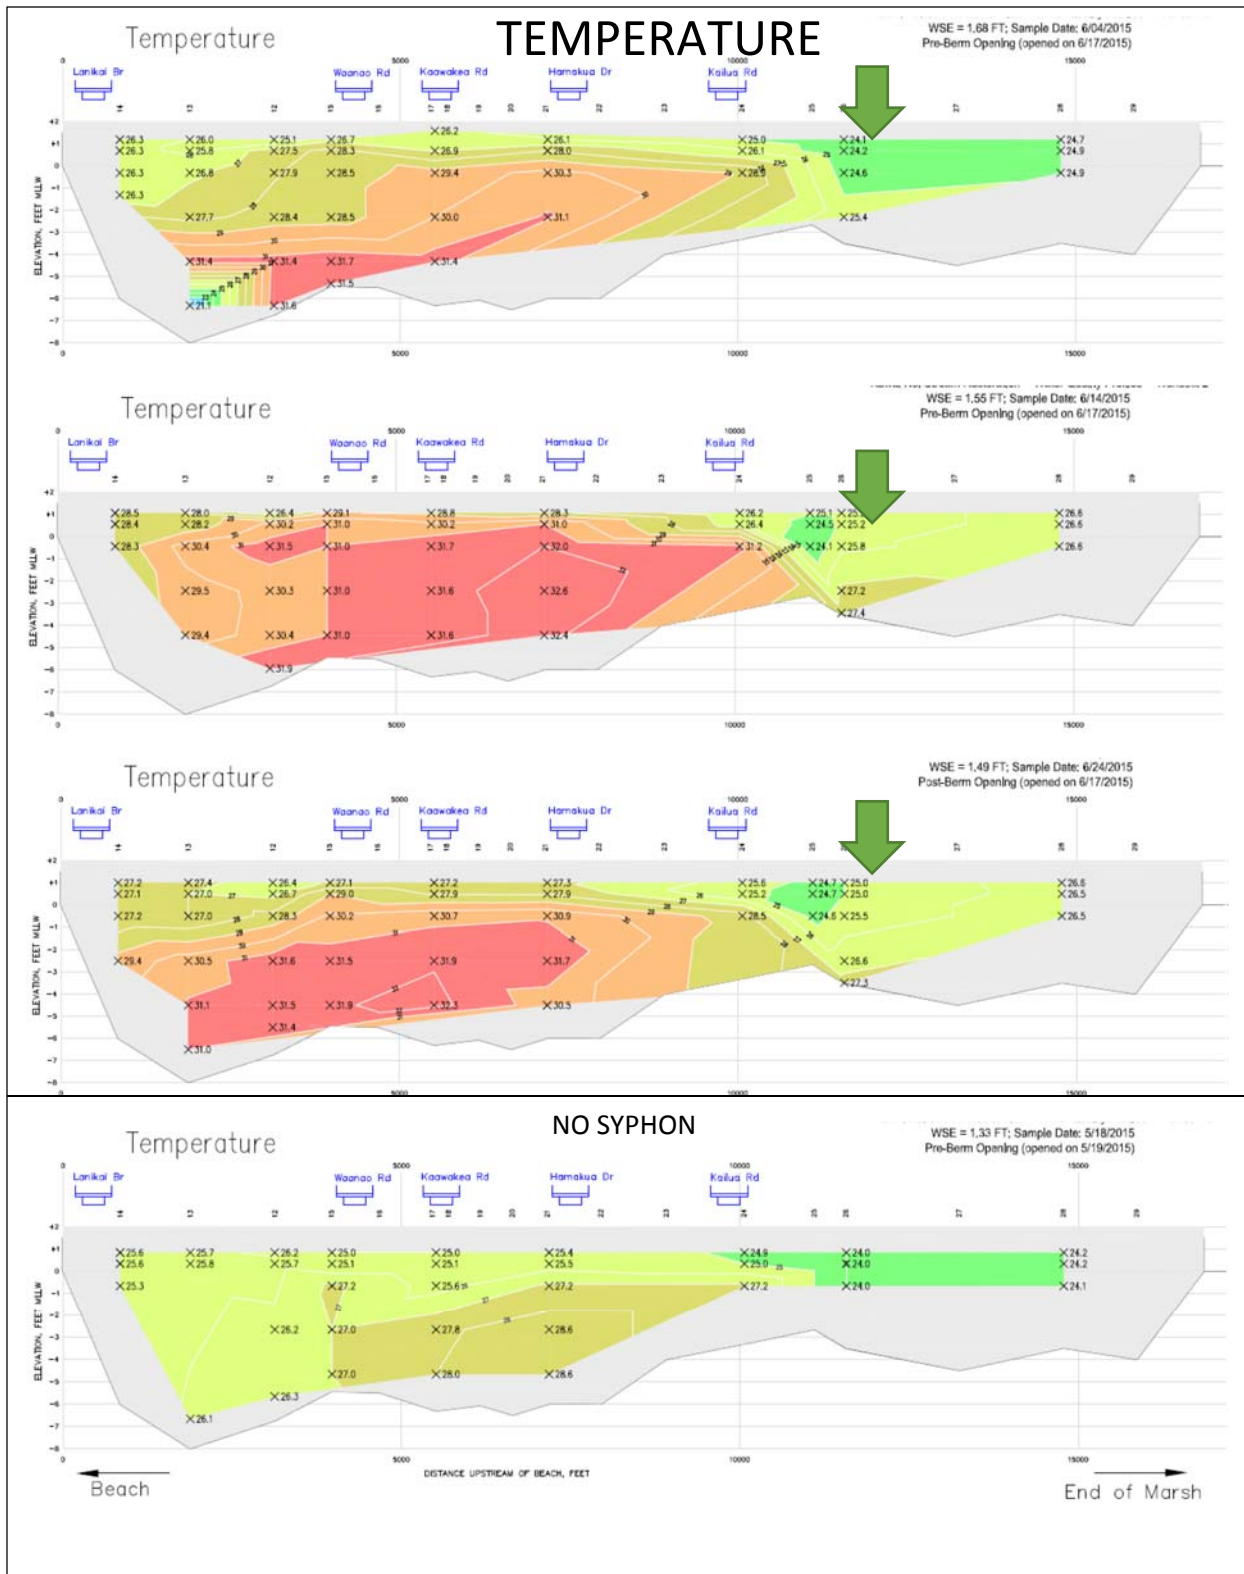
Figure 3.18 Inflow of water from syphon (green arrow) had no impact on temperature levels in Kawai Nui Stream. Transects taken on 6/4 (top), 6/14 (mid), and 6/24 (bottom) with the stream mouth open to flow from 6-17 through 6/20/2015. Bottom transect is from 5/18 prior to any flow from the syphon.

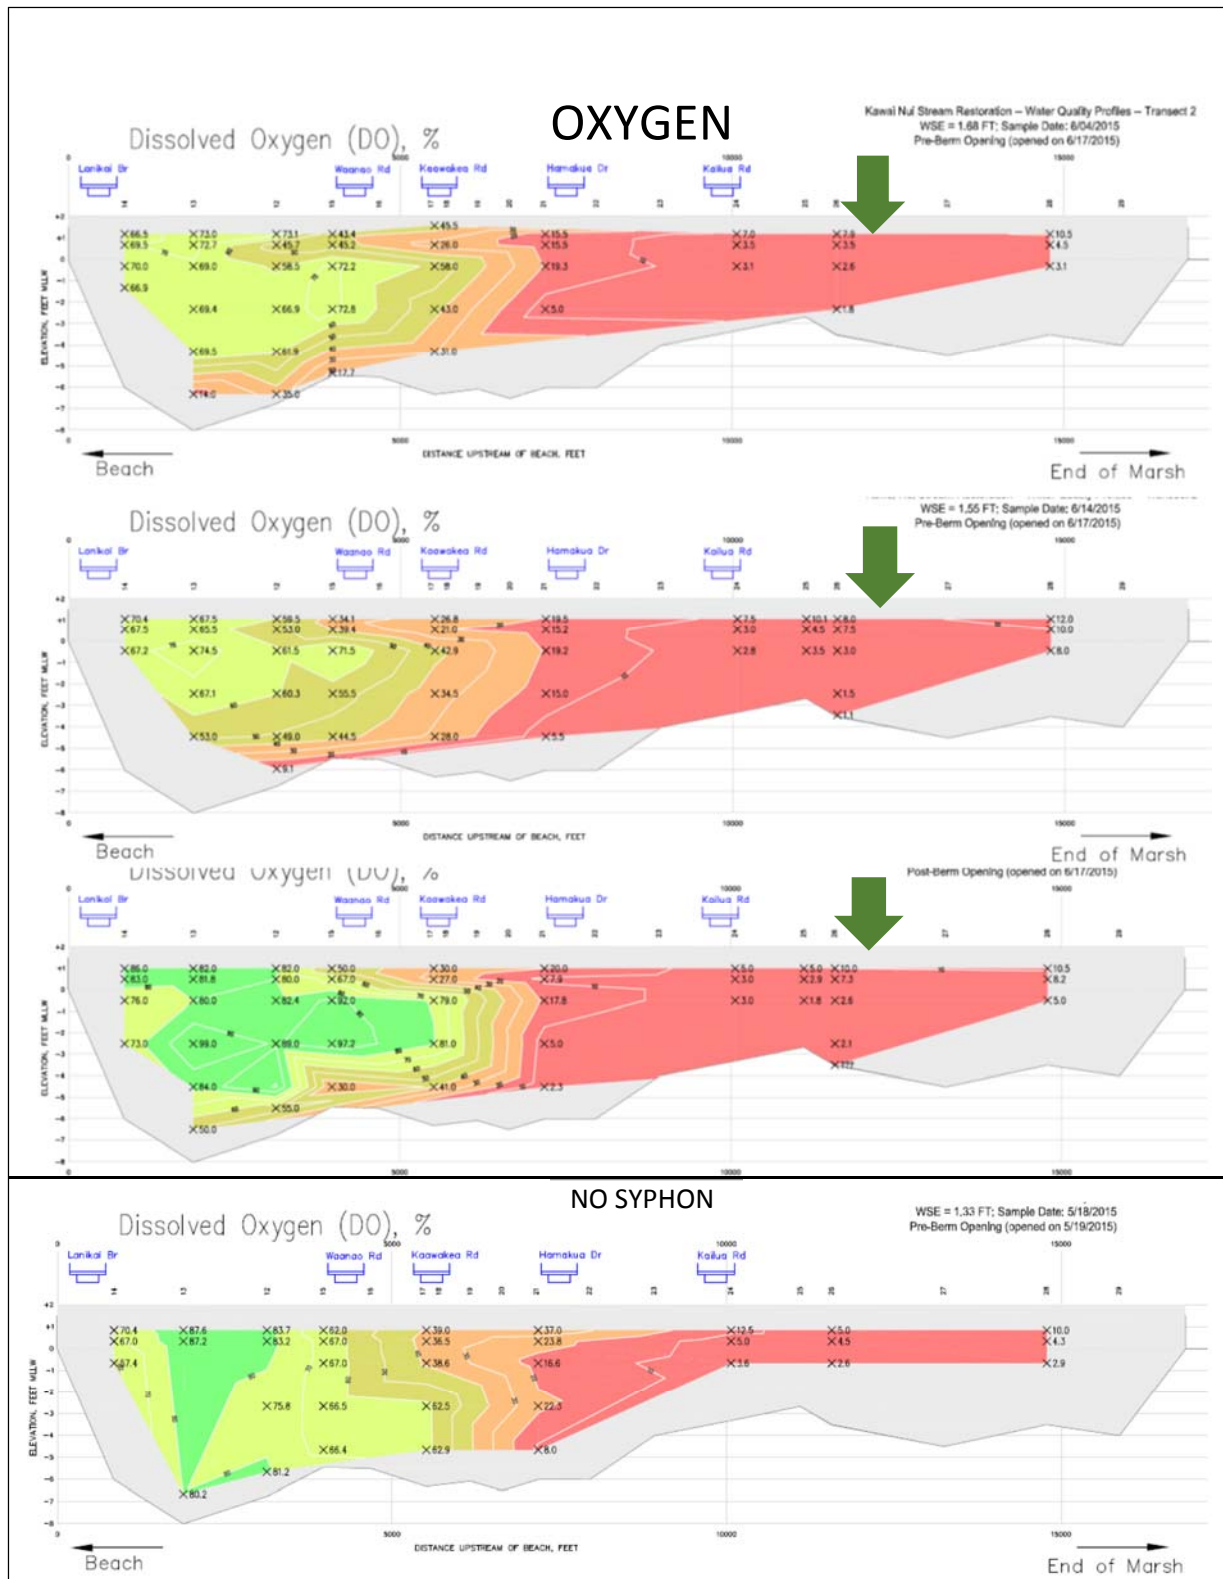
Figure 3.20 Inflow of water from syphon (green arrow) had no positive impact upon the very low dissolved oxygen levels in Kawai Nui Stream. Transects taken on 6/4 (top), 6/14 (2nd), and 6/24 (3rd) with the stream mouth open to flow from 6-17 through 6/20/2015. Bottom transect is from 5/18 just prior to starting the syphon.

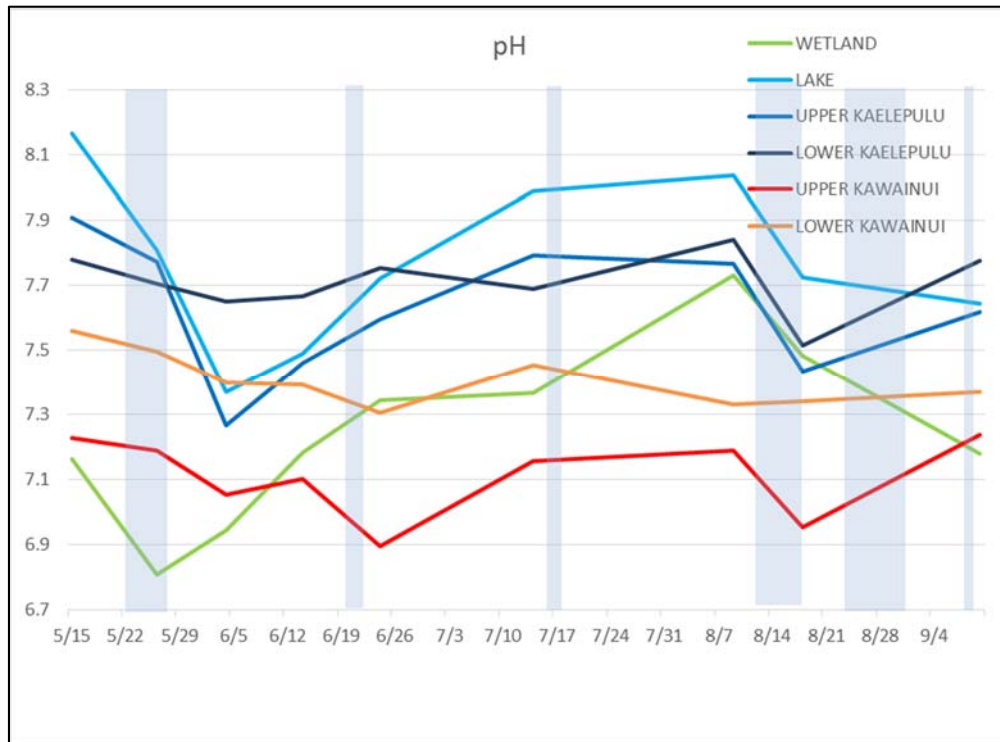
Figure 3.21 pH by estuary reach during 2015. Blue bars indicate periods when stream mouth was open to the ocean.

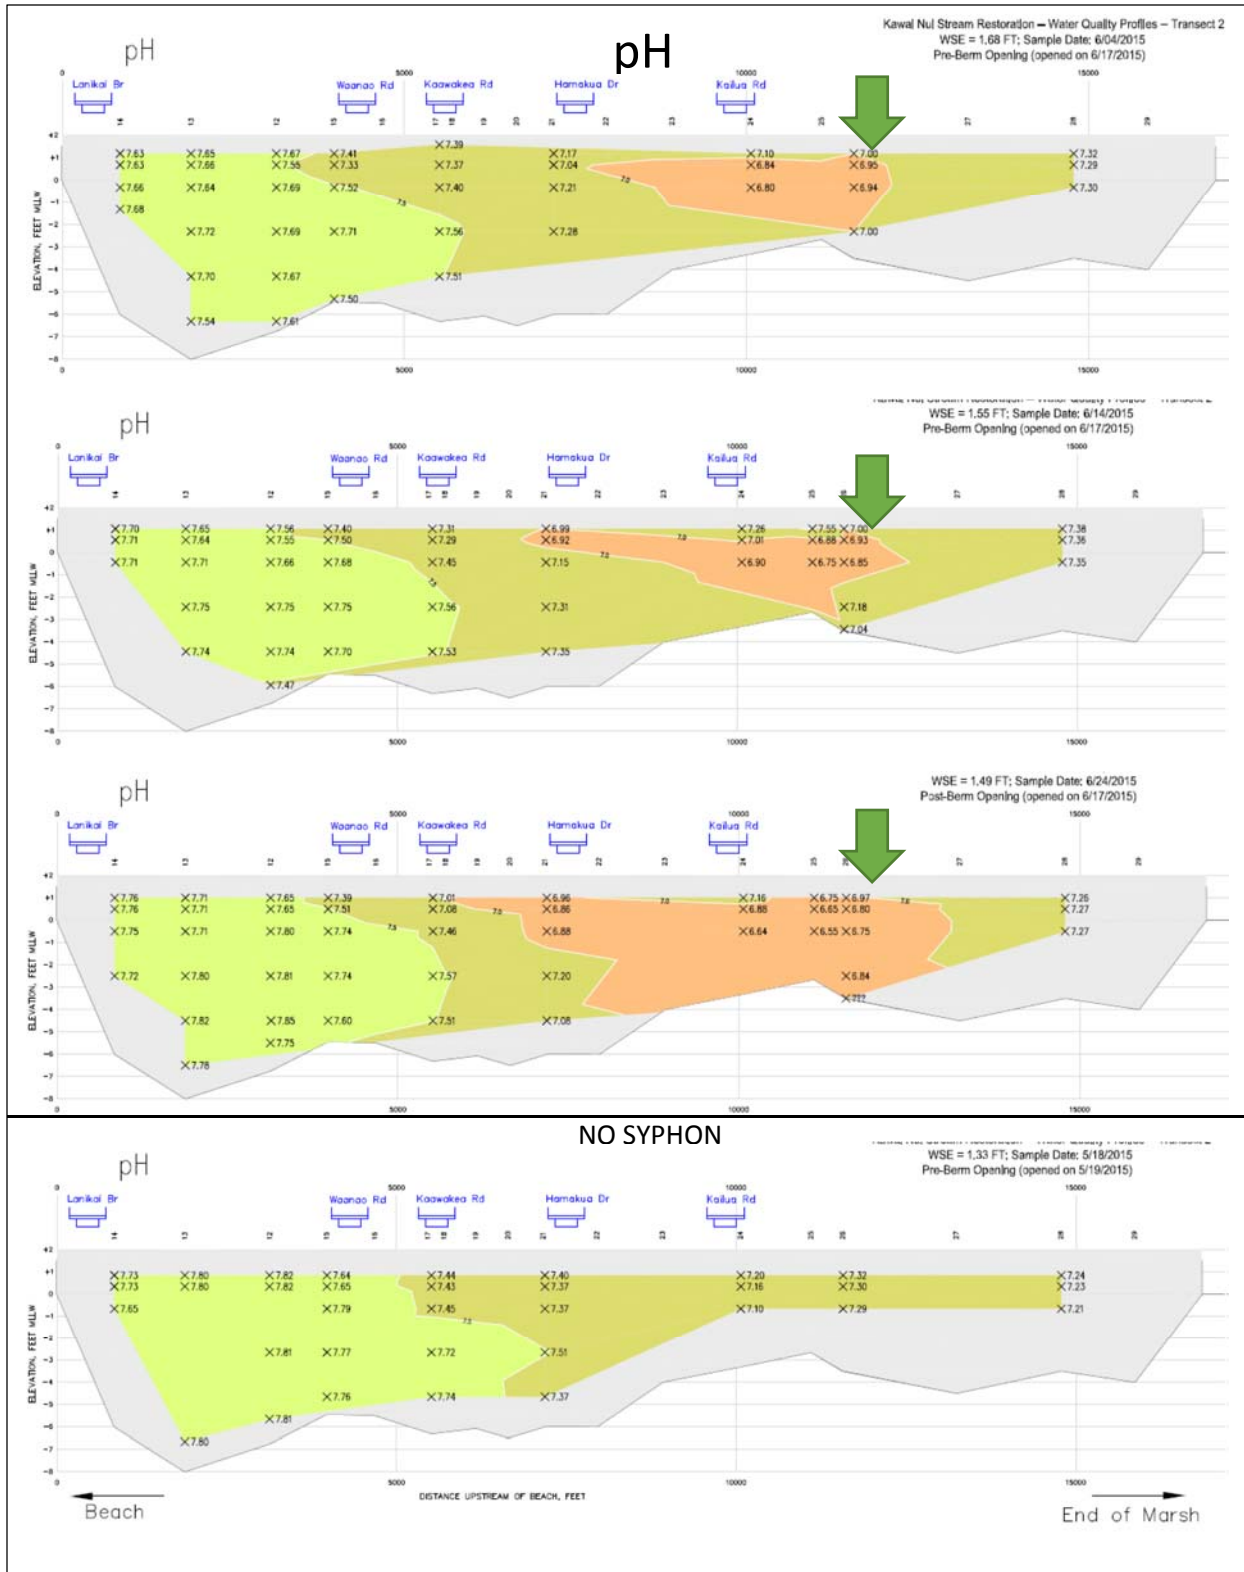
Figure 3.22 Inflow of water from syphon (green arrow) appears to have lowered the pH in Kawai Nui Stream. Transects taken on 6/4 (top), 6/14 (2nd), and 6/24 (3rd) with the stream mouth open to flow from 6-17 through 6/20/2015. Bottom transect is from 5/18 just prior to starting the syphon.

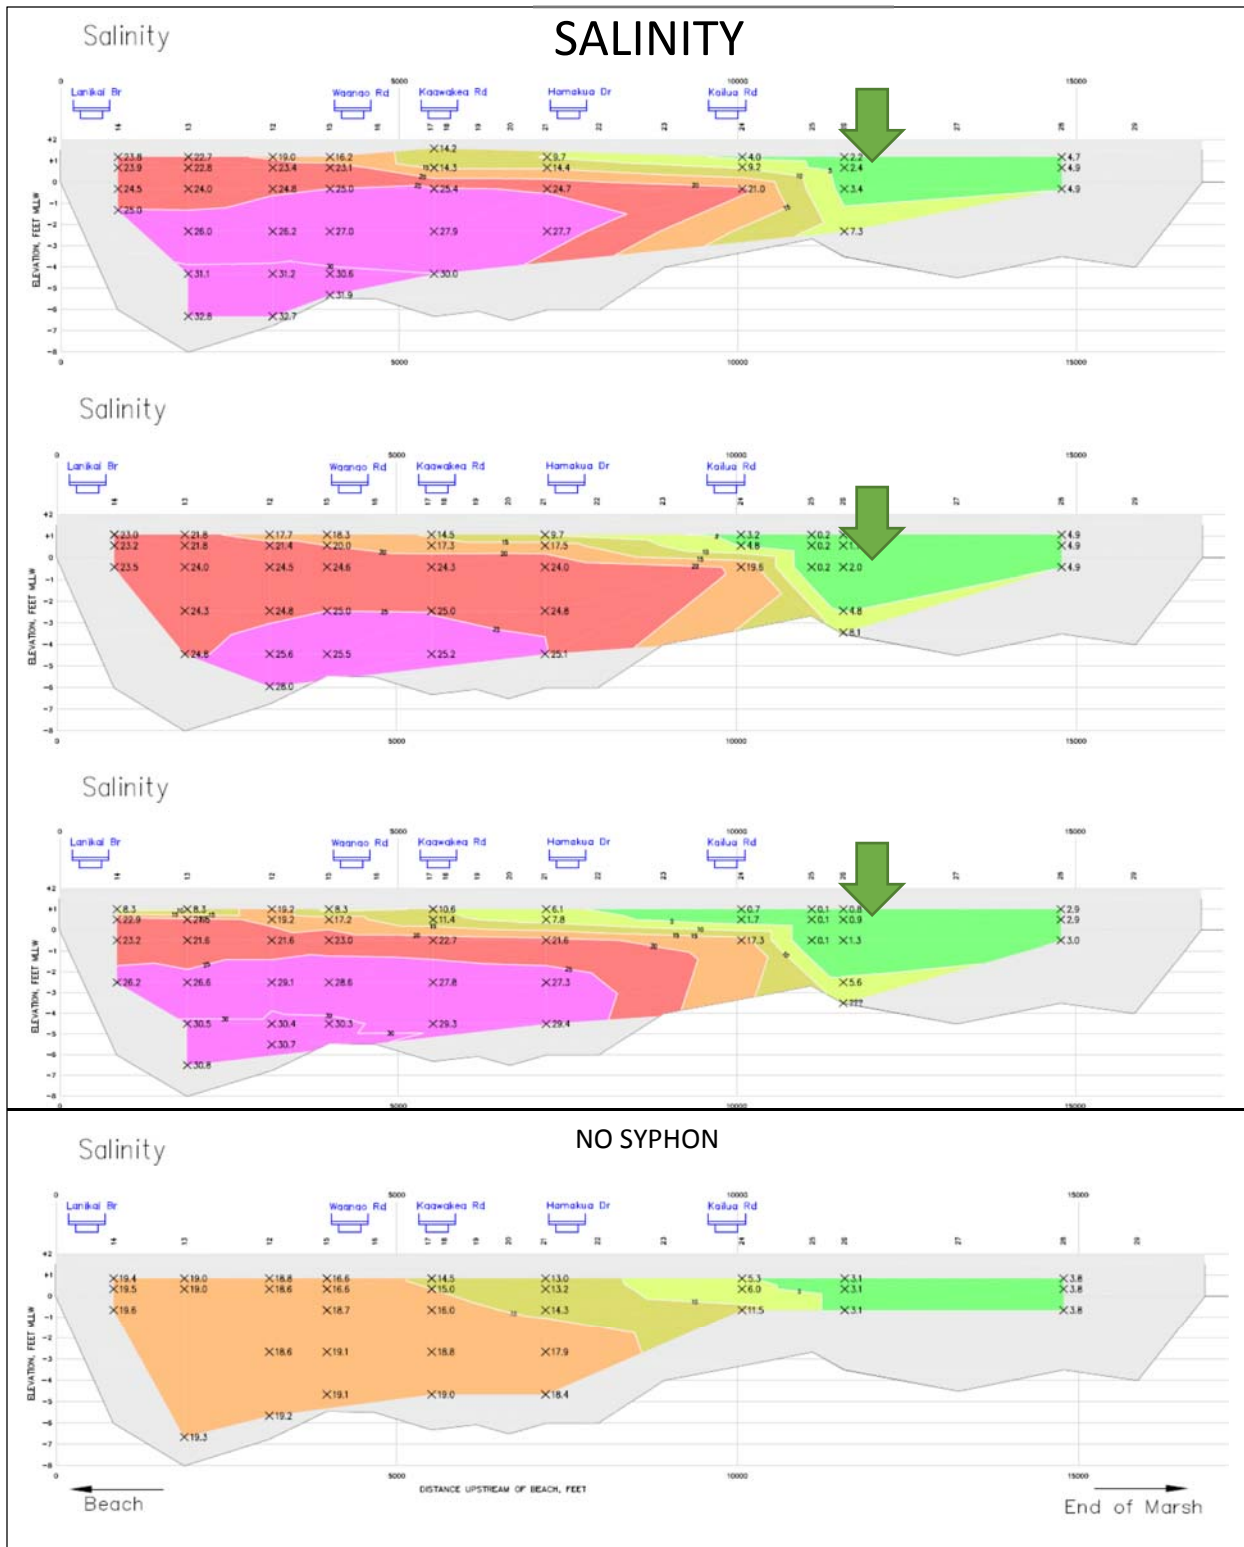
Figure 3.26 Inflow of water from syphon (green arrow) lowered salinity levels and depressed the salt wedge in Kawai Nui Stream. Transects on 6/4 (top), 6/14 (2nd), and 6/24 (3rd) with the stream mouth open to flow from 6-17 through 6/20/2015. The bottom transect is from 5/18, prior to flow from the syphon.
