KAWAI NUI STREAM FLOW RESTORATION PROJECT

SIPHON FLOW RESTORATION EXPERIMENT REPORT

MAY 2016

Oceanit Laboratories Inc.

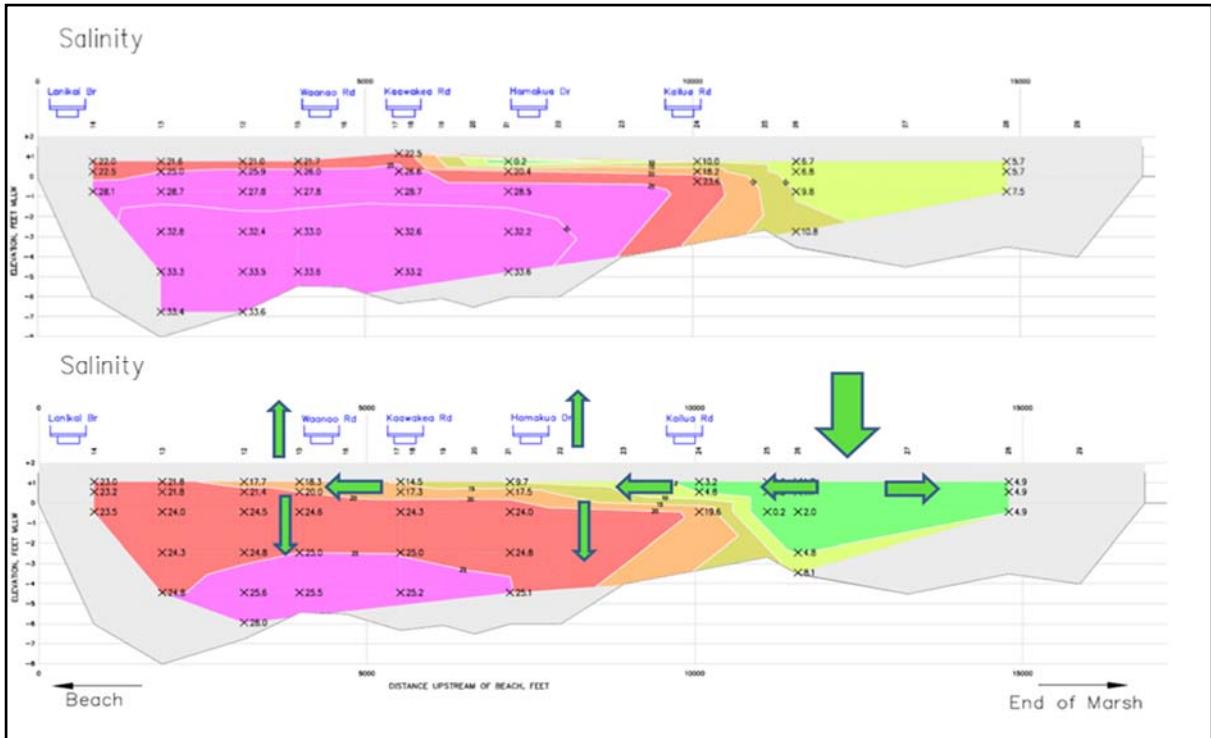
Figure 4.1 General impact of syphon inflow upon salinity. Top: Cross section of Kawai Nui Stream showing intrusion of salt wedge from ocean. Bottom: Same cross section after 1-month of inflow from syphon (large arrow) showing flow of fresh water along stream surface, evaporation, and depression of the salt wedge throughout stream.

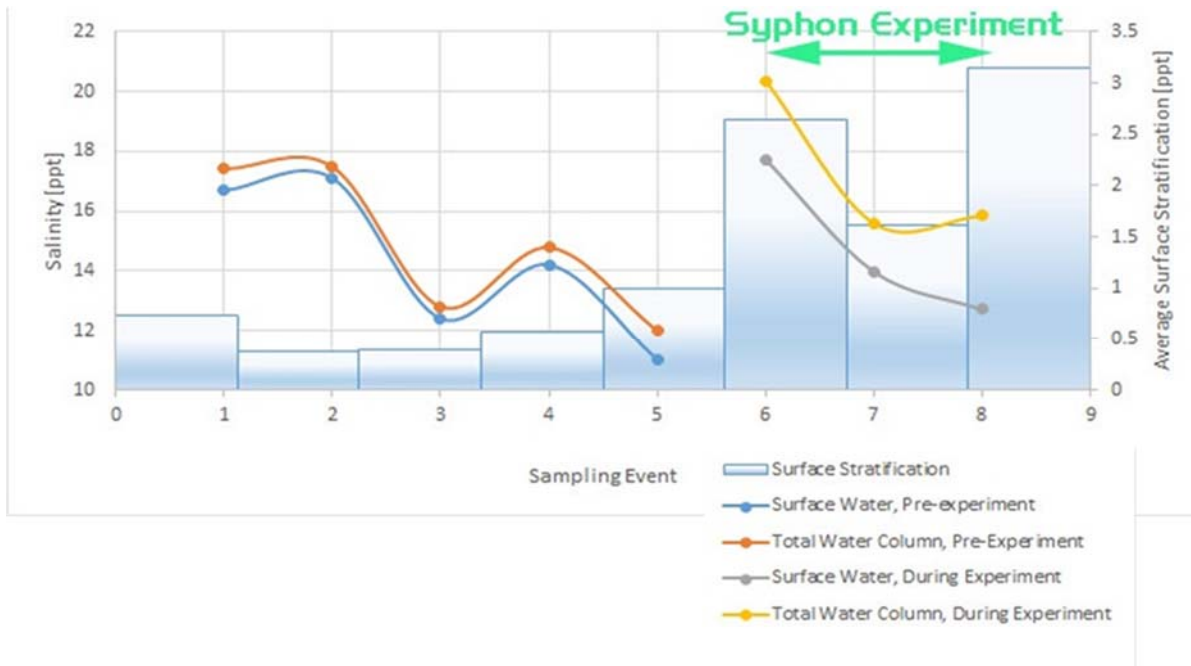
Figure 4.2 Inflow of water resulted in increased water stratification within the Kawai Nui Stream Branch

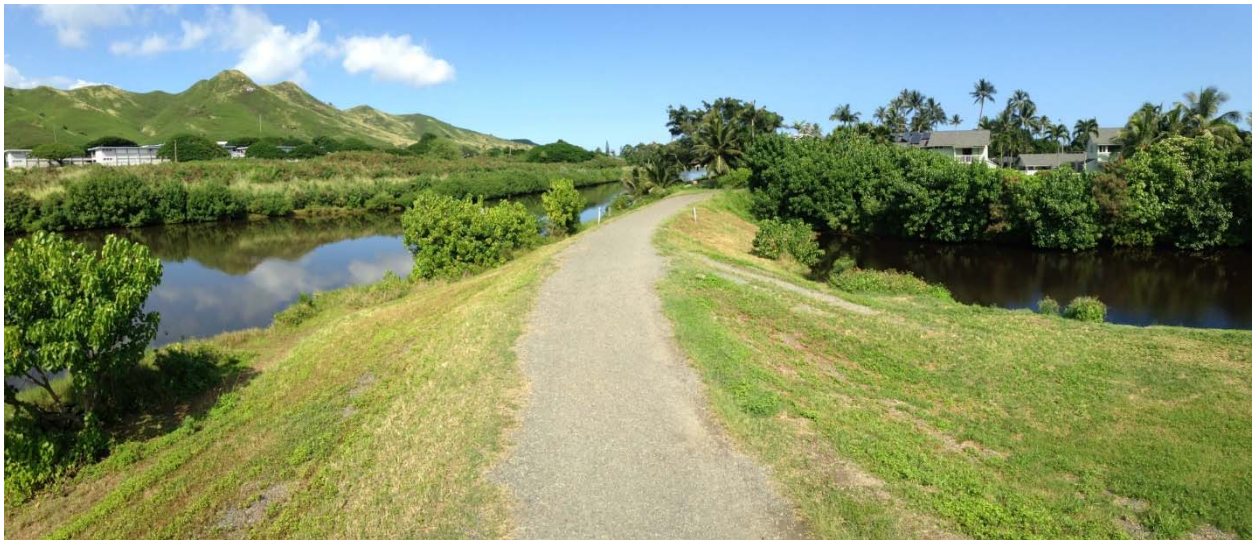
**Figure 5.1 Levee separating Oneawa Canal (left) from terminus of Kawai Nui Stream (right).
Proposed location for 2-foot water surface elevation control drain.**

- Flood threat may be reduced to the community by providing an overflow at an elevation of 2-ft MLLW from the distal end of Kawai Nui Stream through the flood control levee to the Oneawa Canal (Figure 5.1).

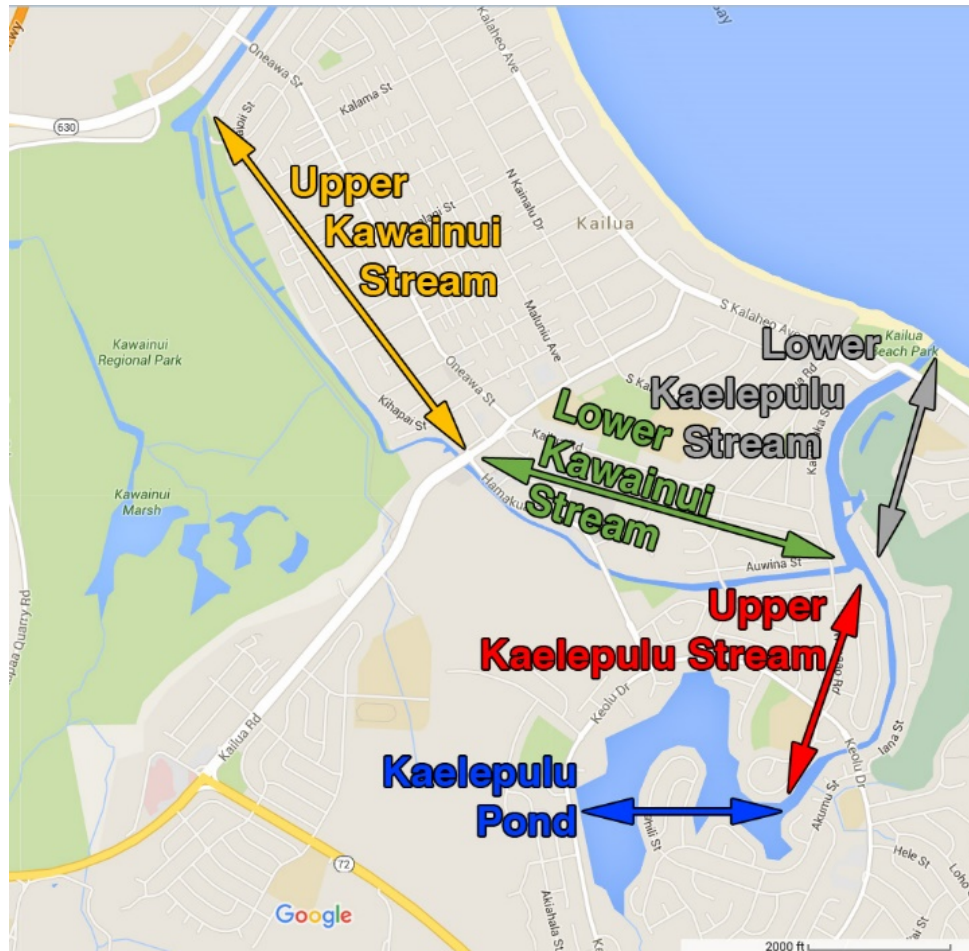
2012-2014 Pre-Experiment Control Water Quality Transects

The graphics in this appendix depict the results of physical water quality surveys through both branches of the estuary. Each survey was conducted beginning at dawn at the Kaelepulu wetland and was generally completed within 3 hours ending at the terminus of Kawainui Stream. The left hand page represents results from the Kaelepulu branch and the right hand page from the Kawainui branch. A color key may be found as a fold-out page at the end of the appendices.

This project was initiated in 2012 and measurements of “pre-syphon control” water quality transects began almost immediately – not anticipating the 2⁺-year delay for permitting of the experiment. As a result quite a few more transects were conducted than was likely necessary for the project. For each transect, physical water quality parameters (Temperature, Salinity, pH, Turbidity, O₂) were measured from the surface down to the bottom of the estuary at 20 key locations in both branches of the estuary (Figure 2.6, main report). The dates of each transect are noted in the table below in relation to the stream mouth opening events. Each double page layout represents the twin transects conducted through the Kaelepulu branch (left page) and the Kawai Nui branch (right page) of the estuary. Color keys for the data are located on an oversized page at the end of the appendix, and is designed to be folded out for reference when viewing the following graphics.

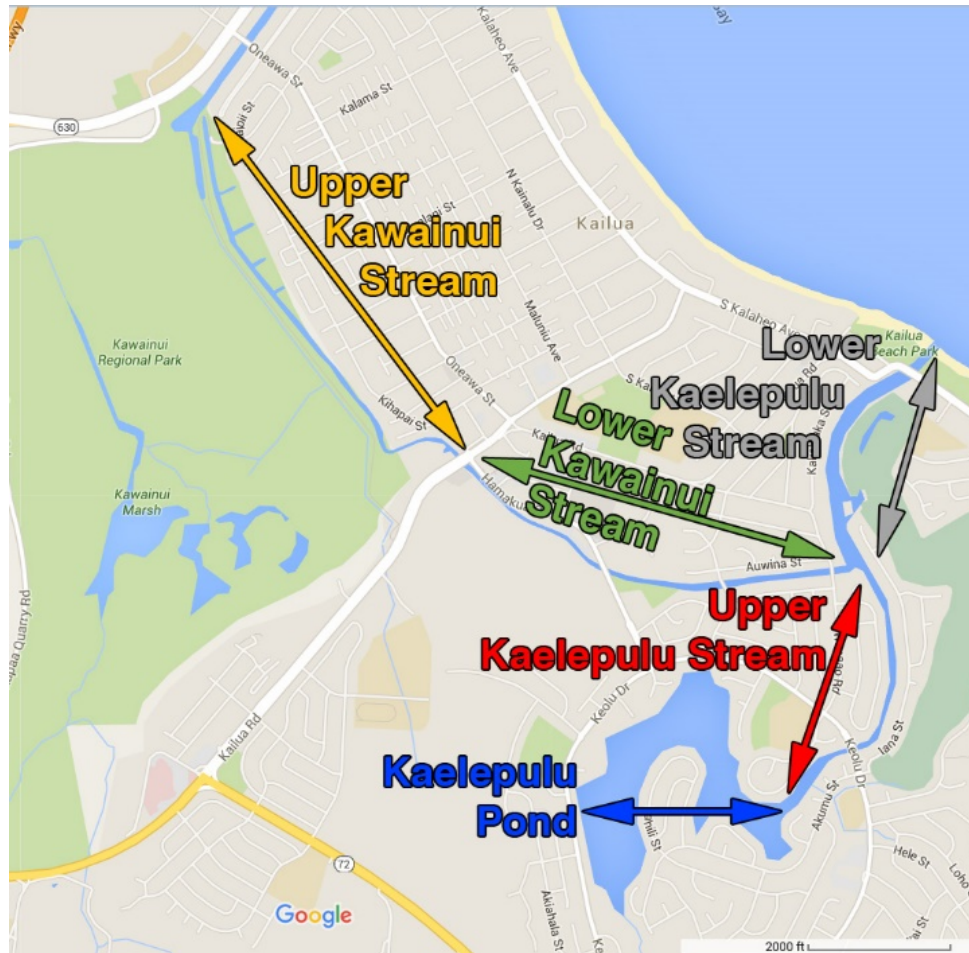
2015 Experiment Water Quality Transects

The graphics in this appendix depict the results of physical water quality surveys through both branches of the estuary. Each survey was conducted beginning at dawn at the Kaelepulu wetland and was generally completed within 3 hours ending at the terminus of Kawainui Stream. The left hand page represents results from the Kaelepulu branch and the right hand page from the Kawainui branch. A color key may be found as a fold-out page at the end of the appendices.
