# Natural History, Hydrology & Water Quality of Kaelepulu Pond

The Urbanized Estuary of Enchanted Lake

Robert E. Bourke  
*Kailua, Hawaii*

## **Natural History, Hydrology and Water Quality of Kaelepulu Pond, the Urbanized Estuary of Enchanted Lake**

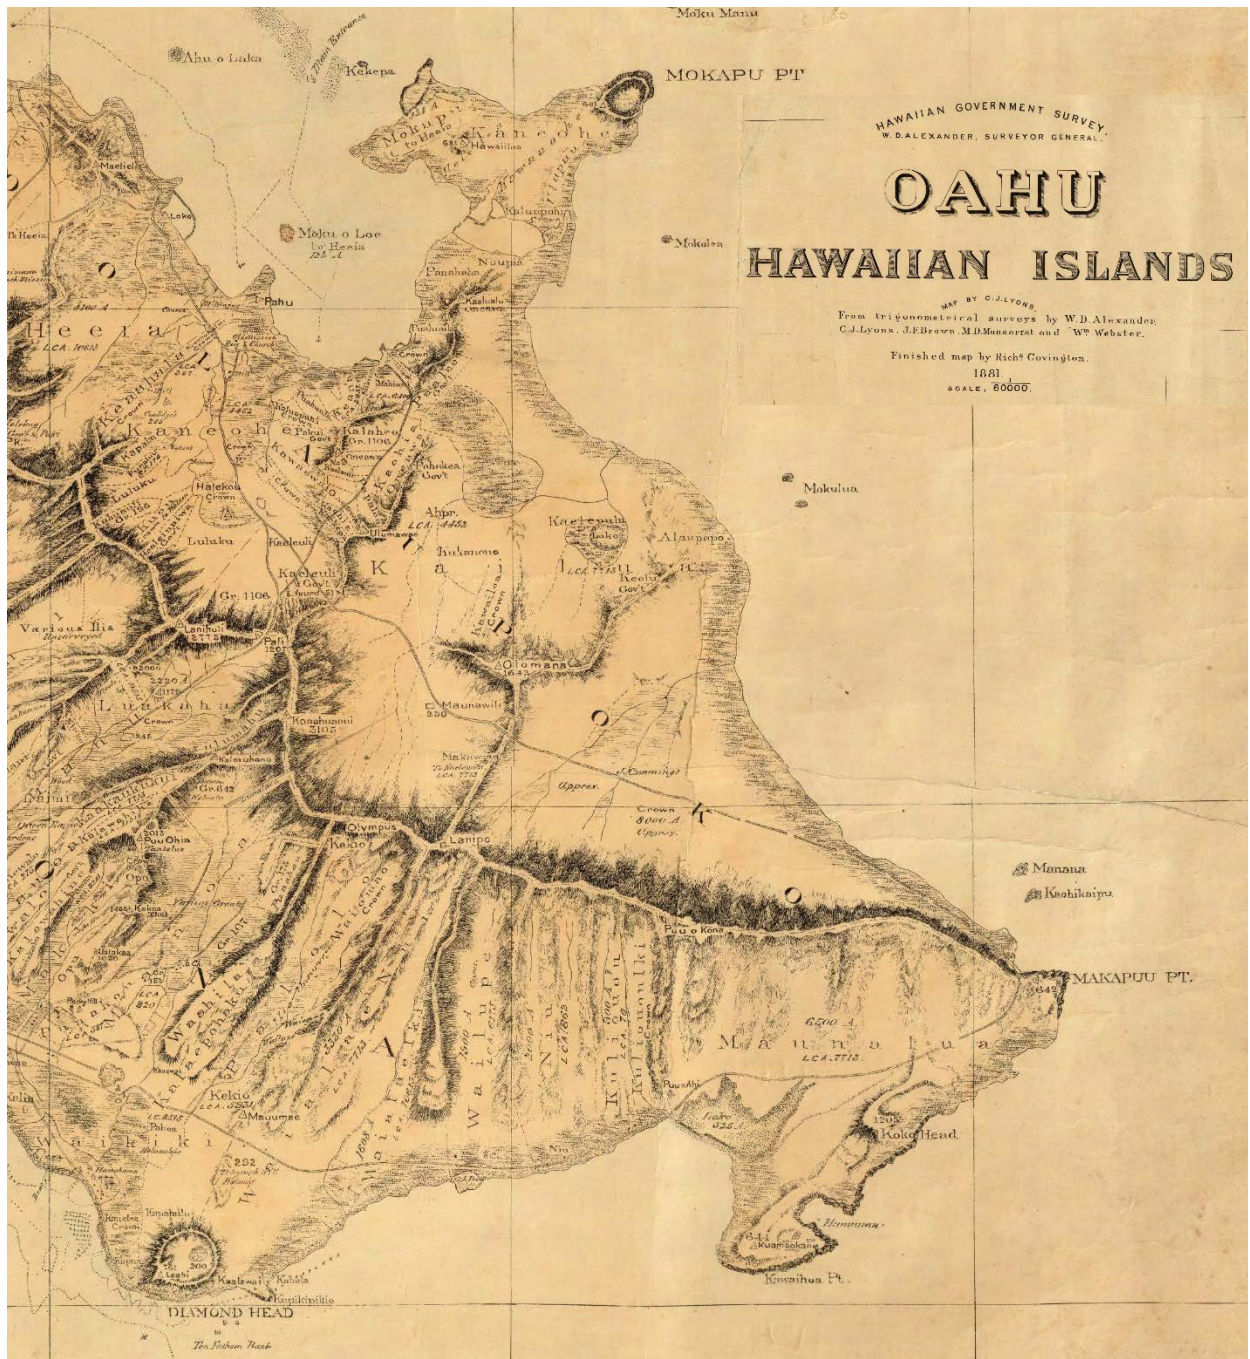
Figure 1. Section of Oahu map of 1881 by Rich Covington showing mouth of Kaelepu Stream about 1,000 feet west of its present location

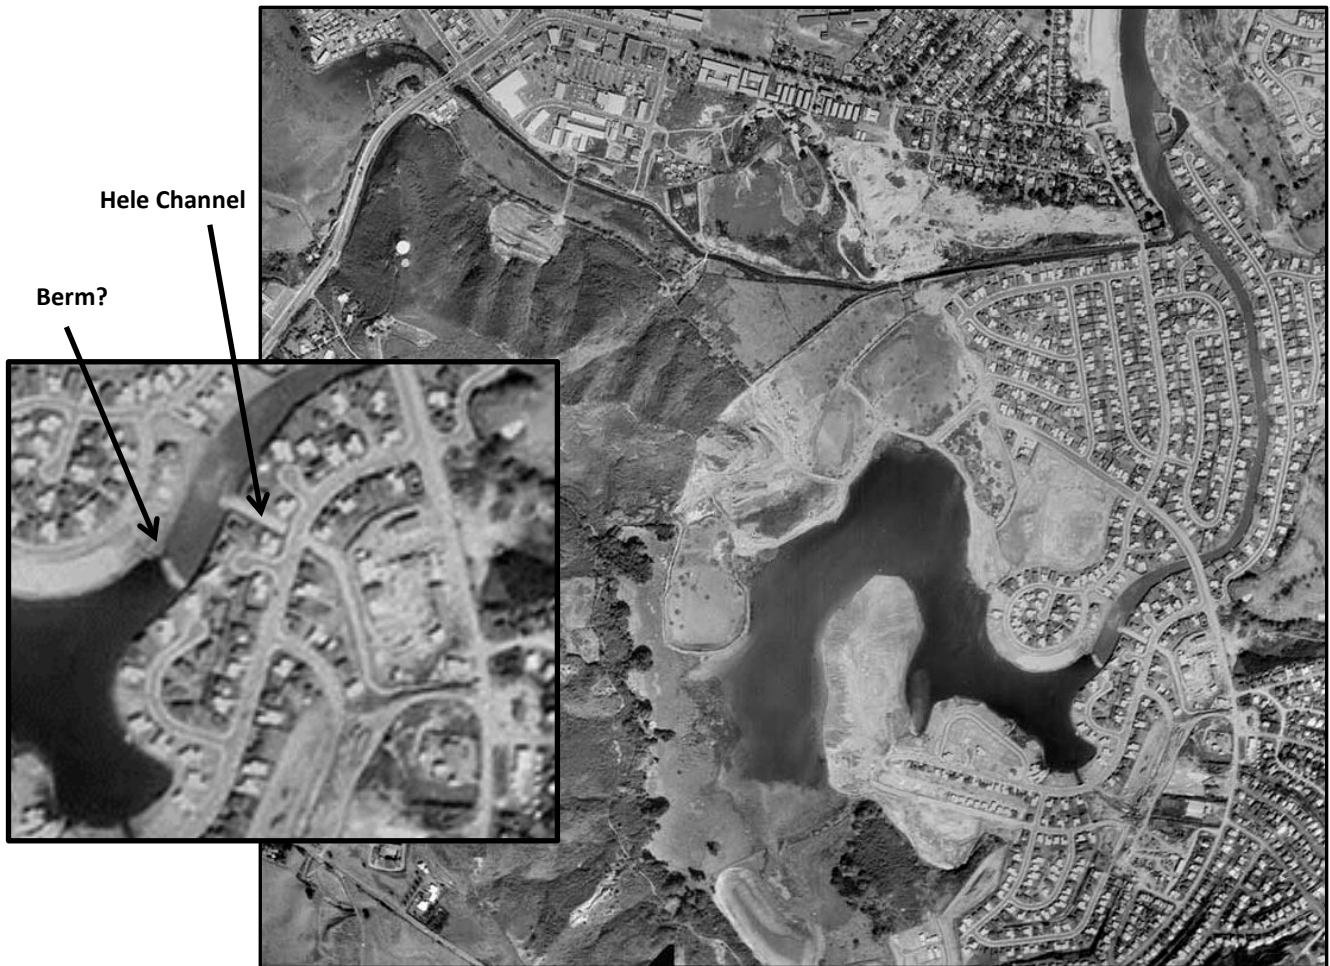
Figure 6. 1963 aerial photo of Enchanted Lake under construction. Note lack of Kawainui levee and presence of berm across stream exit from pond with heavy silt load entering from Hele Channel inlet (enlarged inset) where the stream channel is still very shallow. USGS: EKM-2CC-246, 1-14-63.

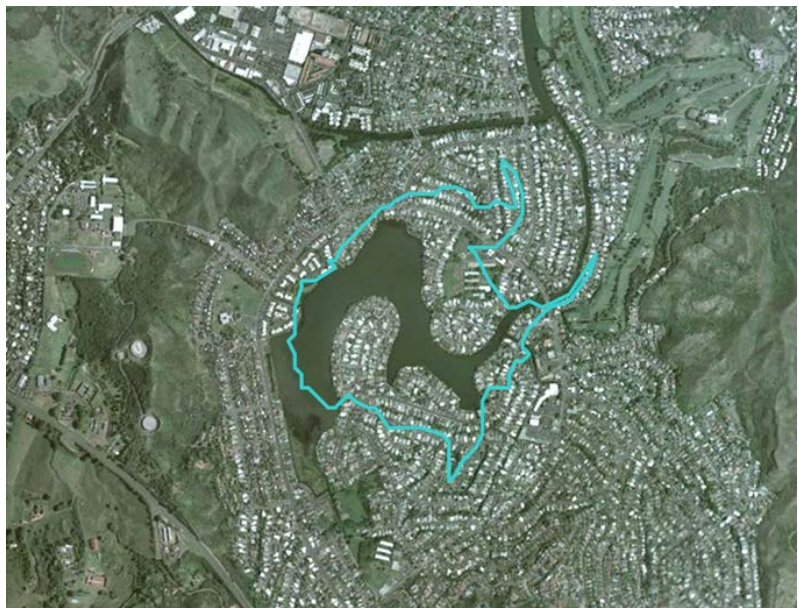
**Figure 7 Outline of the 1926 Kaelepulu Pond superimposed over present day Enchanted Lake.**

water surface area of about 135 acres to the estuary. As the community was constructed, each successive group of shoreline home lots was brought into the “Enchanted Lake Association” (ELA) for a total of 136 private home owners. An additional 37 home lots about the Kaelepulu wetland which, as it was outside the initial Bishop Estate properties leased to Lone Star, are not obligatory members of the community association (ELRA) who now own the lake. The present configuration of the pond has little resemblance to its historical footprint (Figure 7, Figure 8).

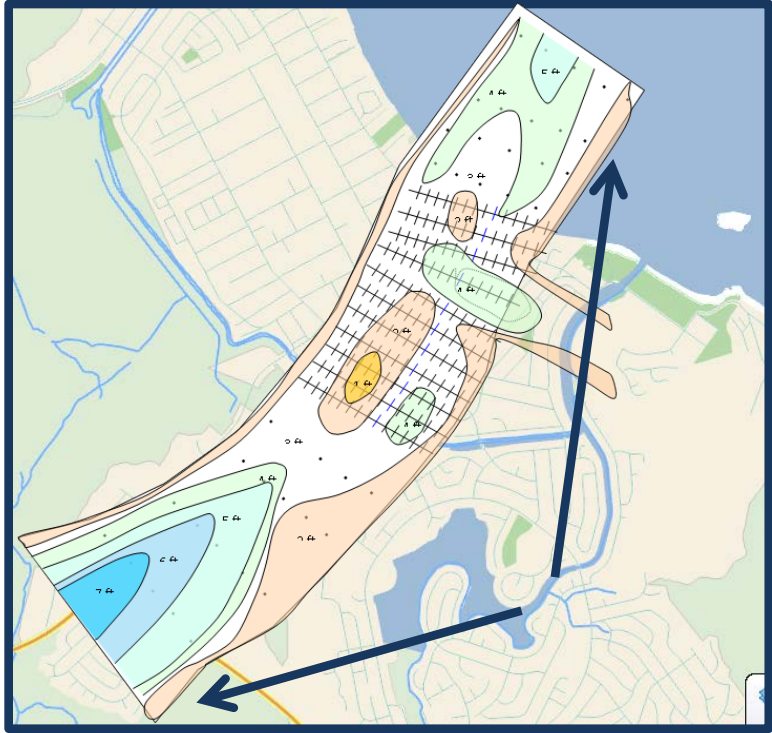
**Figure 17. Top: The mouth of Kaelepulu Stream as it exits the pond is shoaled to within a foot of the surface and dramatically impacts circulation between the stream and the pond. Bottom map graphically depicts the estimated relative volume of water in each section of the estuary as represented by cubes with a base as shown**

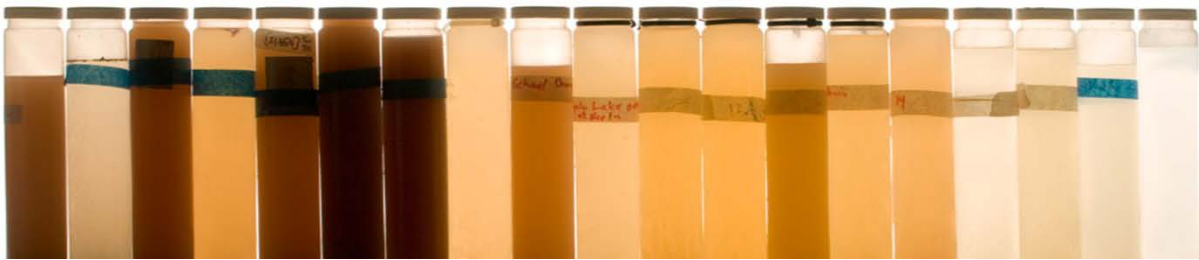
**Figure 19 Water quality samples from pond inlets obtained during a single runoff event (3/19/06) distinguish between drainages that have active construction grading projects and those that do not.**

The most obvious source of pollutants to the system is sediment in runoff from construction sites with inadequate erosion and runoff controls. The samples depicted in Figure 19 were taken during a single storm event from inlets all around the pond. The inlets influenced by construction sites are obvious.

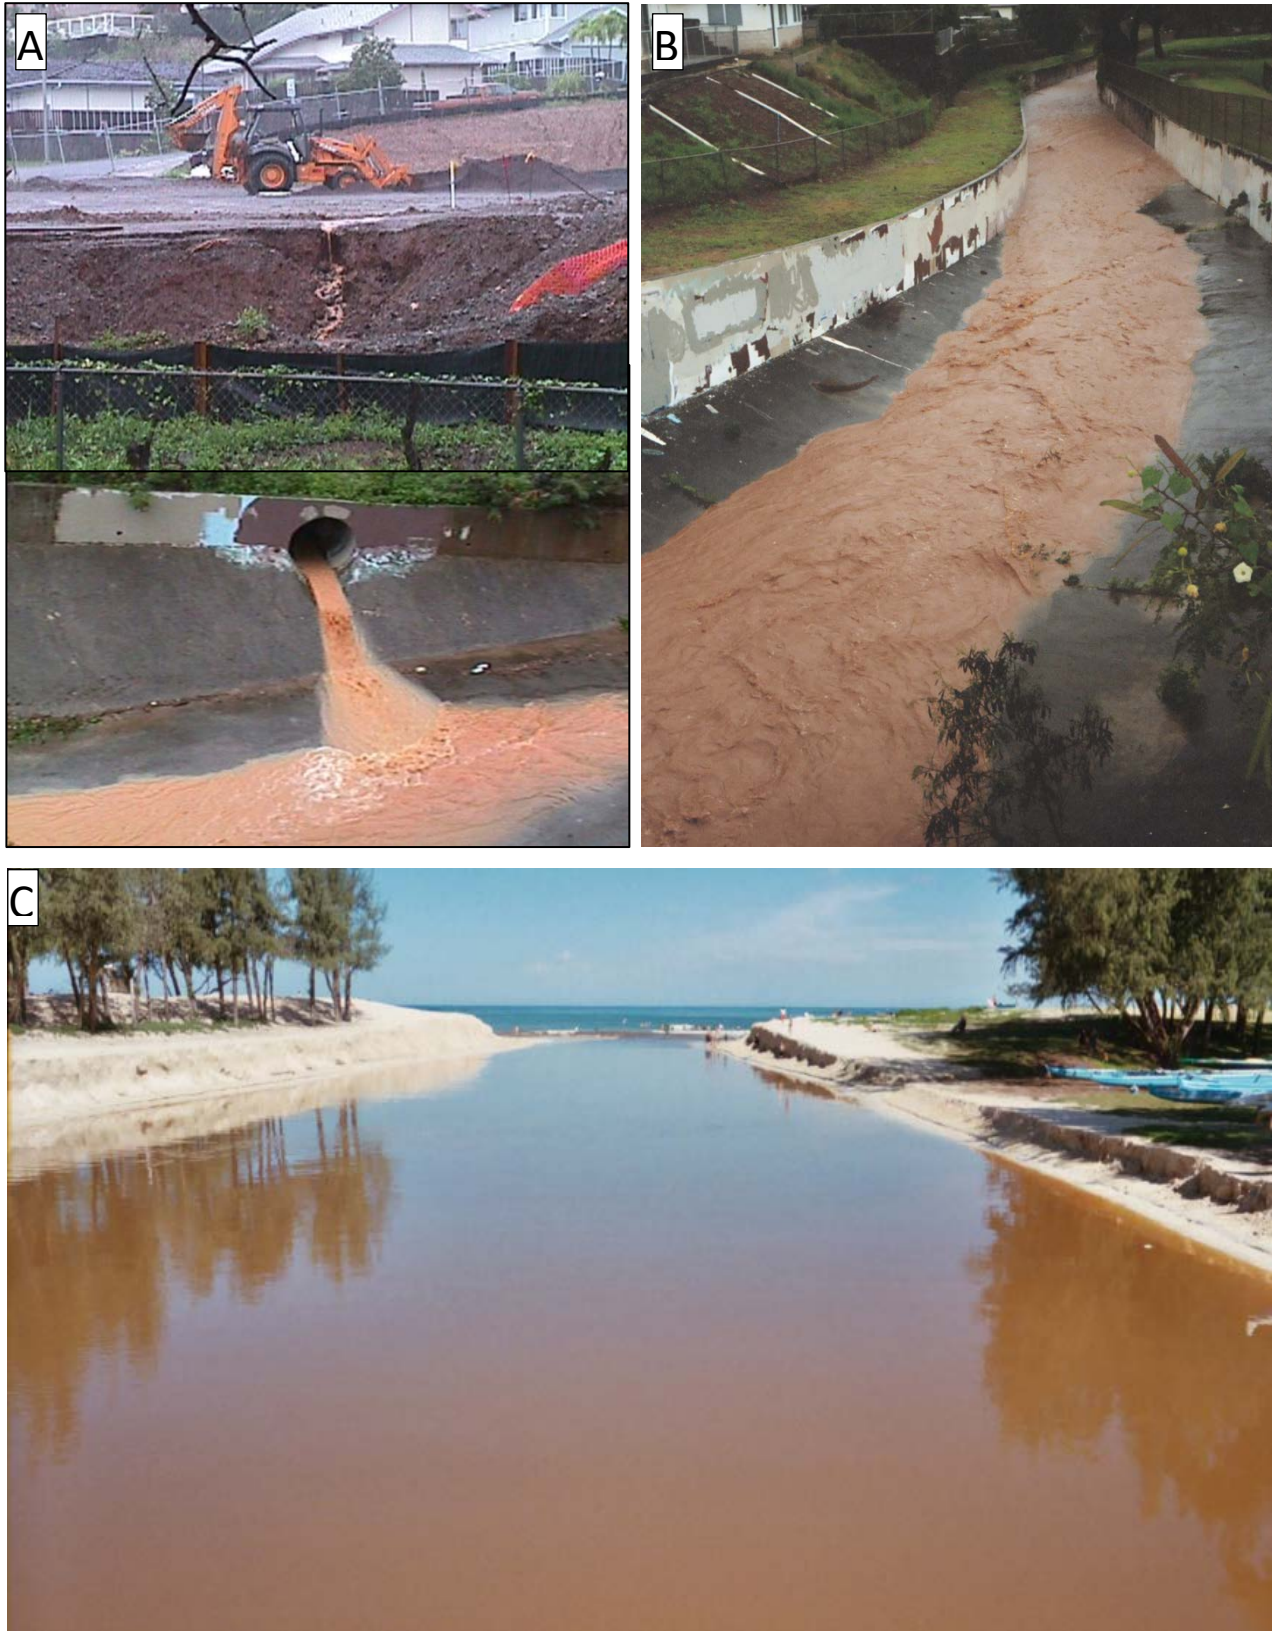
**Figure 20 Construction activities (A) have the greatest impact upon delivery of sediment and nutrient turbidity to the pond (B) and into the ocean (C) when the stream mouth is open.**

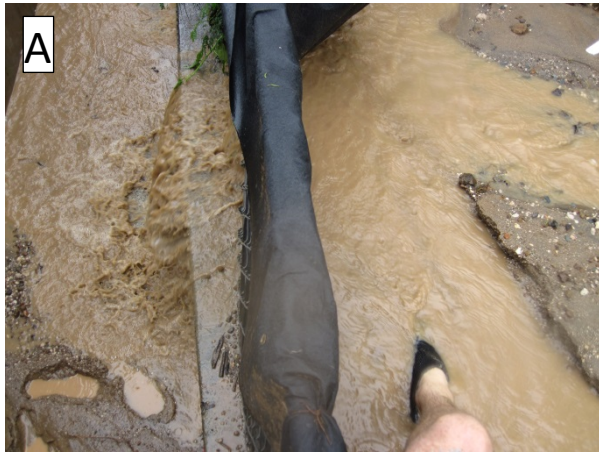
**Figure 21** Poorly implemented BMPs at construction sites (A) or intentional by-passing of required BMPs (B) result in significant plumes of turbid water entering the pond (C) and deposition of fine mud throughout the estuary (D). The high iron content of the soil colors the pond bright orange for several days following major rainfall events when land is being graded in the watershed.

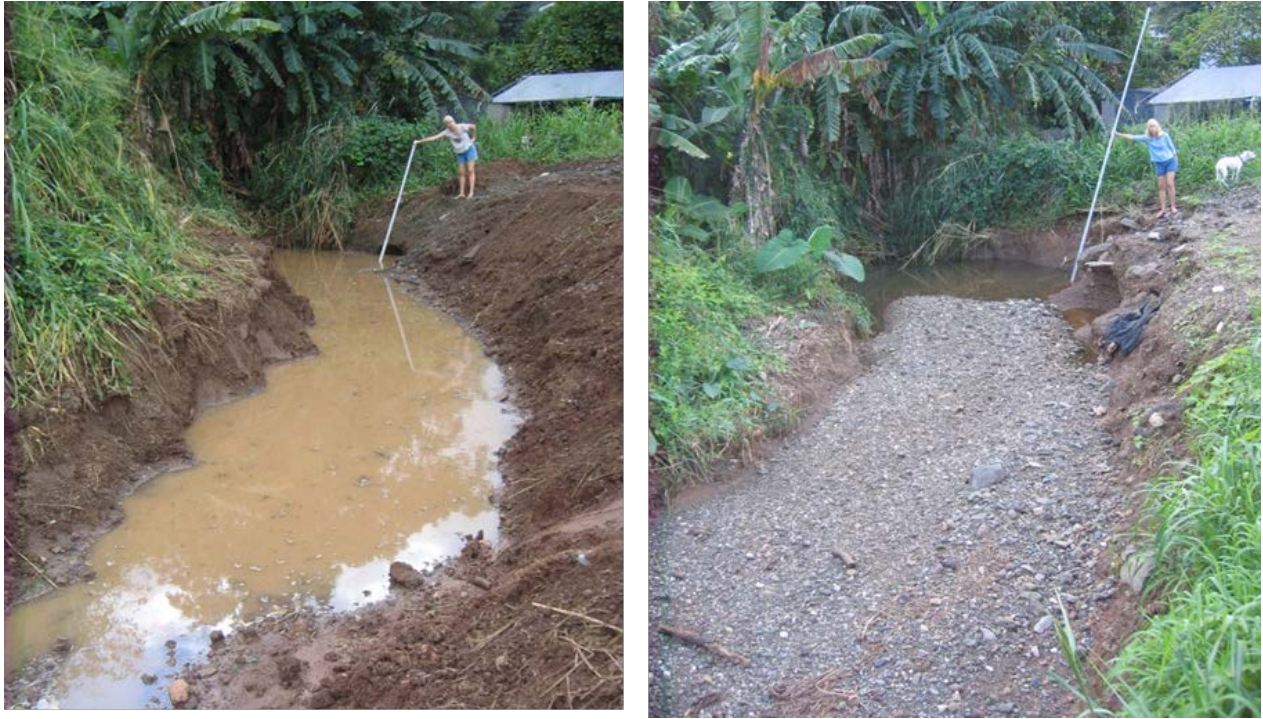
**Figure 25. Before (left) and after(right) sediment from a City storm drain filled this swale during a single storm. The staff is a 16-foot survey rod.**

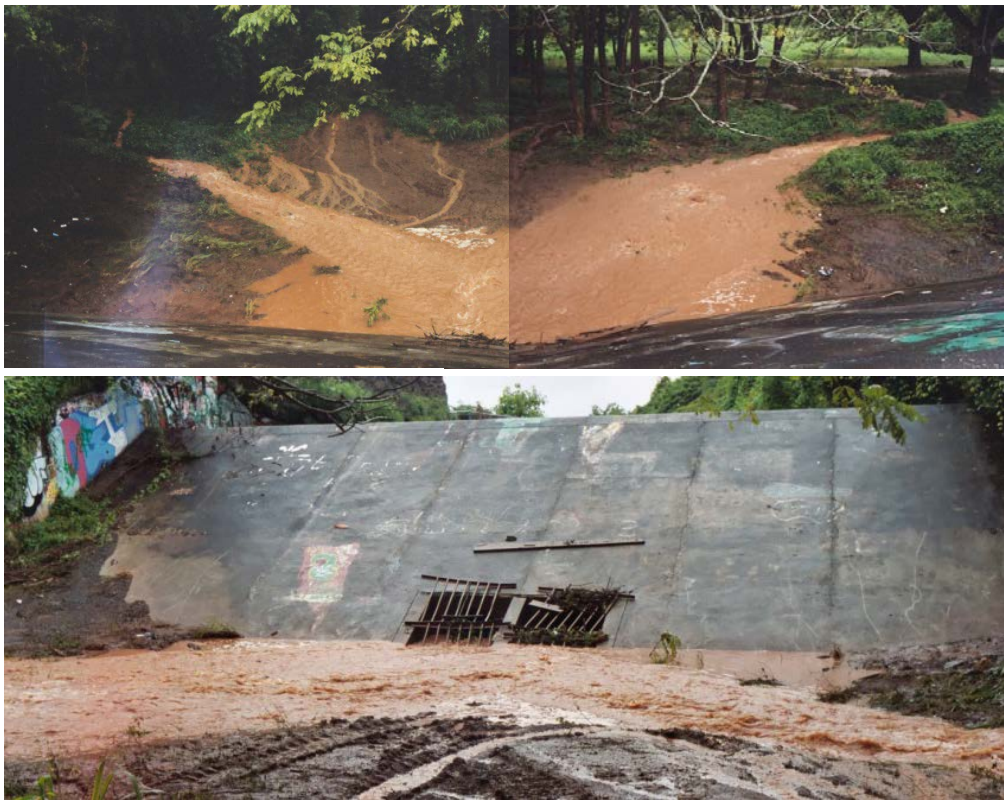
**Figure 26. Top: Looking down the inside Keopu dam face as muddy water pours through the two erosional channels cut through the internal raised berm. Bottom: Inside the basin looking at the back of the dam face with the muddy water flowing into the two flow control structures beneath the dam.**

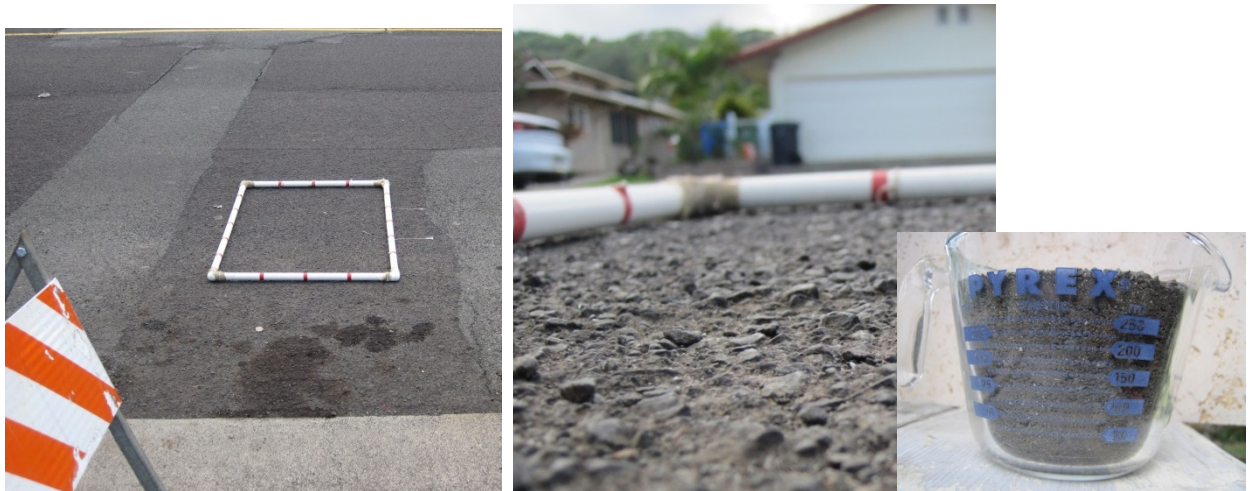
Figure 27 Testing for quantity and quality of material eroded from City road surfaces.

Many of the inlets into the pond are fronted by a shallow area of built up sediment. When digging in these areas one often comes across deposits of fine gravel similar to the type used in asphalt. When Keolu Drive was re-surfaced in 2010, measurements of the eroded street surface were made prior to re-surfacing. One square meter of road surface was found to have eroded at least 3 liters of material of which 325 cc's of sand and gravel still remained indicating 2.675 L of erosion. Given that there are 57.5 miles of City roadways in the watershed, the total area of all roads (assumed average width of 34 ft) is about 1-million square meters and the total eroded material is about 2,675 cubic meters of material. This is equal to about 3,000 cubic yards, or 200 ten-yard dump trucks. Assuming this erosion took place over a period of 15 years yields an annual erosion rate from City Roads of about 200 yd<sup>3</sup>/year.

Road surfaces are often considered to be sources of heavy metals like Chromium, Lead, and Cadmium due primarily from automobile engine and brake wear. Samples of gravel from the lake below a storm drain after a big storm, another of fresh (hot!) asphalt, and the third sample of 325 cc vacuumed from the road surface all tested at below detection limits for arsenic, cadmium, chromium, lead, mercury, selenium and silver.

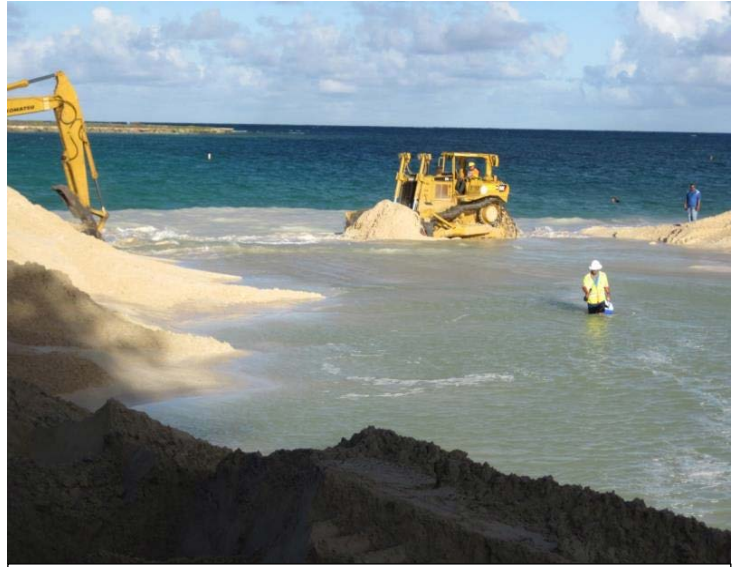
**Figure 29** The City uses heavy equipment to open the stream mouth about nine times per year.

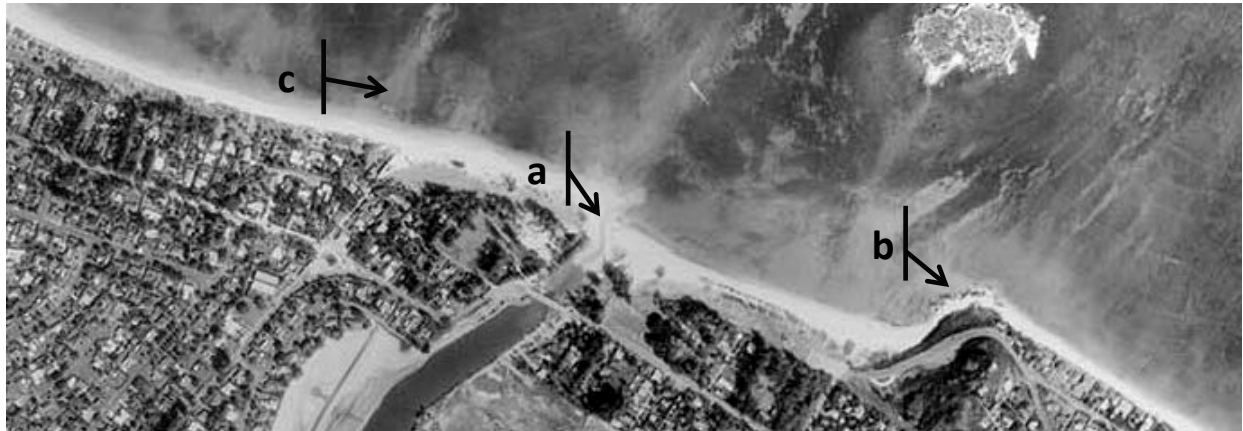
**Figure 30** 1963 aerial (USGS EKM-2CC-246) dated 1-14-63 prior to construction of Kawainui Levee. Note stream flowing across sand beach (a), and wide sand beach continuous around Aala Point and into Lanikai (b). Location of historic stream mouth channel (~1850 nautical chart) can be seen ~1,000 feet to the west (c).

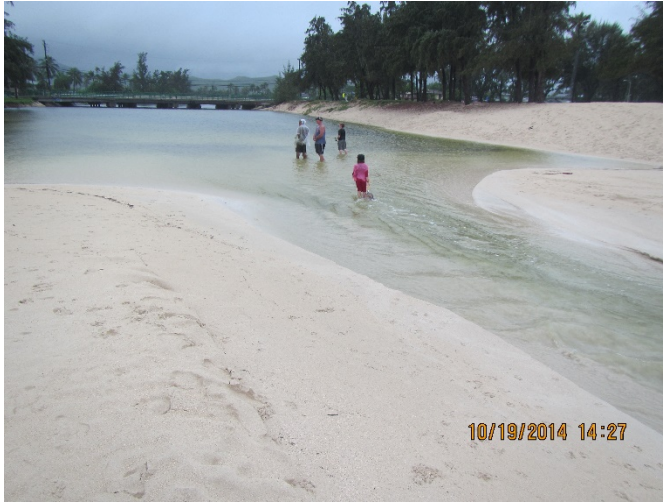
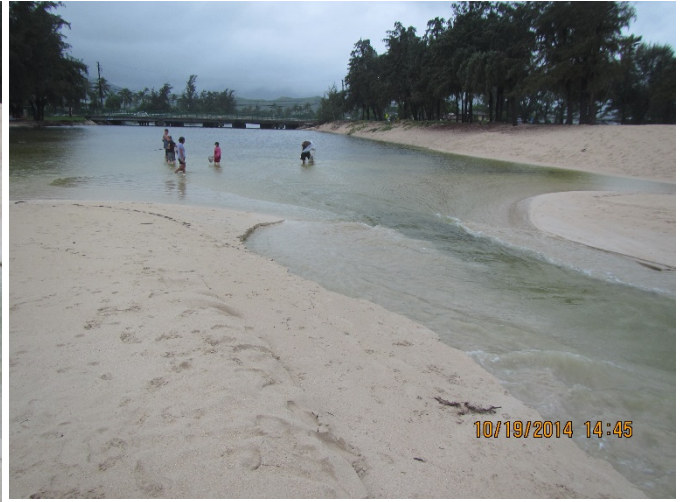
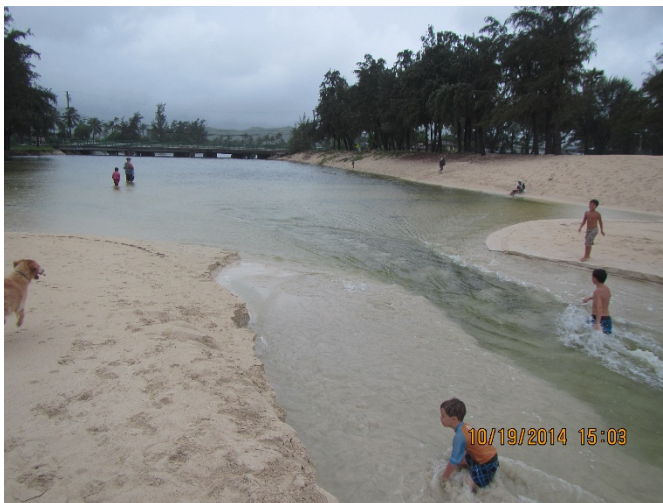
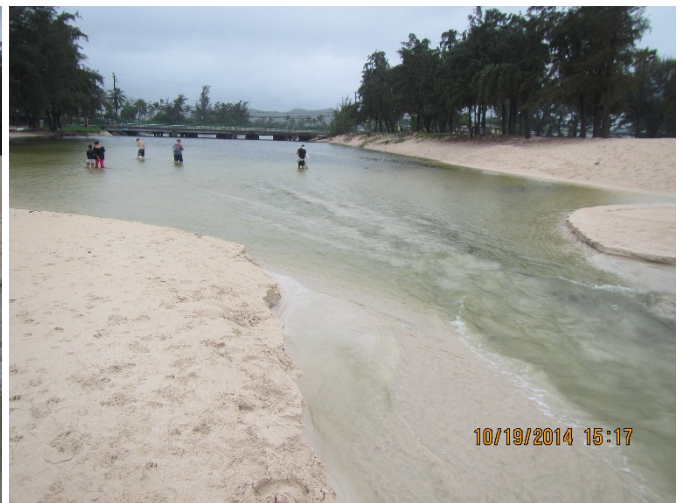
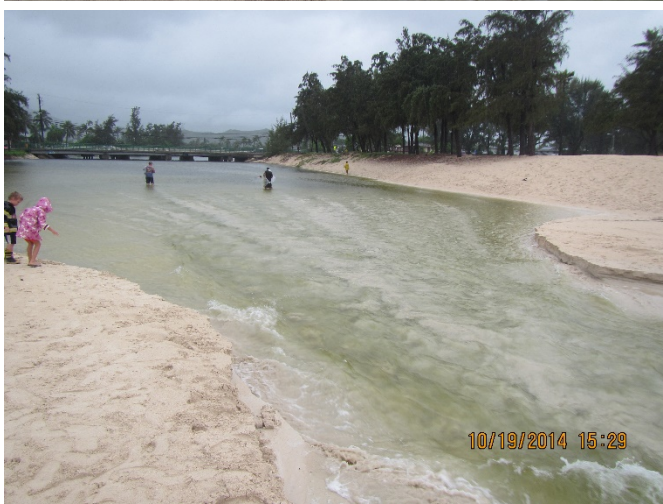
**Figure 34. October 2014 the City responded to a high water surface in the pond and an impending rainstorm to conduct an “emergency” opening of the stream mouth. Flow established in a 1-foot deep 15 foot wide channel completed at 16:15 developed into a 30-foot wide 3 foot deep channel in about an hour and fifteen minutes. Within minutes of the last photo the cameraman had to abandon his location as the bank was eroding from beneath his feet.**

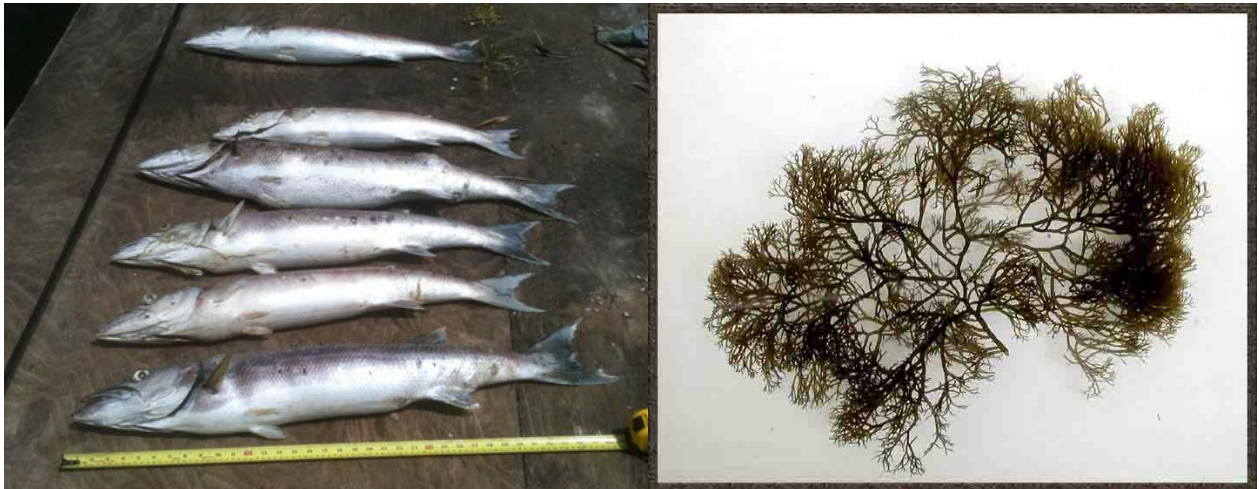
Figure 40 Large barracuda are common the in pond, these died due to an algae bloom. Awa awa schools feed almost exclusively on the macro algae *Gracilaria tikvayahe* as seen in the right hand photo.

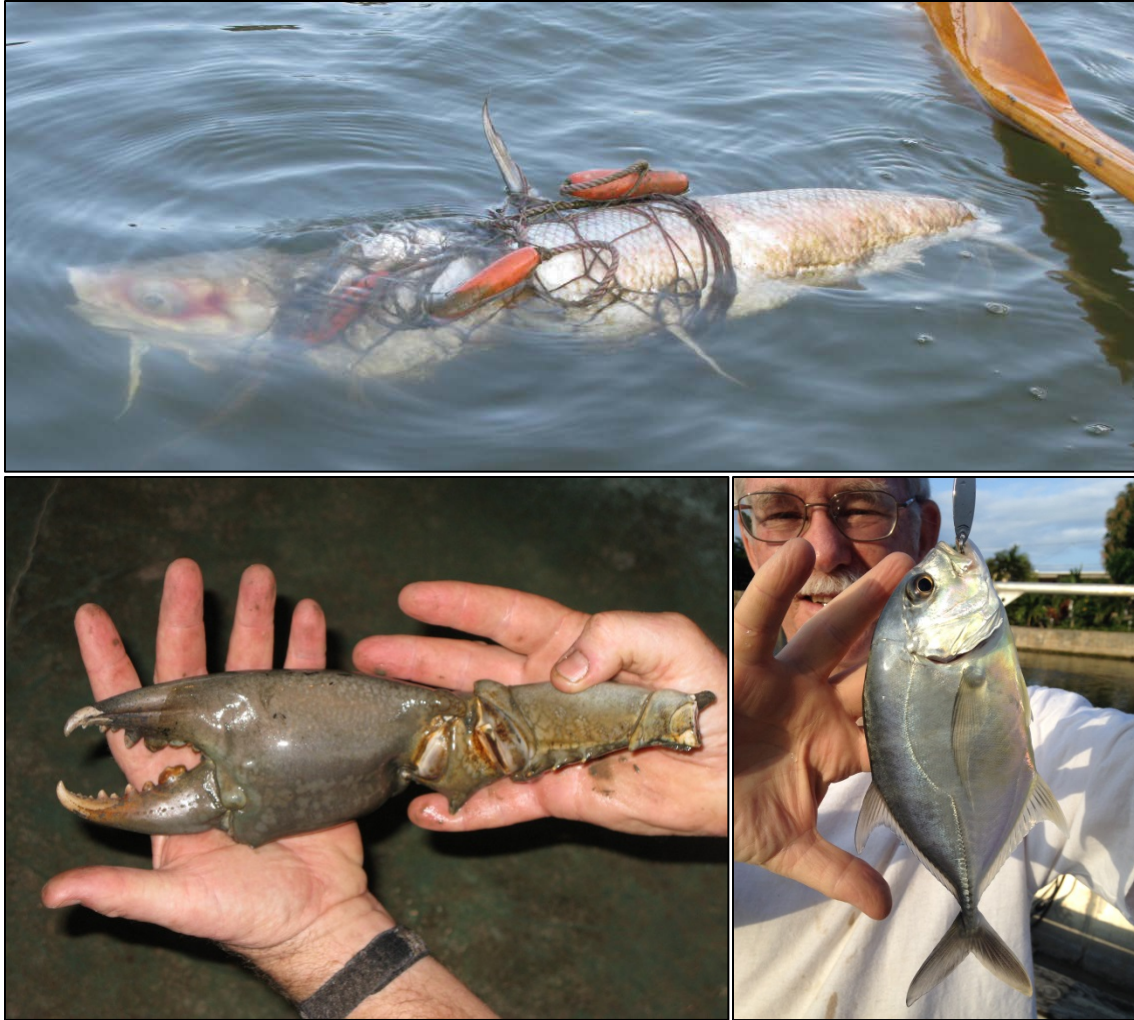
**Figure 41. The use of gill nets is prohibited in the ELRA and Kaelepulu Wetland portions of the estuary. The 10-pound Awa in the top photo provides a good rationale for this prohibition. Samoan crabs can reach sizable dimensions in the estuary. Since 2014, papio have been becoming more prevalent in the pond. By 2017 these papio had reached ulua (10 lb) size within the system.**
