KA'ELEPULU POND AND WETLAND DREDGING

KAILUA, O'AHU

SEDIMENT SAMPLING AND
ANALYSIS REPORT

JUNE 2017

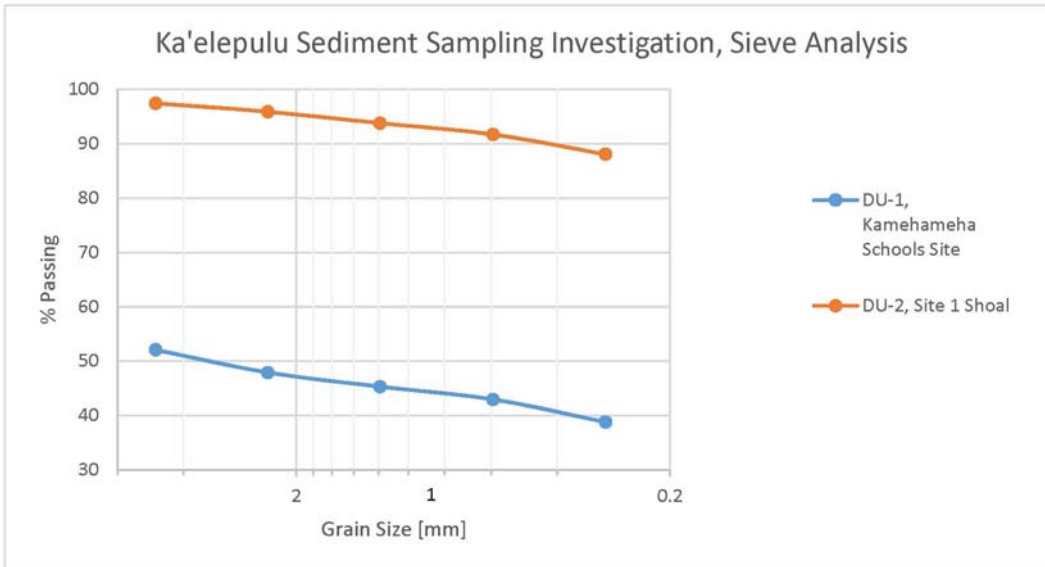
A sieve analysis was performed on the material from each decision unit

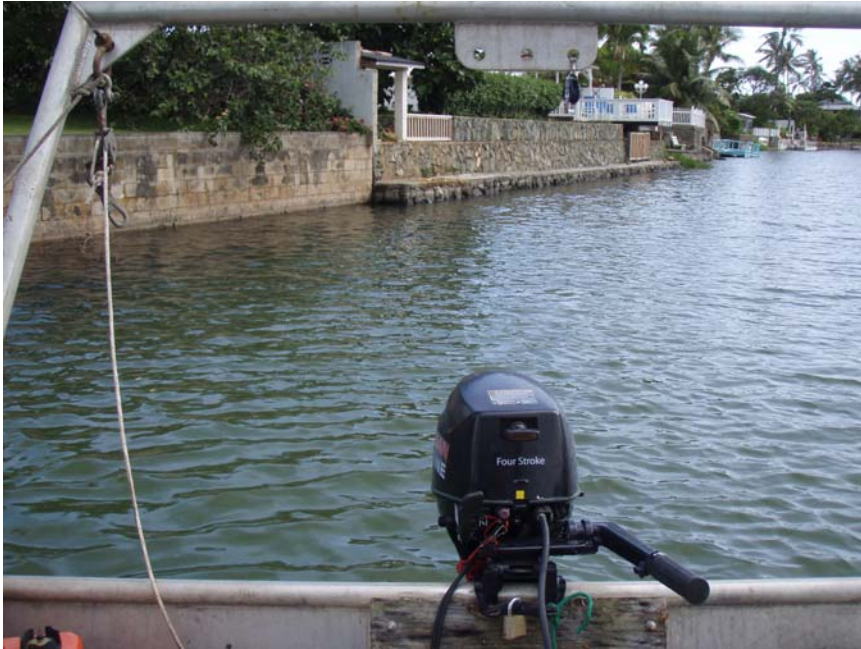
Samples were taken over the stern of a small vessel with an A frame to assist in lifting when necessary

Sampling took place from a small boat that was navigated into position over each sampling point with the use of digital GPS mapping. To prevent drifting at each site, the boat was moored to the pond bottom using a three point mooring with small anchors. Time of day and water depth was noted after mooring at each location.

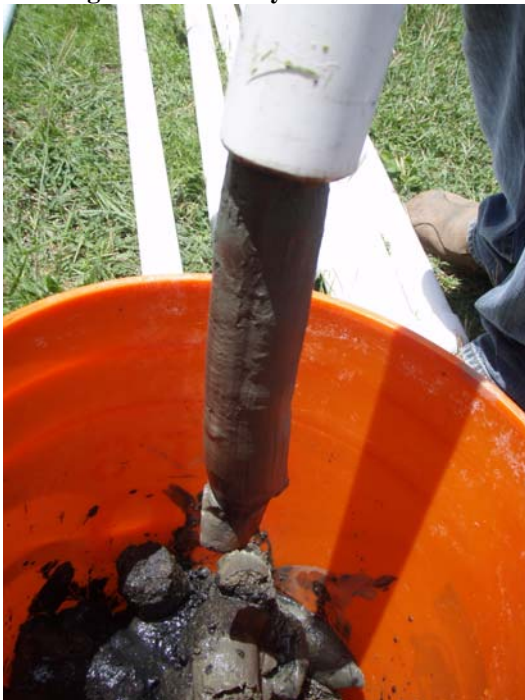
Figure The samples were collected using 1.5" PVC pipe and transferred to clean plastic buckets

At each location a clean, beveled end 1.5" PVC pipe was forced by hand into the pond bed sediment until refusal. A lumber cushion was placed on top of the PVC pipe and a small sledge hammer used to drive the pipe into the sediment. Pipes were hammered until either hard surface was reached, one foot below approximate dredge depth was reached, or the top of the pipe extended below the water surface. After reaching the proper depth, the distance from the water surface to the top of the pipe was measured, the top of the pipe filled with water, capped such that an airtight seal is made, and the pipe extracted using a twisting motion. On the boat, the bottom of each pipe was capped and the pipe labeled with sample location ID and 'Up' direction. Samples from five locations (one DU) were collected before returning to shore.

On shore, the top caps were removed and water decanted from above the sediment cores. The distance from the top of the pipe to the top of the sediment core was measured. The bottom caps were then removed and each pipe's contents were placed into a clean 5 gallon bucket. They were then mixed with a clean pair of wooden chop sticks until homogenous. Once each location sample was well mixed, equal amounts of each sample were composited into a stainless steel bowl. A stainless steel spoon was used to mix the composite sample in the stainless steel bowl until homogenous. Lab provided glass sample jars were filled, two for each DU and placed on ice. Three samples were submitted to the lab, one from each DU and one duplicate sample from DU #2. One sample from each DU were saved and placed into a freezer for preservation. All samples were labeled using indelible ink and placed in a cooler on ice after composition.

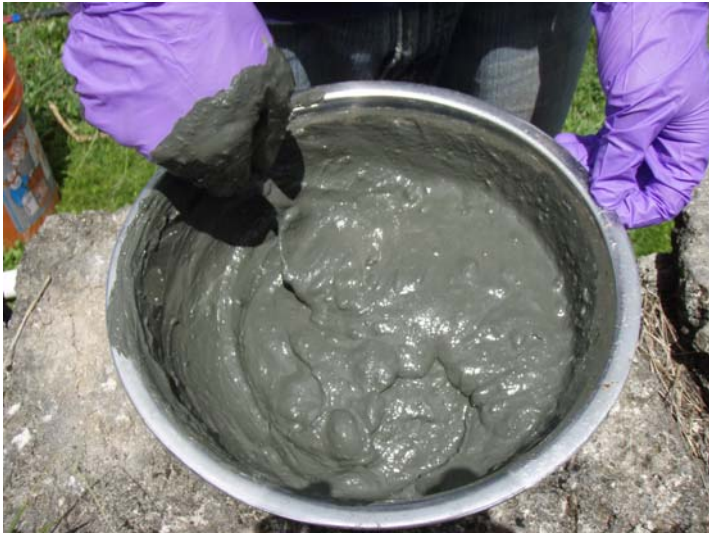
Samples were mixed and composited in stainless steel bowls with a stainless steel spoon

Gloves used by personnel were replaced between sample sites. The PVC coring tubes used for sampling as well as stainless steel bowls and utensils used for homogenizing core samples were not reused between each decision unit sample.
